3D recording of the site of the Finnish four-masted fore-and-aft schooner that sank in 1941

Maili Roio

Muinsuskaitseamet (National Heritage Board), Pikk 2, 10123 Tallinn, Estonia;
maili.roio@muinsuskaitseamet.ee

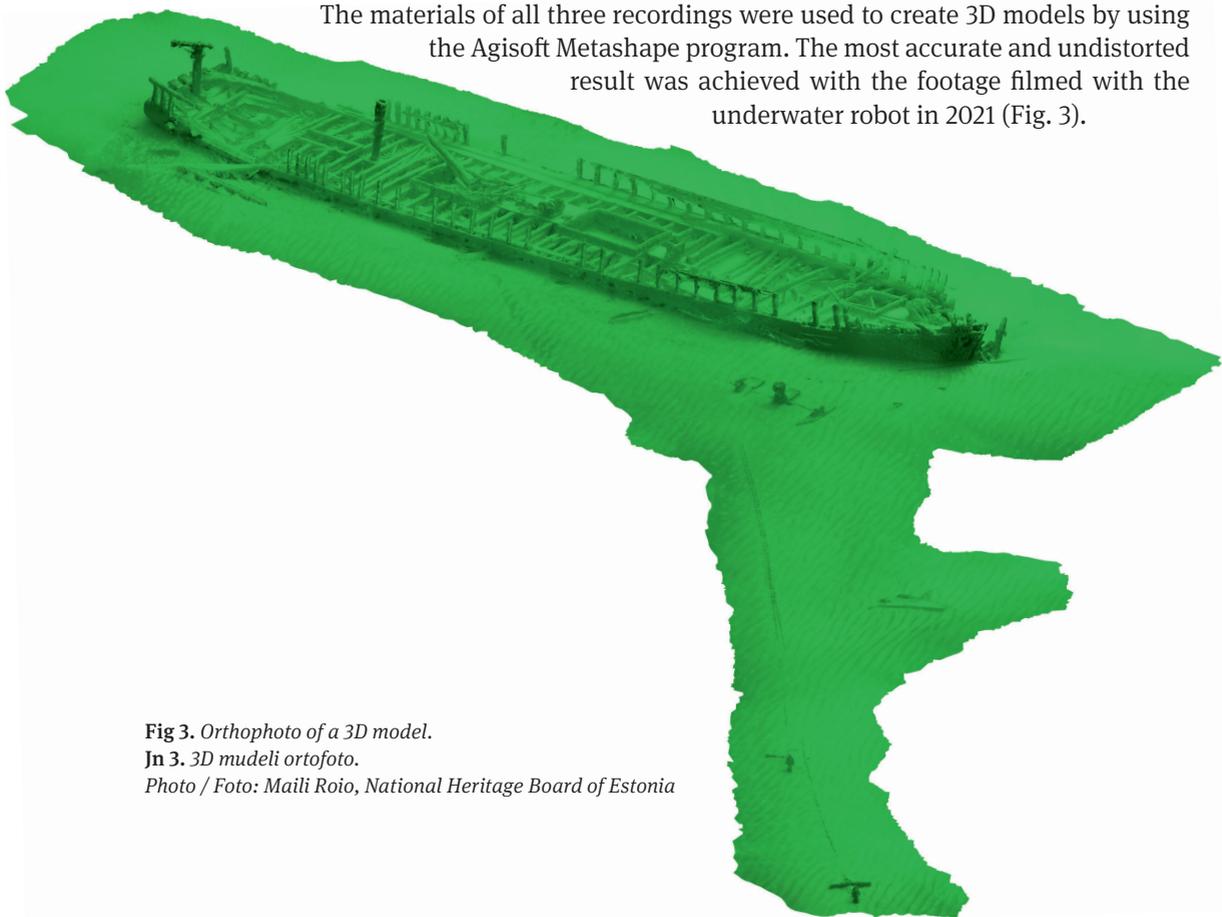
Fig 3. Orthophoto of a 3D model.

The wreck is well preserved, despite the fact that Gullkrona sank in relatively shallow water. Preservation has been facilitated as most of the wreck is embedded in the sand and only a small part of it is above the seabed.

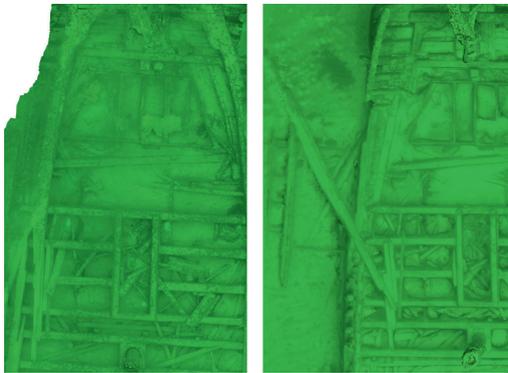
Fig. 4. Comparison of deck planking in the starboard of the aft in 2019 and 2020.

When comparing the recording data, it was possible to observe some damages in the starboard of the aft, where one deck plank has come loose and is now situated with one end of the plank on the deck and the other end on the seabed next to the wreck (Fig. 4). Most likely this has been caused by a diving vessel during anchoring. A line that has been attached to one of the bulwark stanchions at the starboard is also visible (Fig. 5). The line has probably been used as a shot line and at some point the float has been cut loose. There are no other observations and all small details are still in their original location.

The seabed around the wreck is sandy. Since sand is relatively dense and hard, the anchor of a diving vessel has only stopped once it hit the wreck. The damage at the starboard of the aft has most likely been caused by a larger diving vessel anchoring. This type of damage cannot be caused by the use of a shot line.

Placing the wreck under state protection will enable to prevent anchoring at the site. When the wreck is declared a cultural monument, the regulations of the Heritage Conservation Act which address the matter of anchoring at a cultural heritage site and its protection zone will apply – anchoring at the site is not allowed and anchoring at the protection zone of the monument is only allowed when the National Heritage Board has been notified. The National Heritage Board is entitled to refuse the anchoring request, but this is not sufficient to protect the site. It is important to take into account that this is a diving destination that is becoming increasingly popular.

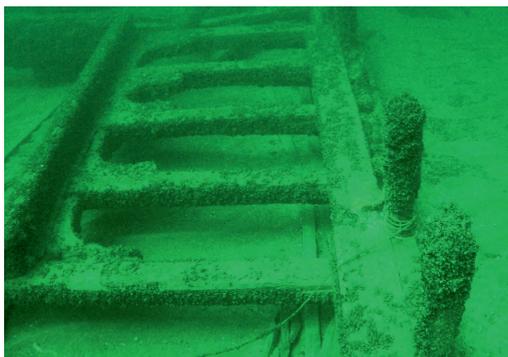
Fig. 5. Bulwark stanchion in the starboard with a shot line attached to it.

The main damage to the ship has occurred at the time of sinking and during the first year after sinking. There are few secondary damages and those have occurred only after the wreck was discovered (Fig. 4–5). The ship's bell was found during the filming in early spring 2019. At the time of finding, only a small part of the bell was visible under the sand. The divers decided to clean the bell from the sand and applied for permission from the National Heritage Board to retrieve the bell from the seabed and display it at the planned seasonal exhibition in Sõru Museum. The first choice is always to preserve wreck finds and everything belonging to it *in situ* (UNESCO 2001). Retrieving objects is not justified with the purpose of displaying an item at a temporary exhibition or
