Preliminary survey of wreck Nimetu-367 off the west coast of Saaremaa Island

Ivar Treffner, Priit Lätti and Lisette Reinvars

SA Eesti Meremuuseum (Estonian Maritime Museum), Vesilennuki 1, 10415 Tallinn, Estonia;
ivar.treffner@meremuuseum.ee

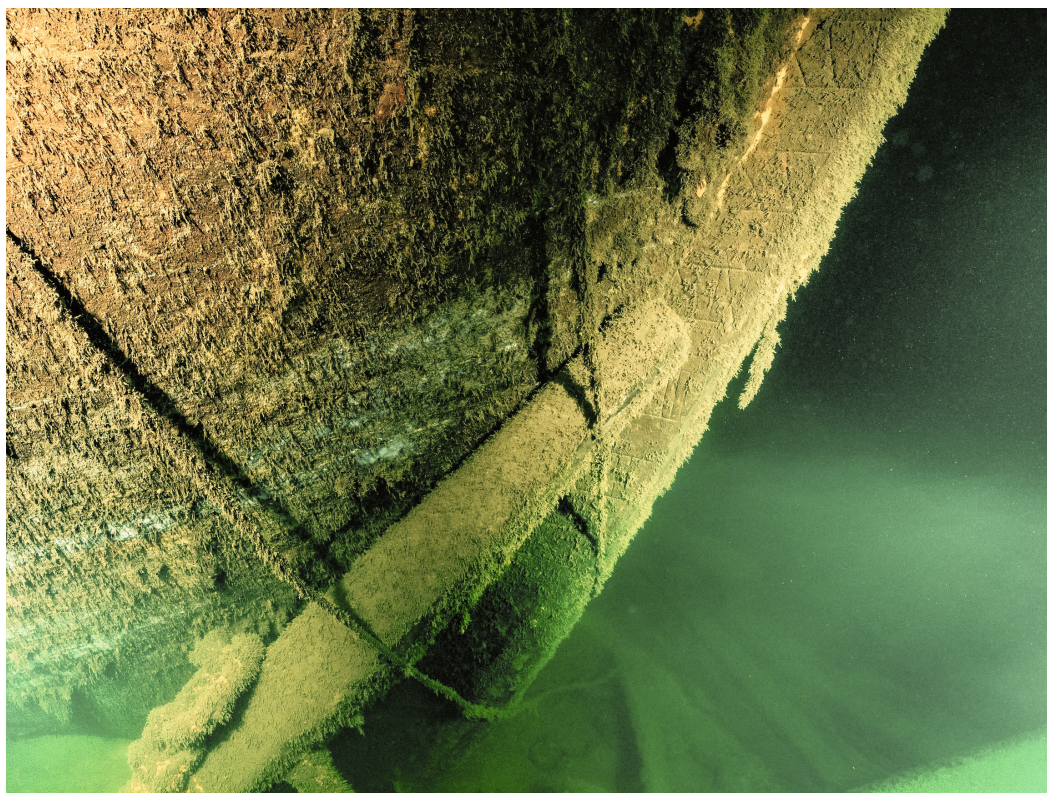
The length from stem- to sternpost is ca. 33.10 m. The breadth of the wreck at $\frac{1}{3}$ of the length is 8.1 m, at midship 8.6 m and at $\frac{3}{4}$ of the length 7.8 m. The height of the stempost from the bottom is about 4.8 m. There are carved Roman numbers on the starboard side of the stempost that are the draft lines (Fig. 2). Unfortunately, these markings went unnoticed during the dive and were only discovered from the photos of the wreck. Thus, there is only one photo where those markings are clearly visible. The highest carving visible in the photo is 'XVI'. The lowest one is 'X', which is about 1.2 metres from the bottom (measured from the photo). As 'X' corresponds to 10 feet (ca. 3 metres) of draught, it would mean that the wreck sits about 6 feet (1.8 m) in the sediment and the whole height of the stem post would be around 6.6 metres.

Fig. 2. Carved depth marking on the stempost.

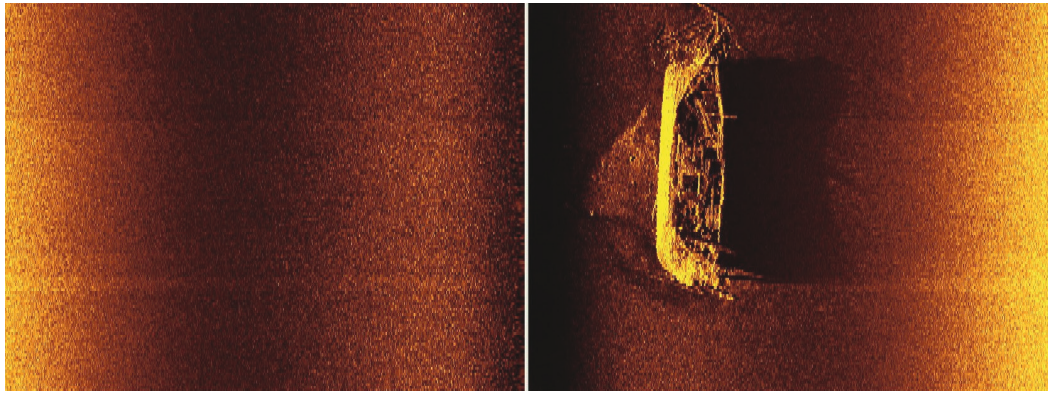
The wreck sits on its keel, without any noticeable list to either side. The ship was made of wood, and the hull is in a relatively good condition. However, remnants of old fishing trawls and dislocated windlass prove that the wreck has been damaged by trawling. There are some loose structural parts of the ship near the wreck (up to 3–4 metres from the hull), but further out, no ship parts are lying on the seabed. This can be seen from the sonar image uploaded

Fig. 3. Side scan sonar image of Nimetu-367.

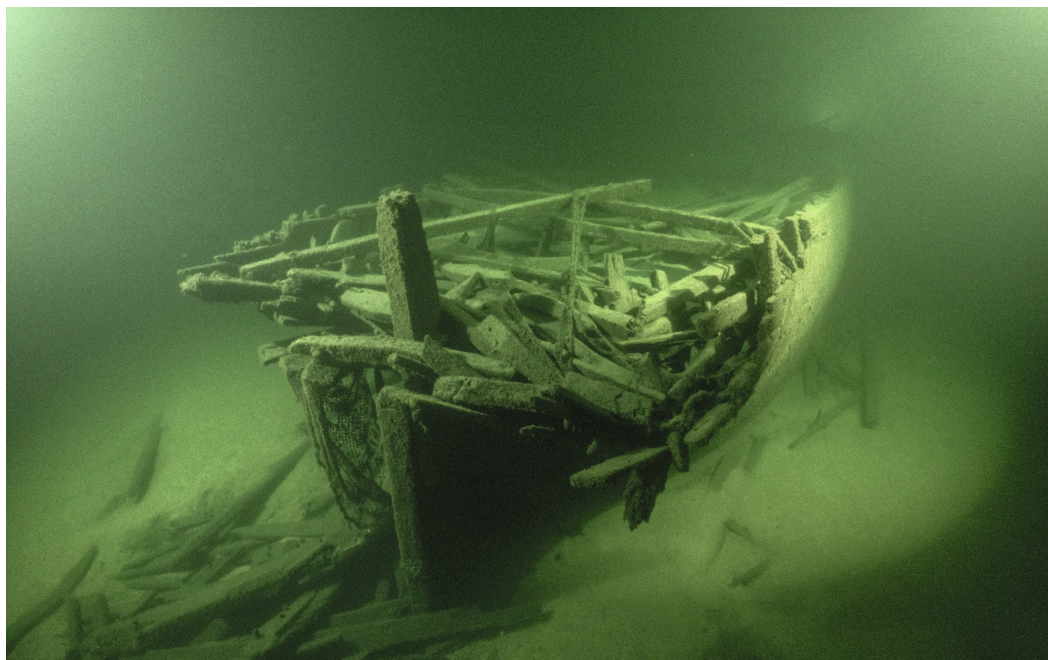
to HIS (Fig. 3). The bow of the ship has survived better than the aft part, which has suffered a rather extensive damage up to about midship (Figs 4–5). The ship had a flat transom. The sternpost is still standing, with the lower part of the rudder attached to the sternpost. The upper part of the rudder has been torn off and lies on the bottom behind the stern. The sternpost rises about one metre above the remaining stern, illustrating the level of destruction inflicted on the stern. Although many details of the stern construction are missing, the flat transom suggests a relatively late construction. Although there were several ways to construct the stern of the ship, the flat transom seems to be the most common solution at least from the 18th century (Kenchington 1993).

Fig. 5. Stern of Nimetu-367.

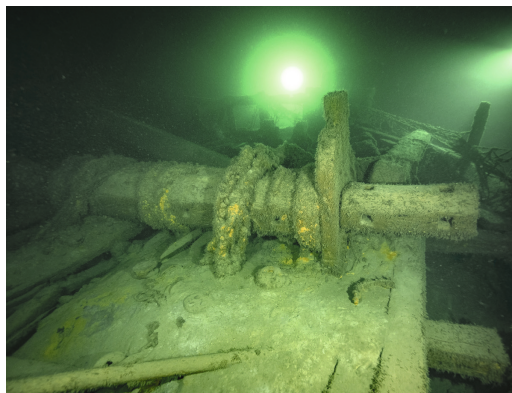
Fig. 6. Windlass on the bow.
Jn 6. Võõris paiknev ankrupeli.
 Photo / Foto: Ivar Treffner

The windlass (Fig. 6) has also been dislocated from its original position by the trawl. The carrick bitt on the starboard side is still whole, and the barrel of the windlass is attached to it. The port-side carrick bitt has been broken, and the barrel has come out of it. The barrel is octagonal with remains of a heavily corroded iron mechanism in the centre. This could have been a ratchet for fixing the position of the barrel with a retaining pawl. On both ends of the barrel where it enters the carrick bitts, there are remains of yet another iron mechanism – most likely ratchet wheels for either push pawls or retaining-pawls. What makes this interesting is that even though the barrel has iron ratchets, and it may have had

push pawls, it still has pawl bitts in the barrel and on the outside of the carrick bitts, making it possible to use the windlass the old-fashioned way with handspikes. The windlass may have been a basic one with only retaining pawls and no drive mechanism except handspikes. No remains of any drive mechanism or levers could be observed, which does not fully rule out that something might have existed, yet has now been destroyed and removed by the trawl.

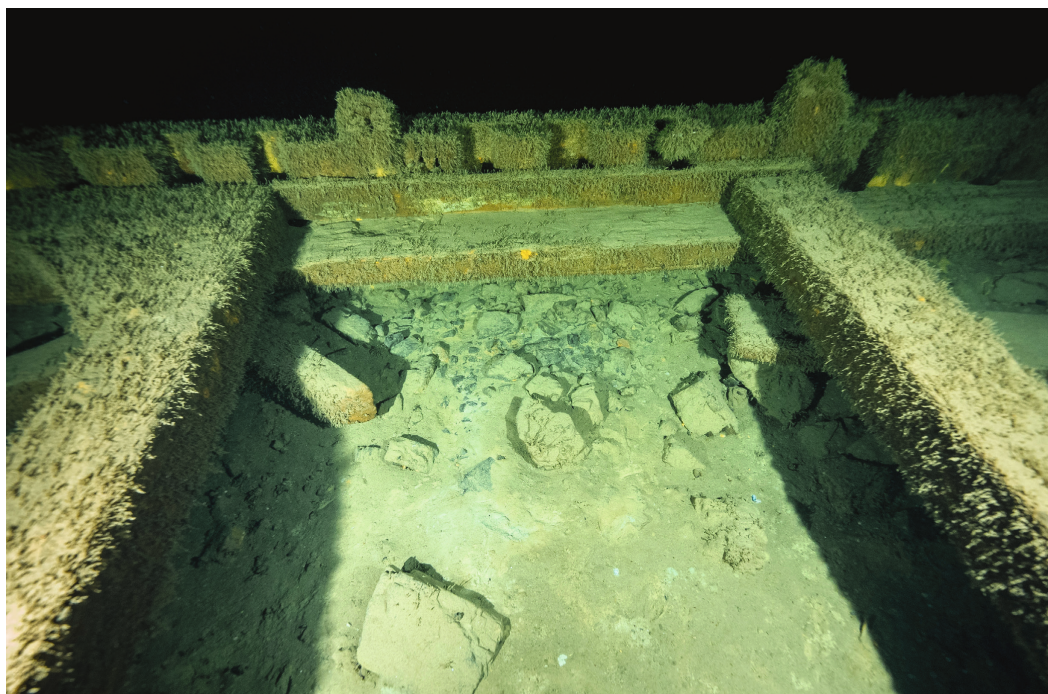
The hold of the ship is full (Fig. 7). Although the cargo in the hold is mostly covered with sediment, in some places it has been washed off and a cargo of coal can be observed (Fig. 8). It seems that most of the wreck is filled with coal and therefore, in terms of identification we need to look for a ship that sank while carrying coal.

Fig. 7. Full hold of the wreck.

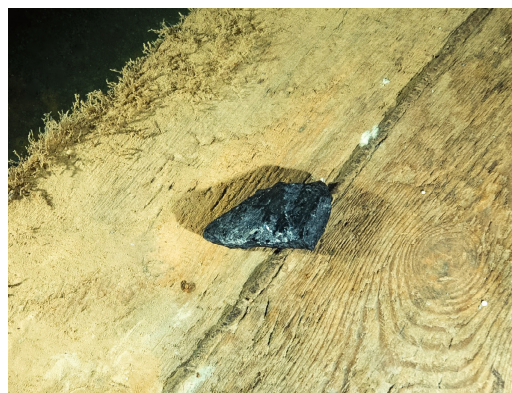
Fig. 8. Piece of coal from the cargo.
