# ARCHAEOLOGICAL FIELDWORK DURING THE RECONSTRUCTION OF THE VILJANDI SONG FESTIVAL GROUNDS

Due to reconstruction works at Viljandi song festival grounds, a series of archaeological investigations took place during the spring and summer of 2013. Archaeological supervision was carried out during several construction works necessitating soil removal, and minor archaeological excavations were carried out. Several construction remains were found at the territory designated for new buildings and for the installation of water, sewerage and electric pipelines.

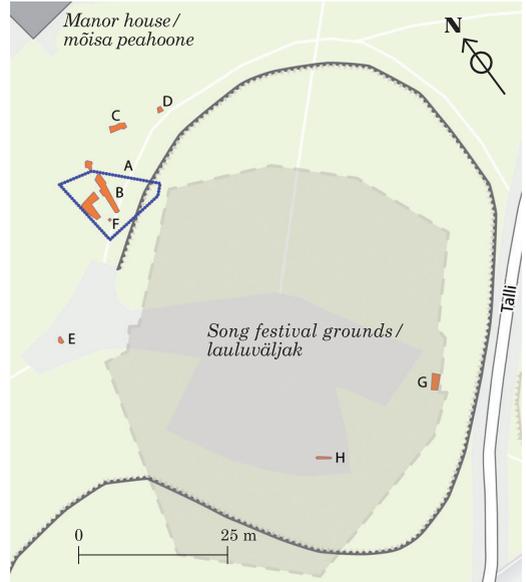
Fig. 2. Location plan for a storage place of burnt lime (A) and remains of buildings (B–H).  
 Jn 2. Lubjapõletusjäätmete hunniku (A) ja ehituskonstruktsioonide (B–H) asukohaskeem.  
 Base map / Aluskaart: Eesti Maa-amet;  
 mapping / kaardistus: Jekaterina Lissitsina;  
 drawing / joonis: Kristel Roog

A heap of burnt lime remains (Fig. 2: A) consisted of lime, limestone blocks, charcoal and pebbles belonging to granite group rocks (which partially were covered by lime beds). In some carbonate-rich areas a red Devonian sand line was visible. Lime contained plenty of goats' and cows' horns, no artefacts were found. Several limestone pieces were covered by colourful (varying from white to green) vitrified surface. The thickness of the carbonate-rich layer reached 0.7 m. The total area of the bulk of burnt lime is unknown, but it was investigated in an approximately 15 × 20 m area.

Partly within lime burning remains and natural Devonian sand, a stone construction was situated (Fig. 2: B). The two-part structure consisted of two parallel walls (made of granite group stones) that were divided in two by brick columns (Fig. 4). The western exterior wall of the construction was 1.2 m to 1.55 m thick. It was laid from stones with an average size of 30 × 40 cm, with pieces of bricks and roofing tiles in between. Some of the tiles were brittle or had a vitrified surface, indicating that the construction was severely burnt. The eastern part of the wall could only be explored from the southern part of the building. It was stacked quite irregularly with 10 cm to 55 cm stones in diameter, between which there were a few brick pieces. The thickness of the wall reached up to 1 m. Red clay mixed with sand was used as a binder; in the northern part also lime mortar was used. From the northernmost wall until the central part (ca. 3 m) the inner part of the wall had traces of fire: in some places the clay had sintered.

Northeast of the stone construction and heaps of lime burning remains **two fragments of stone walls** were excavated from the congeries of lime burning remains. The purpose of the walls and exact time of their construction are not clear; however, both the position and building method would rather link them to the period of the manor. The western wall, up to 2.75 m thick (Fig. 2: C), had a north-southern direction and was laid with large granite group stones (diameter 30–40 × 20–30 cm) bound with greyish lime mortar and clay and was established on the natural sandy ground. The eastern construction (Fig. 2: D) had the same direction but the stones (diameter up to 40 × 40 cm) were placed into a 1.45 m thick wall rather irregularly and without a binder.

It is possible that one of the oldest excavated building remains was a corner of the building that could be investigated in a limited area. It was located on the west part of the study area (Fig. 2: E). A 0.6 m thick foundation was stacked from granite group stones. The wall (three rows of which had been preserved) was made of 30 × 14 × 8 cm bricks. Greyish lime mortar was used as a binder. The oldest found artefact from there was a piece of stove tile<sup>7</sup> with green glaze, made in the end of the 15th and the beginning of the 16th century. It was found from the construction's inner fill soil together with a fragment of glazed ceramics<sup>8</sup> probably originating from the second half of the 17th century. Thus, the few discovered finds gives us an opportunity to state that the building was demolished in the second half of the 17th century or later. The finds, however, do not offer many clues about the time of constructing the building. It is only possible to speculate that if the aforementioned stove tile fragment originates from the oven that was in this building, it would mean that the brick building erected onto a foundation of granite group stones is medieval. Large-sized bricks seem to support this hypothesis, however, it is not certain that the bricks were not used secondarily in the walls of this building.

Stratigraphically, one of the oldest facilities in the area is a north-south directed wall remnant (Fig. 2: F), which was located a few metres west of the aforementioned stone construction (Fig. 2: B). The wall was built into a trench, excavated into natural Devonian sand. A 0.85 m thick wall bound with lime mortar was made of granite group stones (sized on average 20 × 20 cm), with pieces of bricks crammed in the joints. Lime mortar was used as a binder. During the cleaning of the wall a rim sherd of a wheel-thrown pot was found from the lime-rich debris. According to its shape, edge profile and contents of the moulding mass, the potsherd probably comes from a Northwest Russian pot originating from the late 16th and early 17th century.<sup>9</sup> With a certain

From the southeastern part of the study area the remains of an at least two-roomed building were found (Fig. 2: G). The walls had been constructed on the natural sand surface, and were built of granite group stones (up to 60 cm in diameter). The northeast-southwest directed wall was 0.55 m thick, and the northwest-southeast directed wall 0.45 m thick. In both cases greyish lime mortar was used as a binder, which also contained tiny bricks pieces. The floor (Fig. 7) made of large bricks (entire bricks sized  $36 \times 15 \times 12$  cm) had been preserved next to the northeast-southwest directed wall. Bricks were stacked upon the natural sand surface. Since there are no finds from this area, we cannot make any reasonable as-

Also, in the south-western part of the researched area, a part of the remains of another building was cleaned on a small scale (Fig. 2: H). There it was possible to document a part of a wall in southeast-northwest direction, that was at least 0.4 m thick. The wall was made of granite group stones (sized  $20 \times 30$  cm) bound with red clay containing brick dust. No datable finds were obtained.

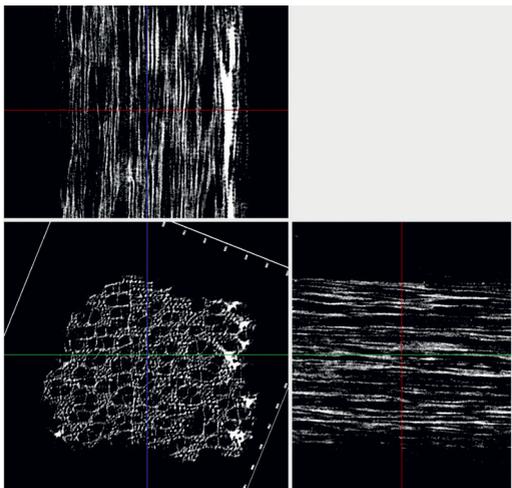
Fig. 3. Cross section of willow charcoal find from the storage place of burnt lime.

Based on the published comparative data (Benkova & Schweingruber 2004), the charcoal used for dating was also used for wood identification by nanotomograph Sky-scan 2011. The sample taken from the southern part of the heap showed that wood was diffuse-porous, with pores in small radial files (2–3) and clusters, rays uniseriate with 2–30 cells height (Fig. 3). Accordingly, most probably it was a willow (*Salix*). The sample taken from the northern part of the heap showed that wood was also diffuse-porous, with pores in radial chains, rays uniseriate with 4–20 cells height. As a result, most probably it was an aspen (*Populus*).

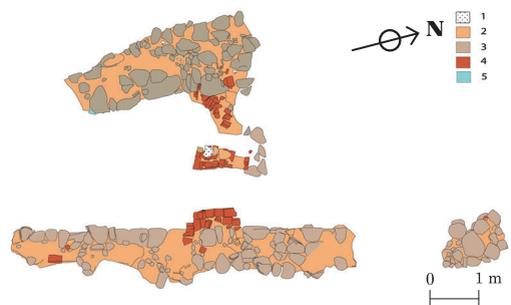
Fig. 4. Stone construction viewed from above.  
1 – limestone, 2 – binder, 3 – stone, 4 – brick,  
5 – limestones with vitrified surface.  
Jn 4. Kivikonstruktsiooni pealtvaade. 1 – lubjakivi,  
2 – sideaine, 3 – kivi, 4 – tellis,  
5 – glasuuristunud pinnaga kivid.  
Drawing / Joonis: Evelyn Fridolin

The construction consisted of an inner porch and a chamber behind it, the wall between them was mainly made of bricks. Between these chambers there were two openings 0.75 and 0.85 m wide, located next to each other. The west side opening still preserved the fragments of a straight arch. However, it was severely sunk, therefore it was impossible for us to reconstruct the shape of the straight arch. We can only hypothesize about the straight arch in the eastbound opening (Fig. 5). The brick fragments of this straight arch were bound by clay, the upper part of which has sintered in the heat. Bricks (especially on the easternmost column and on the eastern part of the middle column) were in some places se-

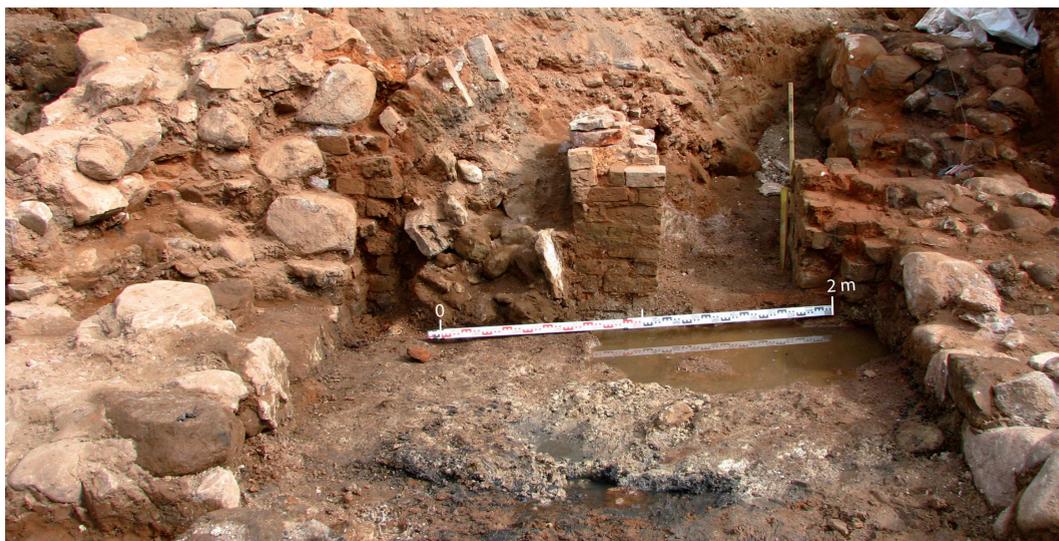
Fig. 5. Stone construction viewed from the south.

The construction used to be at least 10 m long. The southern chamber was 2.1–2.5 m wide and 3.86 m long (the western wall was 2.2 m and the eastern 3.86 m in length) and with two anthropogenic layers inside. The upper layer was lime and under it were remnants of burnt wood (Fig. 5). In case of the determined carbon piece, early-latewood transition was gradual, rays uniseriate with 10–15 cells high, occasionally 2-seriate rays with resin canals. Consequently, most probably it is spruce (*Picea*) (Fig. 6). From the chamber on the northern side we managed to open only the eastern outer wall; however, even then not entirely. The chamber itself was at least 5 m long.

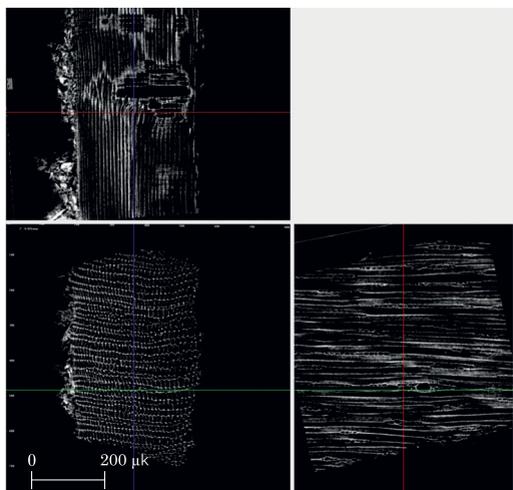
Fig. 6. Cross section of spruce charcoal find from the burned wooden floor of the cellar.

lower layer of the southern chamber, which resulted in  $165\pm 25$  radiocarbon years. This again, during calibration<sup>6</sup>, provides a very wide time range – with 95.4% probability – years 1664–1950 cal AD. According to the highest probability, the layer originates from the 18th century (with 38.3% probability from 1733–1781 cal AD) and in broad terms is similar to the date of the coal derived from lime burning remains.

Osaliselt lubjapõletusjäätmete kuhjas paiknes suur kivikonstruktsioon (jn 2: B), mis alumisest inimtekkelisest kihist võetud kuuse söe järgi (jn 6) ehitati tõenäoliselt samuti 18. sajandil (165±25 radiosüsiniku aastat – SPb\_988). Kivikonstruktsioon on olnud vähemalt 10 m pikkune ja koosnenud kahest, ligi 4 m pikkusest ja 2,1–2,5 m laisusest ja vähemalt 5 m pikkusest, kambrist, mida eraldas kahe kõrvuti võlvitud avaga peamiselt sekundaarkasutatud tellistest laotud vahesein (jn 4 ja 5). Kuni 1,55 m paksused välismüürid olid laotud kuni poole meetrise läbimõõduga kividest ning seotud savi ja kohati lubimördiga. Tegemist võib olla kas keldri või lubjapõletusahju jäänustega.

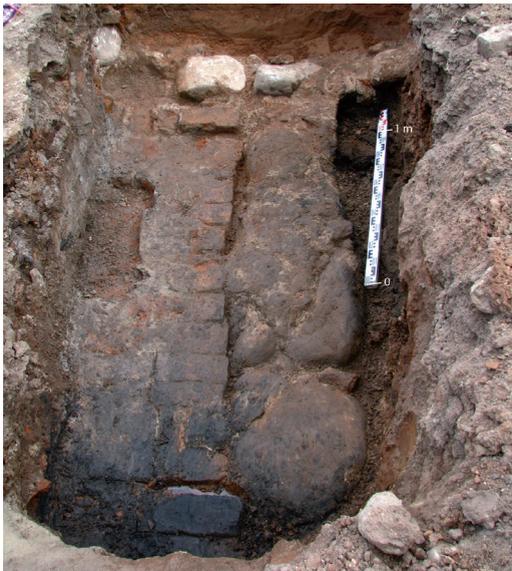
Fig. 7. Multi-room building remains in the southeastern part of the investigated area.

Uuringuala kaguosast leiti veel ühe vähemalt kaheruumilise hoone jäänused (jn 2: G). Looduslikku liivapinda rajatud kivimüüride vastas oli säilinud suurtest tellistest põrand (jn 7). Väikeses mahus puhastati välja ka ühe ehitusjäänuse osa (jn 2: H) uuringuala lõunaosas. Mõlema hoonevare dateerimiseks puuduvad aga paraku pidepunktid.
