## Archaeological rescue excavations on Kivi street, Tartu

Jekaterina Lissitsina, Raido Roog and Aivar Kriiska

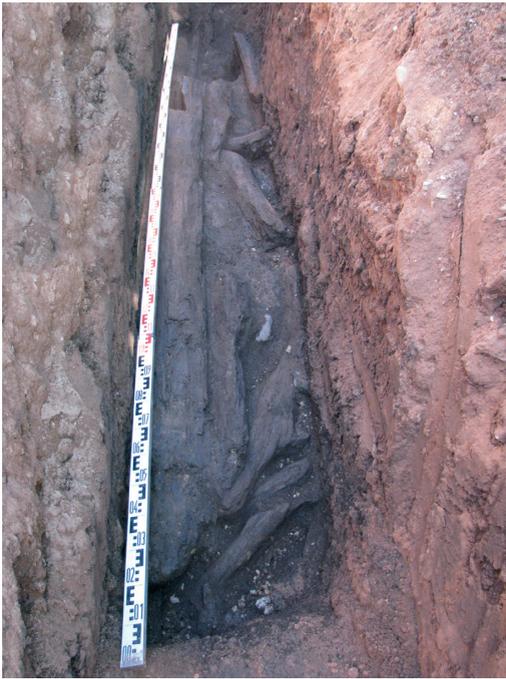
**Fig. 4.** Wood from a demolished Medieval building used to cover the street. Presumably laid during the first half of the 18th century.

Before the cobblestone pavement was laid, the street had been repaired by placing logs and half logs on top of the humus surface. In front of the house at Kivi Street 57, the stratum of logs was at least 9 m long (Fig. 4); this was the largest fragment of wooden paving in the investigated area. The aforementioned stratum comprised of more than 20 peeled logs each being 30–65 cm in diameter. The end of one of the logs had a joint indent in it. The logs were radiocarbon dated from the 14th to 16th century ( $614 \pm 25$  BP, 95.4% likelihood 1296–1400 AD;  $400 \pm 30$  BP, 76.4% likelihood 1436–1522 AD and 19% likelihood 1575–1625).<sup>2</sup> Fragments of ceramics that were found from the cultural layer beneath the structure have been dated to the turn of the 17th century (fragment of a tripod pot, TM A-220: 476); these suggest that the building material of a medieval structure had been reused in the first half of the 18th century.

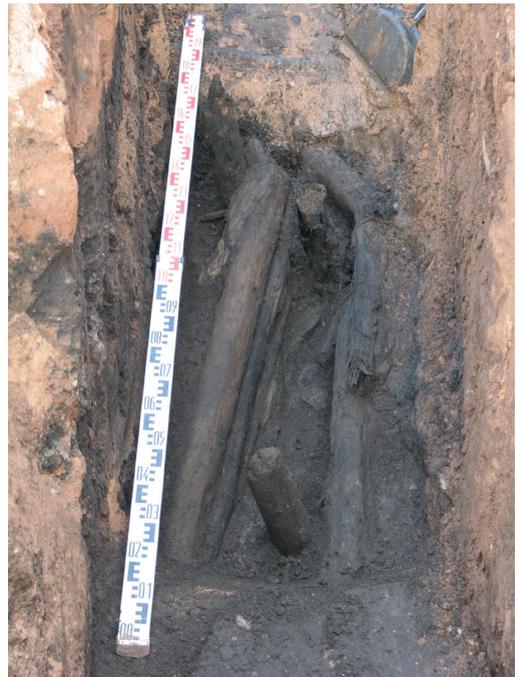
**Fig. 7.** Drainage trough, presumably built during the Medieval period.

Approximately 0.5 m below the 18th century cobblestone pavement and log stratum, sections of wooden drainage systems were found. These were 30–40 cm wide troughs made of 3–4 unpeeled logs placed on top of each other and supported by wooden poles (Fig. 7). The logs were 19–38 cm in diameter and the poles were 25–69 cm in diameter. Upon cleaning the troughs, only one item was discovered – a fragment from a Siegburg stoneware pitcher (TM A-220: 585). That type of pottery was in use in the 14th – 16th century (Russow 2006, 44–45). Since this was the only archaeologically important find, it can be assumed that at least the section where the fragment was discovered dated from the Medieval period. Similar constructions from other sites in Tartu may support this hypothetical dating. Similar troughs in Tartu have been found for example at Riia Street 1 and these have been dated to the 14th – 17th century (Heinloo 2006, 43).
