Results of archaeological surveillance in Tallinn during the reconstruction of Viru, Vana turu and Kuninga Streets in 2015–2016

New data about the fortifications of the Viru Gate

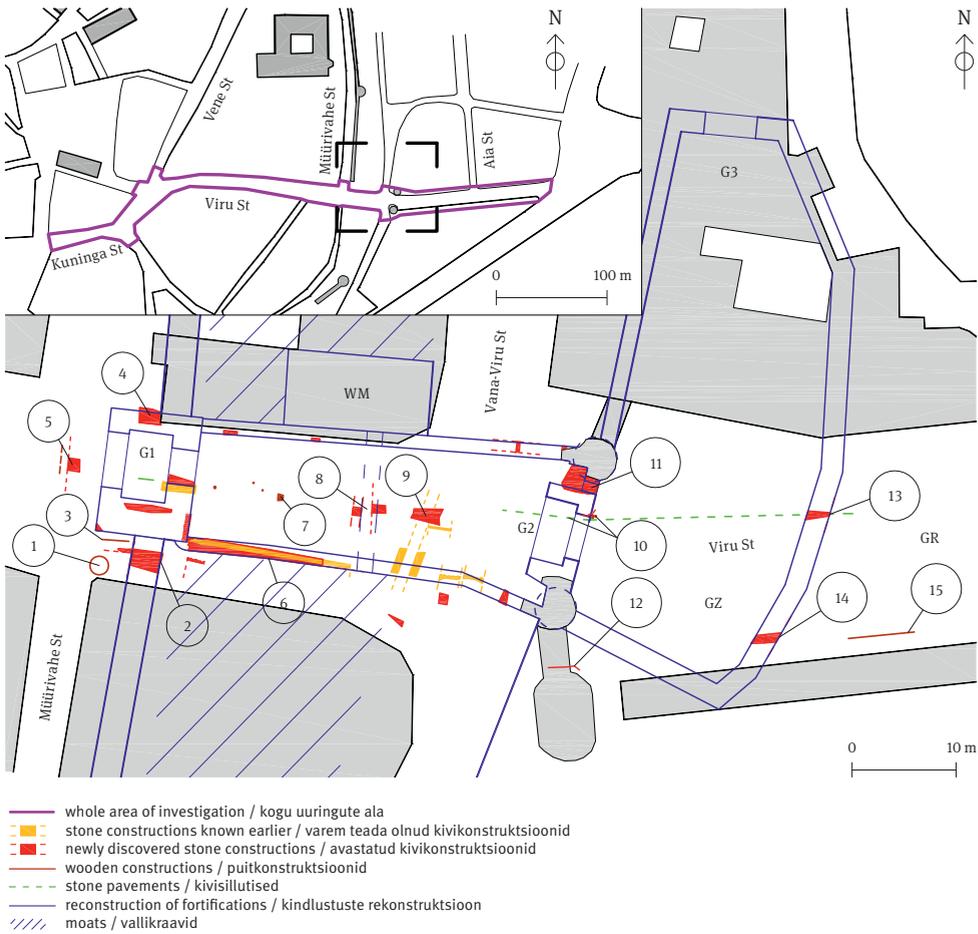
Fig. 1. Plan of the research area at Viru Street. Numbers 1–15 indicate the location of excavated sections.

The present paper introduces the main results of the fieldwork, moving in the Old Town from inside to outside: from the crossing of Kuninga, Kullassepa and Harju Streets to the Viru Street ending at Viru Square / Pärnu Road. Since drawings are still in draft format and artefacts collected are not yet properly analysed, the following is a preliminary overview which can be specified after the completion of the report. Several measurements are approximate. The logistics of the reconstruction work (different pipelines at different heights, securing access for pedestrians and servicing personnel *etc.*) required that some sections were excavated several times or parts of the same constructions were seen one fragment after another and not together. The studied sections, objects and finds are designated with numbers on the plan (Fig. 1: 1–15).

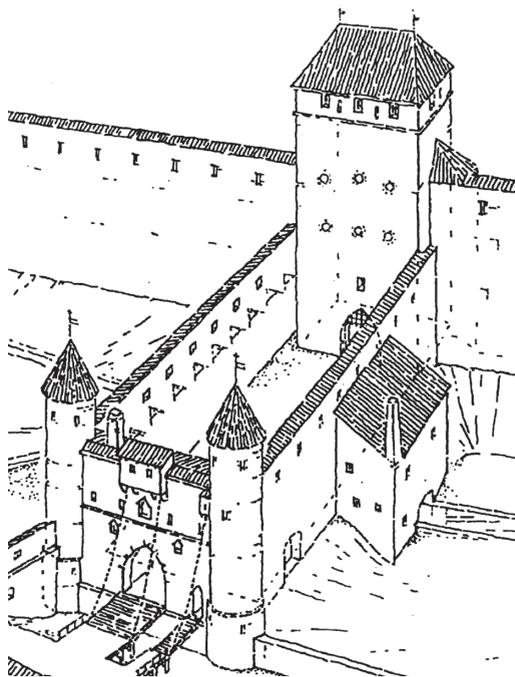
Fig. 2. Viru Gate: the main gate and barbican in the mid-15th century as suggested by Rein Zobel (2014, fig. 303).

Aastatel 2015–2016 teostati arheoloogilist järelevalvet Tallinnas Viru, Vana turu ja Kuninga tänavatel seoses kommunikatsioonitrasside uuendamise ja ning kõnni- ja sõidutee ühte tasapinda viimisega. Sõltuvalt tööde iseloomust teostati arheoloogilist jälgimist ja vajadusel väikesemahulisi kaevamisi ning dokumenteerimist. Uuringu olulisemad tulemused esitatakse artiklis lõikude kaupa Harju tänavast kuni Pärnu maanteeeni (jn 1), keskendudes esmajoonel Viru värava ümbruskonnale, kus välitööd pakkusid olulist lisa Rein Zobeli poolt varem välja pakutud rekonstruktsioonikatsele (jn 2).

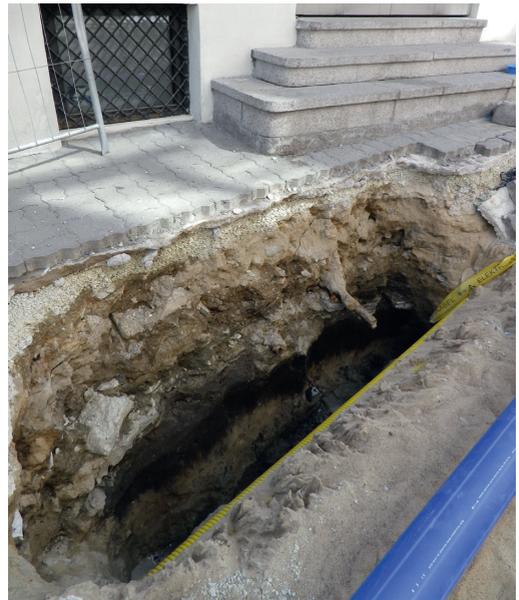
Fig. 3. Darkened natural sand layer in front of Kuninga St. 3.

Kaevetööd Vanal turul puudutasid peamiselt varem läbikaevatud kihte kohatiste säilinud huumuselaikudega (jn 3) ja vundamentidega Kuninga tänaval. Tänavas lõunaküljel puhastati välja ja markeeriti sõjas hävinud hoonete vundamendid.

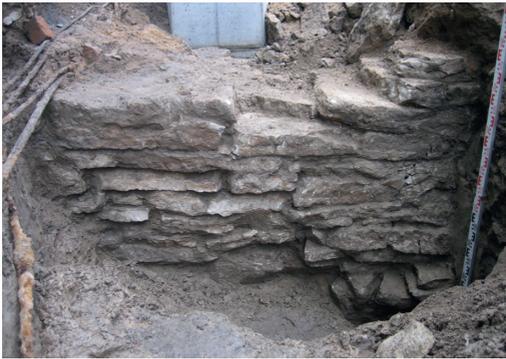
Fig. 4. Outer side of the town wall south of the main gate.
Jn 4. Linnamüüri vundamendi väliskülg peaväravast
 lõuna pool.

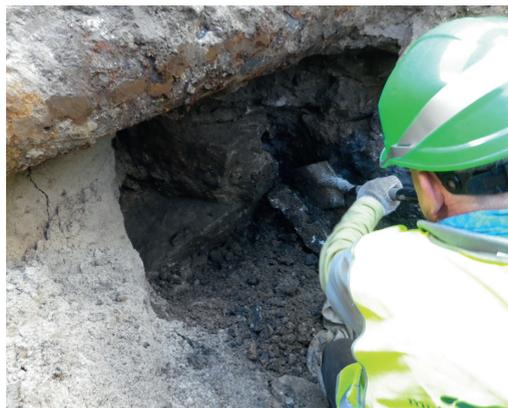
Fig. 5. *The south-western corner of the main gate tower foundation.*

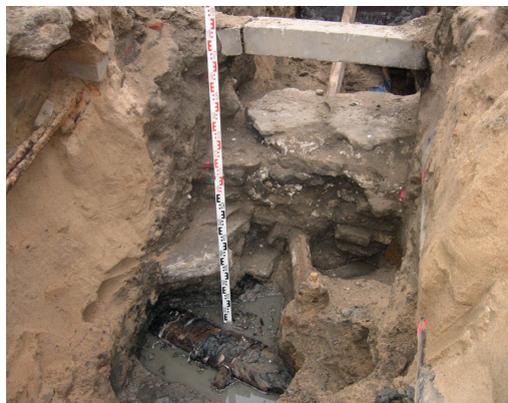
Fig. 6. *Section of a lime stone wall and wooden water pipe at the crossing of Viru and Müürivahe Streets.*

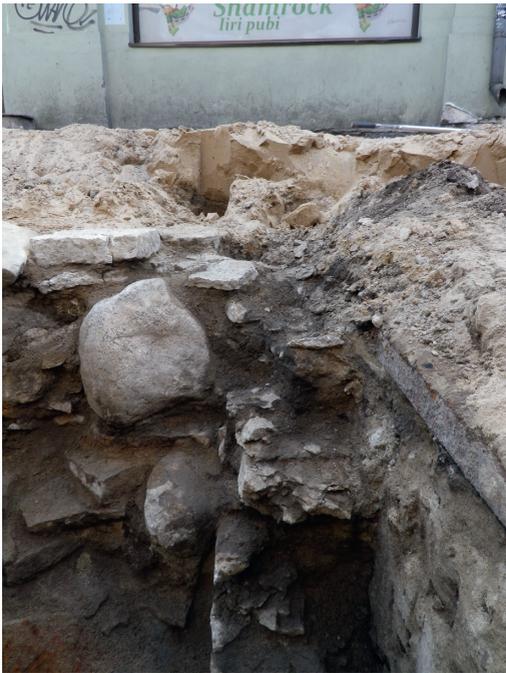
Fig. 7. The spot where barbican's S-wall (to the left) was built towards the main gate tower.

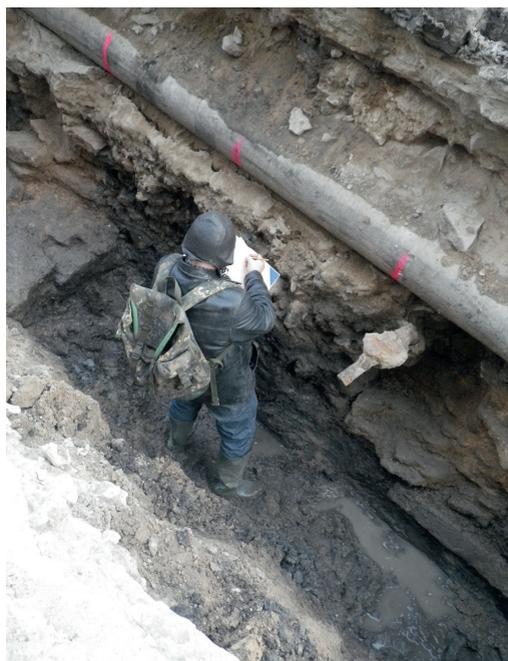
Fig. 9. Measuring of the conduit of the watermill in the barbican.

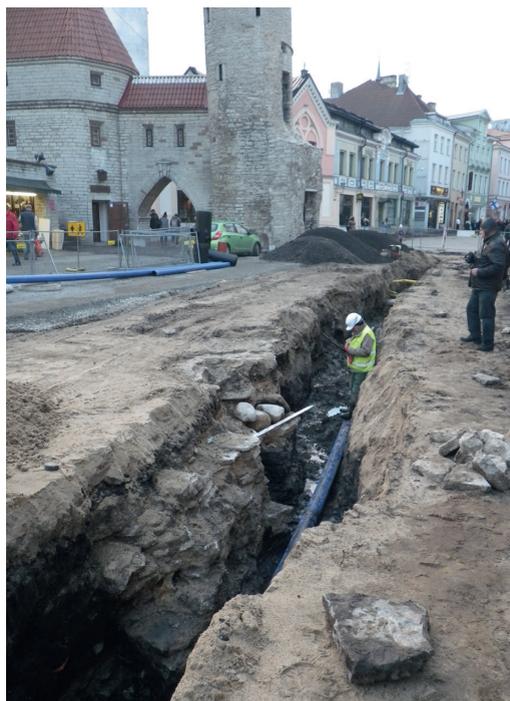
Fig. 11. Section of the wall in the E-side of the Great Zwinger.

The full cross-section was revealed in the profile of a water pipeline trench (Figs 1: 13; 11). The foundation trench for the zwinger wall was dug *ca.* 1 m inside earlier layers, 2 m from the present ground level. On both sides of the wall it was still possible to trace the lowermost pavement made of very small stone pieces which was documented inside the barbican's gateway (see above). There had been another pavement which was visible in the profile only as a stripe

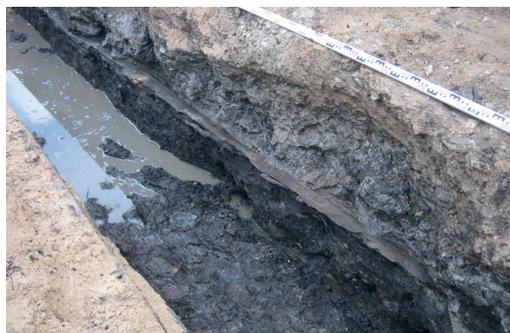
Fig. 12. Section of the pavement made of planks outside the zwinger wall.
