## Archaeological studies in Paide, Posti Street 12

Villu Kadakas

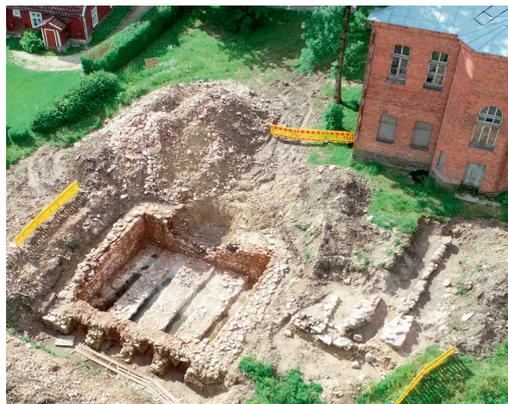
**Fig. 1.** Lime kiln (left) and remains of a medieval dwelling (right) in July 2020.

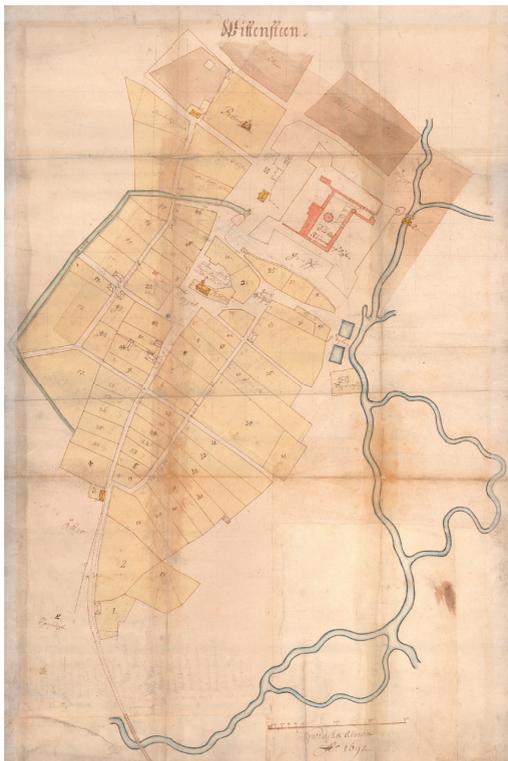
**Fig. 2.** Map of Paide from 1692.  
**Jn 2.** Paide plaan 1692. aastast.  
 (RA, EAA.1.2.C.IV.173, p. 1).

Kalle Kroon has recently drawn attention to the gap in the southern curtain wall of the castle, depicted on the plan of 1692 (RA, EAA.1.2.C.IV.173, p. 1) and has supposed that during the Middle Ages the castle had a gate in this spot and it was connected with the town with a bridge across the southern moat, following the line of Rüütli street (Kroon 2017, 22–23, 60–61). Such an extension of Rüütli street towards the north, the supposed castle gate, theoretically must have been located in the western part of Posti St. 12, in the excavation area of 2018.

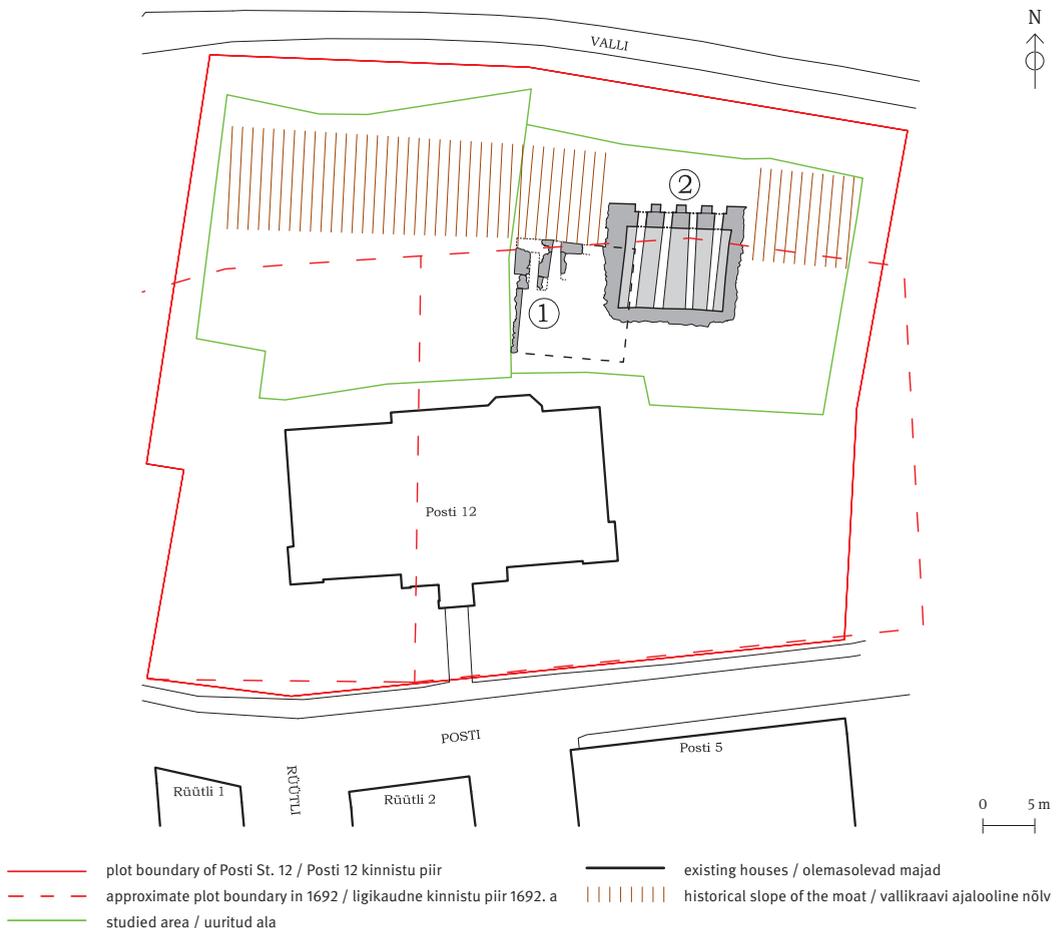
**Fig. 4.** Plan of Post St. 12. 1 – house remains, 2 – lime kiln.

Four ca. 80 cm wide doorways with low segment arches were positioned in the northern façade wall (Figs 4; 7–9), built probably on the level of the bottom of the moat. The façade wall was especially thick (ca. 2.2 m) near the corners and designed as three buttresses between the four entrances. From every doorway a passage extended to the southern wall. The width of

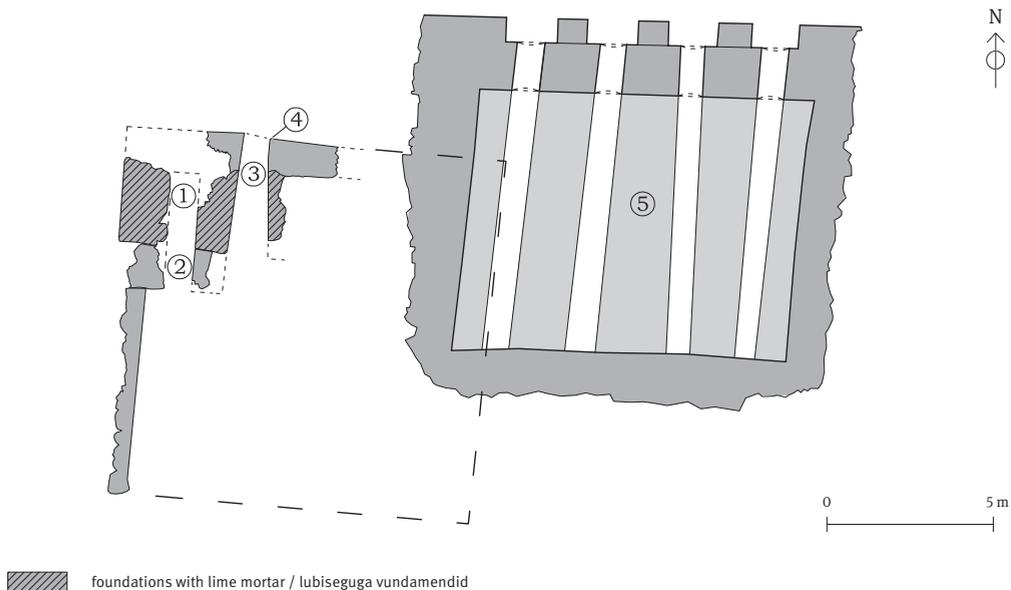
**Fig. 5.** Plan of house remains and lime kiln. 1 – heating furnace, 2 – furnace’s antechamber with a sloping floor, 3 – doorway, 4 – recess of an iron hinge, 5 – lime kiln.

The main part of the preserved structure was a furnace, made of limestone and boulders with lime mortar, built at least 1.2 m deep into the natural ground (Figs 5: 1; 6). Only two side walls of it, ca. 1.1 and 1.5 m thick, had preserved. There were no traces of brick lining or bottom inside the furnace – the heat had directly affected the side walls built of erratic boulders still covered with soot. The furnace could be accessed from a small antechamber (Figs 5: 2; 6) on its southern side, built of limestone and boulders with clay. The floor of the antechamber was designed as a slope, because the floor of the cellar room was ca. 90 cm higher than the bottom of the furnace.

A very thin (35–70 cm) foundation, consisting of one row of boulders without mortar, was attached to the south-western corner of the antechamber (Figs 5: 2; 6), positioned in north-south direction. Whereas other foundations were thick enough to carry a stone wall, this one could obviously carry only a timber or framework structure. Only its eastern side had been built straight, as the inner wall surface of a cellar, stones laid along a construction string, but the other was uneven, built against natural soil. The floor level of the room was once positioned at least 0.3 m deeper than the natural ground level. Taking into consideration that the cultural layer had been removed in the Early Modern period, the floor of the cellar must have initially been even deeper in the natural ground.

door (Fig. 5: 4). The eastern wall of the doorway towards the south was built with lime mortar, like the walls of the furnace.

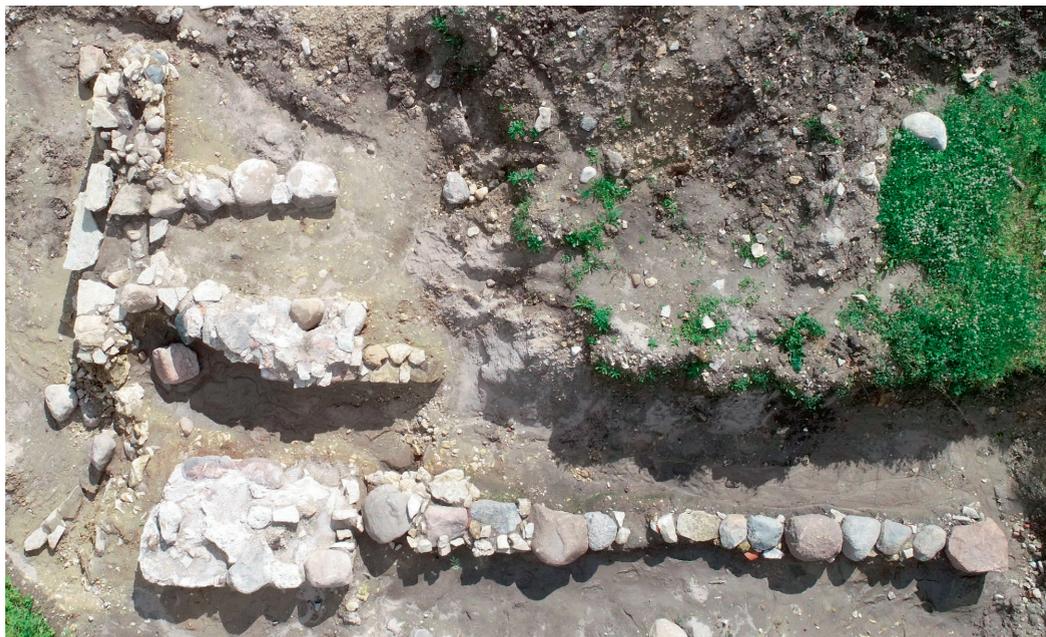
**Fig. 6.** Remains of the medieval dwelling.

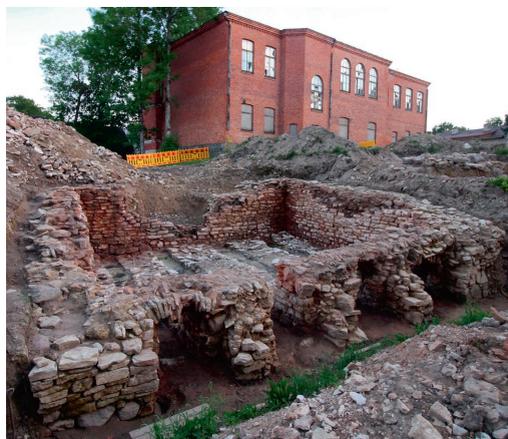
Fig. 7. Lime kiln, view from the north-east.

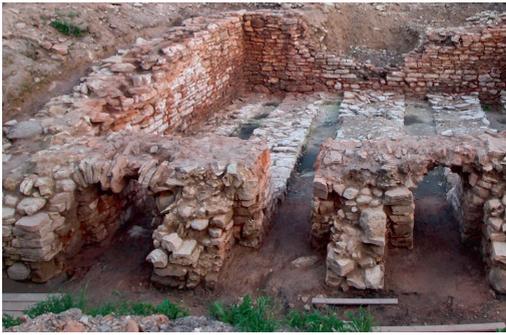
**Fig. 8.** *Façade of the lime kiln with arched entrances and buttresses.*

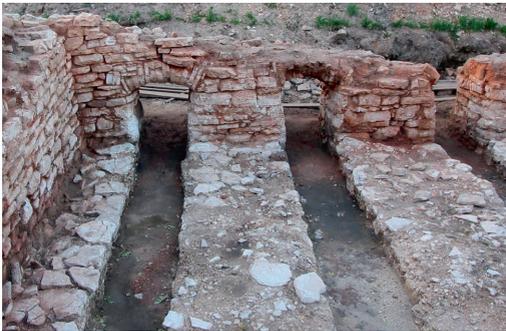
**Fig. 9.** *Inner view of the façade of the lime kiln with arched entrances.*

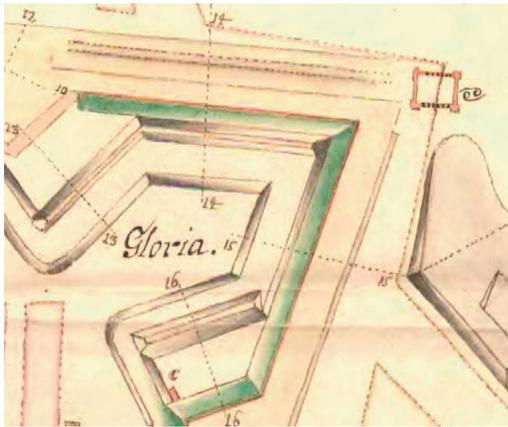
**Fig. 10.** Lime kiln depicted on a plan of Narva fortifications from 1698 near bastion Gloria. Detail with the vicinity of bastion Gloria. S – marked in the explication as den stora Kalckugnen ('big lime kiln' in Swedish).

A comparable lime kiln in regard to size, design and context is depicted on some plans of the fortifications of Narva from 1680 and 1697–1699 near the tip of bastion Gloria, and marked in the explication as *den stora Kalckugnen* ('big lime kiln' in Swedish) (Fig. 10; SE.KrA.0406.28.031.065; SE.KrA.0406.28.031.036; SE.KrA.0406.28.031.039; SE.KrA.0406.28.031.040).<sup>7</sup> It was situated not in the slope, but on flat land, so that all four corners were supported with large rectangular buttresses. Its name reflected the size, it was even bigger than the kiln in Paide, with inner dimensions ca. 12 × 17 m, and had six entrances side by side. As it was situated on flat land, also the opposite wall was provided with entrances as a

mirror image. These maps have been created with an aim to record the progress of the construction work of the bastions, hence there should be no doubt that the kiln was used to produce lime for the construction of various walls within the rampart fortifications. It is difficult to estimate, if the 'big lime kiln' was able to provide all the necessary lime for the military enterprise in Narva, but no other lime kilns have been marked on the surviving maps of the period.
