# Archaeological rescue investigations on Vaabina manor site

Heiki Valk

## INTRODUCTION

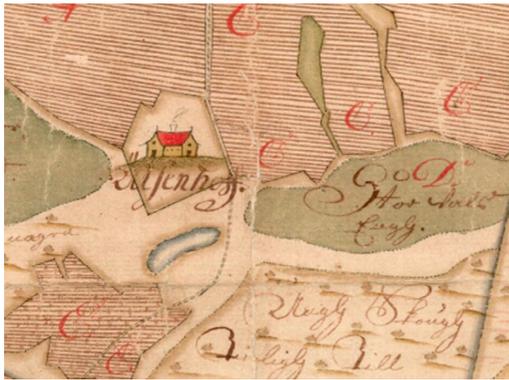
**Fig. 1.** Abstract from the earliest plan of the lands of Vaabina manor. *Charte von dem Guthe Ueltzen mit dessen dazu gehörigen Bauern und deren Ländereyen im Urbschen Kirchpiel belägen.* Copy made in 1737 from the original from the 1680s or 1690s.

The earliest information about the location of Vaabina manor dates from the 1680s or 1690s (Fig. 1). The landscape and the network of roads indicate that the manor centre of the Swedish period was located in the same place with the historical manor centre depicted on the earliest detailed manor map from 1868 (Fig. 2). The last stage of the big manor house – a building in Historicist style with two wings – had two floors, but there were three floors in its central part (Fig. 3). Since the image of the manor on old photos does not correspond well to the plan of the building depicted on the map from 1868 (see Fig. 2), the house has been reconstructed in the last third of the 19th century.

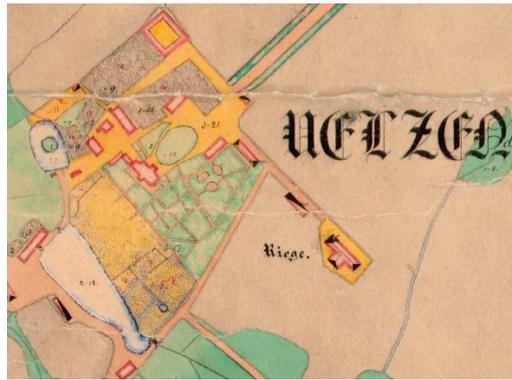
**Fig. 2.** Map of Vaabina manor centre in 1868. *Charte von dem im Livländischen Gouvernement Doerpt-Werroschen Kreise und Anzenschen Kirchspiele belegenen privaten Gute Uelzen 1868.*

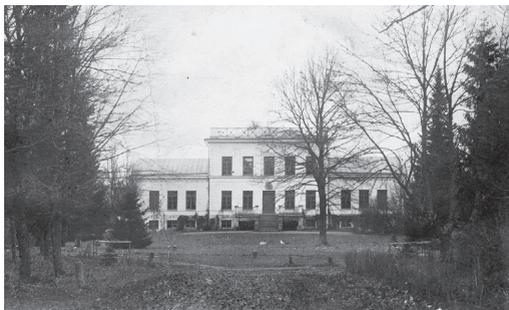
**Fig. 3.** Photo of the main building of Vaabina manor from before the 1920s, view from the north.

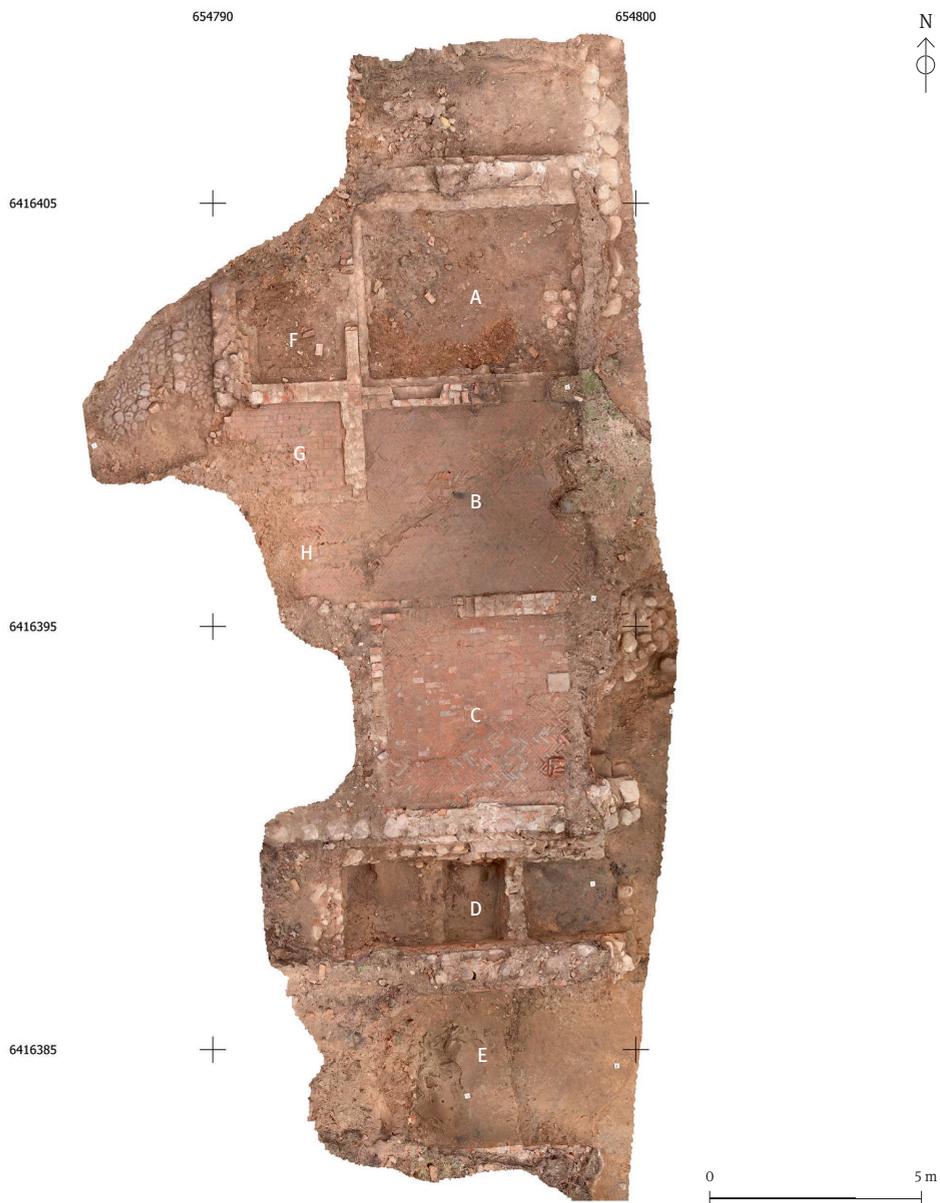
**Fig. 4.** Photogrammetry-based ortophoto of the unearthed rooms of Vaabina manor.  
**Jn 4.** Vaabina mõisas avatud ruumide fotogramm-meetria põhine ortofoto.  
 Photo / Foto: Ragnar Saage

building remains, turf and top soil were removed by backhoe from the area planned for the road. Now brick floors and lower parts of walls of six rooms of the latest stage of the manor house (Fig. 4: A–C, F–H; Fig. 5b: A–C; Fig. 6) – the remains of the southern part of its western wing were unearthed. West of the western end of the building, beside the rooms F and G (Fig. 4) the cobblestone pavement of the yard was discovered.

Walls of two more cellars south of the 19th-century manor house – those of rooms D and E came to light in the southern end of the profile (Figs 4–5). Since the walls of these rooms with no remains of brick floors were thicker and built mainly of granite, they seemed to be earlier than those of the latest stage of the manor house. Fill of demolition debris was removed from these rooms by backhoe until the cultural layer in the bottom of their cellars. These cultural layers were archaeologically investigated by sieving all soil.<sup>2</sup>

The same stratigraphy as in room D could be observed in the same depth in the road trench profile also in the bottom of room C. Since the brick floor of the latest stage of the manor house had preserved well in room C (Fig. 4), its cellar was not opened. The 17th-century cultural layer in its bottom was studied only by approaching from the trench profile.

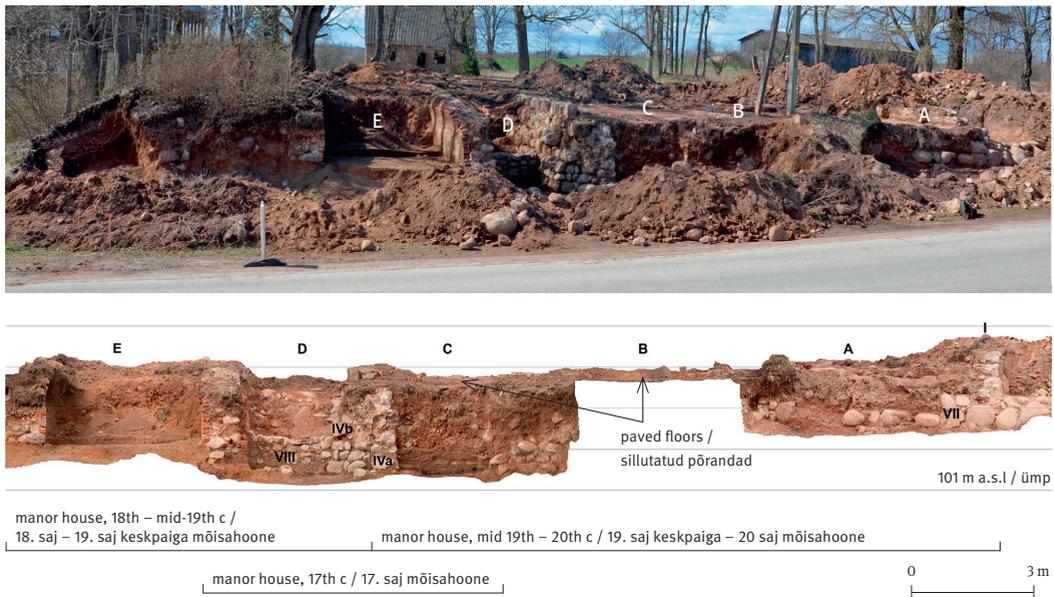
**Fig. 5.** Foundations and rooms A–E of Vaabina manor in the profile of the road. View from the east. A photo and photogrammetric image.

Room D was 2.2 to 2.6 m wide<sup>3</sup>, lined with bricks on the south side and with granite stones on the north side. The upper part of the cultural layers in its bottom consisted of ca. 20 cm thick layer of disturbed sand which contained big fragments of hand-made glass bottles, probably for wine, dating from the 18th or 19th centuries.<sup>4</sup> The lower part of room D was divided into two by a ca. 30 cm wide stone wall whereby west of it a fill layer of disturbed clay followed the floor sand. On both sides of the wall there was a 10–15 cm thick 17th-century grey cultural layer which contained fragments of a big dark gray low fired earthenware vessel (Fig. 7: 5), as well as smaller earthenware and glazed redware (Fig. 7: 2–4) fragments. The cultural layer was followed by a layer of debris which contained fragments of stove tiles from

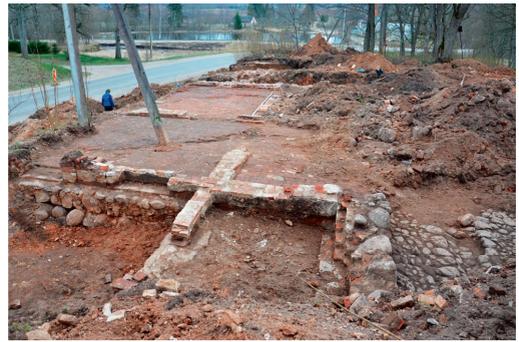
**Fig. 6.** Foundations of the rooms and floors of the latest construction stage of the western wing of Vaabina manor. View from the north-west.

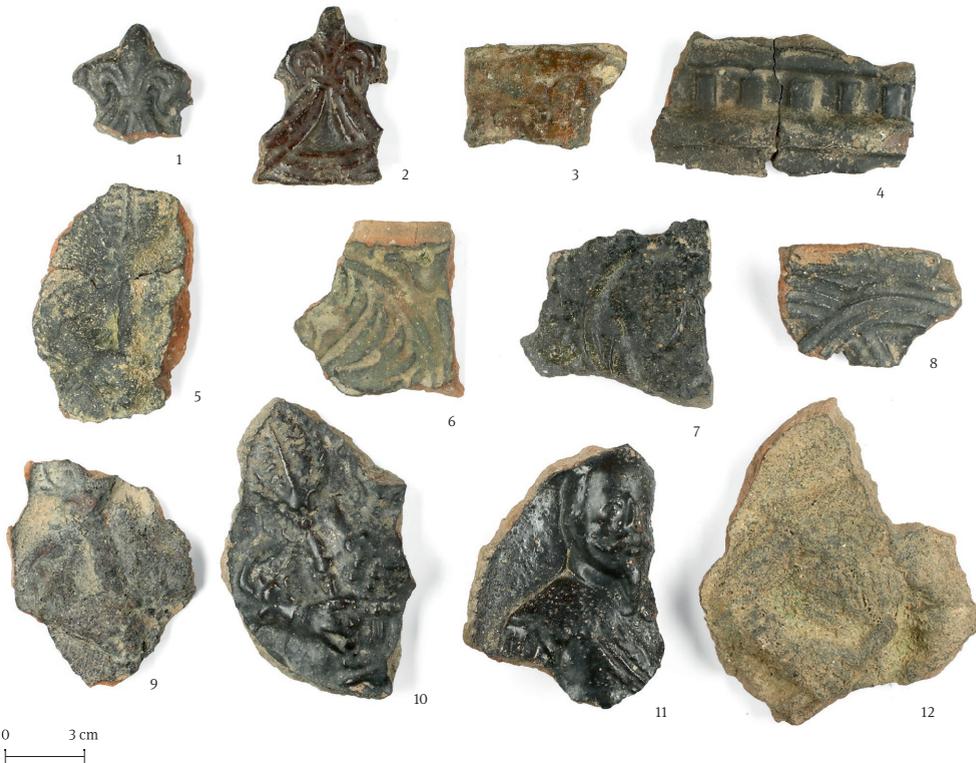
**Fig. 8.** Fragments of stove tiles, probably from the 1630s or 1640s, from the cellars of Vaabina manor.

From the layer of debris, mainly from room C, several fragments of stove tiles (Fig. 8), some with the images of the Swedish royal couple – King Gustav II Adolph (ruled 1611–1632) (Fig. 8: 11, 12) and his wife Queen Maria Eleonora (since 1620) (Fig. 8: 5, 9, 10) were discovered.<sup>5</sup> Some of them were strongly burnt, glaze covered with bubbles, evidently damaged in the fire which destroyed the manor house.

Stove tiles with the images of the royal couple Gustav II Adolph and Queen Maria Eleonora have until now been found only from the territory of Estonia.<sup>7</sup> Therefore, since there are no direct parallels known from Latvia or Sweden, they seem to represent a local production centre. As known from written data, the manor of Vaabina was endowed after the Swedish conquest by King Gustav II Adolph (1611–1632) to Friedrich Rosladin (Frizz Radislai), since 1636 by Queen Christina to Johann Eberhard von Bellingshausen (Johann Ewerdt Billingshusen) (Revisjon 1638, 51).<sup>8</sup> The use of tiles with the images of the royal couple can be regarded as a sign of loyalty of the manor owner to the King of Sweden.
