Archaeological monitoring in medieval Rannu Church: construction remains and coin finds

Heiki Valk

Mauri Kiudsoo

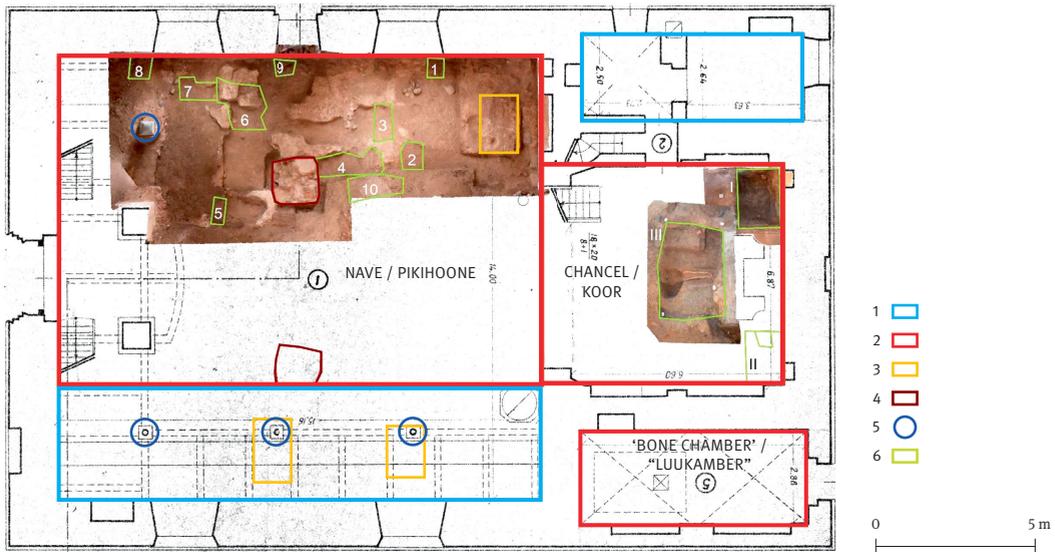
Fig. 2. Investigation areas in Rannu church. 1 – investigation areas of 2020, 2 – investigation areas of 2021, 3 – discovered altar foundations, 4 – foundations of medieval pillars, 5 – find places of medieval pillar details, 6 – trenches.

Archaeological monitoring of the removal of sand and soil was performed by the University of Tartu, assisted in metal detecting by Aleksandr Kotkin and occasionally by Igor Tsakuhhin (both from history club Taaler). In 2020 the work was undertaken in the southern third of the nave and in the sacristy and its entrance hall, in 2021 in the rest of the church (Figs 2, 3).

More information about the history of the church was gained from the northern part of the nave (Fig. 2). Here ground was removed and sieved until the appearance of fragmentary remains of compact mortar floor(s) in the depth of ca. 50–60 cm from the present floor level, and between the mortar patches also somewhat deeper. In addition, 10 trenches were dug beside preserved patches of mortar, to get information about intact stratigraphy under them, as well as beside the walls.

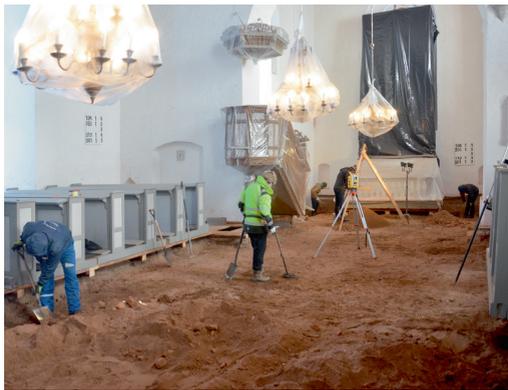
Fig. 3. Archaeological investigations in the nave of Rannu church.

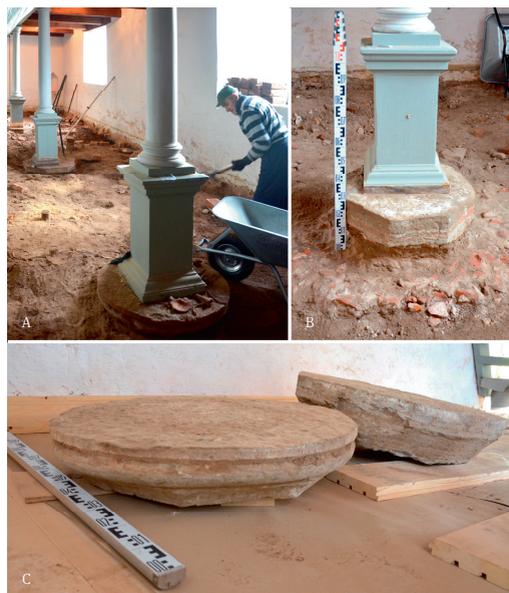
Fig. 4. Details of the medieval pillars in Rannu church from the southern aisle. a – unearthened pillar details in situ, b – the easternmost pillar fragment in situ, c – the pillar bases after removal.

The southern balcony of the church, built in the 18th or 19th century, was supported by three timber posts. When the church floor was removed, a medieval limestone pillar fragment, re-used as basis for the balcony posts, was found under each post (Fig. 4). The details located under the western and central posts were round bases for pillars, 90 and 85 cm in diameter. The eastern fragment originated from an octagonal column with a 70 cm diameter. The medieval details were removed from their location and are presently being exposed in the church.

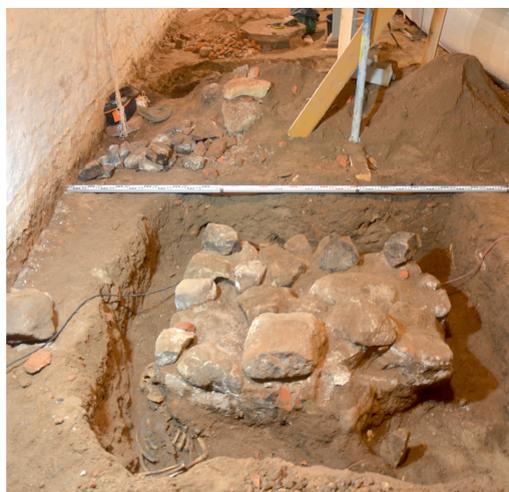
Fig. 5. The eastern altar foundation in the southern aisle. **Jn 5.** Lõunalõovi idapoolne altarivundament.

When removing soil from under the easternmost pillar basis, an assemblage of granite stones bound with hard white lime mortar appeared ca. 35–40 cm below the floor level. Although the structure with minimal addition of brick fragments was first thought to originate from the foundation of an earlier church, its distinct eastern and western edges disproved the opinion. The structure appeared to be a rectangular stone foundation measuring 1.2 m in the east–west and 1.5–1.53 m in the north–south direction (Fig. 5). Its southern edge was situated ca. 0.85 m north and eastern edge 3.5 m west of the nearest church wall. Evidently, the foundation originates from a medieval side altar in the southern aisle.

When looking for the south-eastern corner of the altar foundation, it appeared that the construction of the altar had damaged the skeleton of an elderly man (aged 44–86)²: the bones of his left shoulder region had been removed. It also appeared that his skull was filled with bright white limewash and there was limewash also between his ribs and vertebrae. This must have been the result of a mortar box on top of the burial that tipped over or through during construction work, possibly of the altar. From the chest of the skeleton a bracteate of prince-bishop of Tartu Bartholomaeus Savijerwe (1441–1459) was found. Since the flesh had to be totally decayed by the time of construction, the side altar cannot have been built before the 1470s. Its possible upper date is the beginning of the Livonian War in 1558. After the reconstruction of the floor the structure is exhibited in the wooden church floor, being covered by glass.

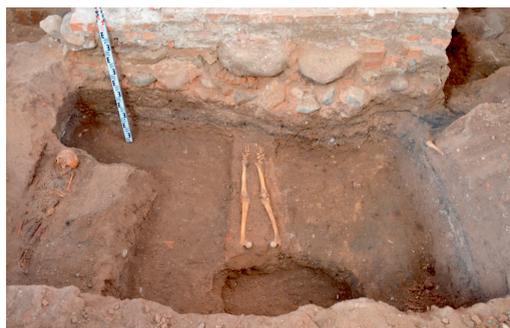
Fig. 6. The trench in front of the altar.

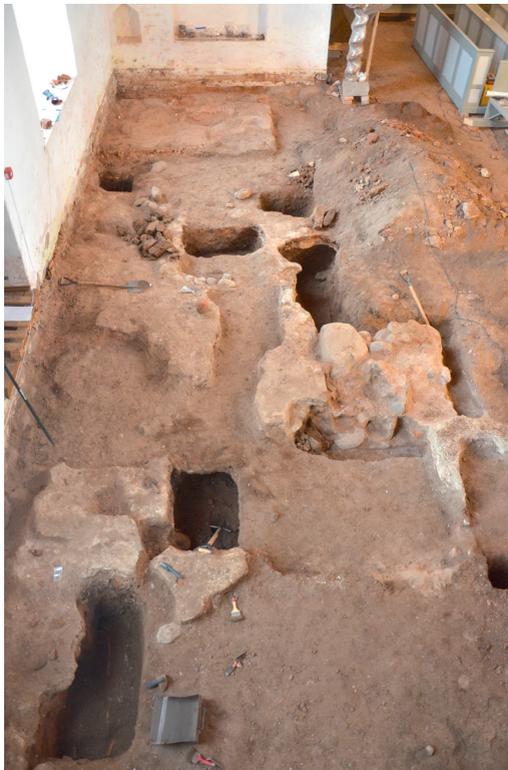
Fig. 7. Mortar floors and trenches in the northern nave of Rannu church.

In total, 17 mortar patches of different size, shape and state of preservation, mostly with broken, but in some cases also with preserved original flat horizontal surfaces came to light in the northern aisle (Fig. 7). The mortar, appearing at different heights, was of diverse consistence, varying from bright white to greyish yellow or yellowish grey.

Judging by unworn clay surfaces of preserved units, the mortar layers did not function as ‘real’ church floors – in such case the soft surfaces of patches near the northern portal would surely have been worn out. Evidently, the mortar served as a subfloor or basement for beams under the floor boards, avoiding direct contact between timber and soil. The subfloor of similar character has also been found from the chapel of Helme, built, probably, in the 1420s (Valk 2020).

The mortar layer(s) had greatly been destroyed by digging graves. Repeated damages necessitated continuous repairs, as shown by the different consistence and colour of preserved areas. Occasionally thin layers of disturbed soil were between the mortar layers, resulting, evidently, from grave digging. Since mortar floor remains appeared under the layer with numerous burnt coins, mortar subfloors existed before the great fire around 1400 AD already.

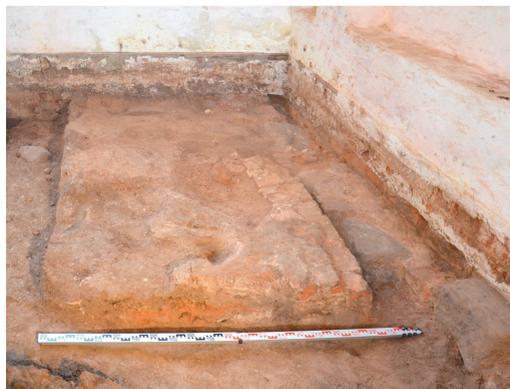
Fig. 8. Late 16th century altar foundation in the eastern end of the northern aisle.

In the eastern end of the northern aisle remains of a rectangular side altar with preserved measures of about 1.7 × 1.12 m appeared under the layer of demolition debris at the distance of ca. 53 cm from the eastern wall with an altar niche in it (Fig. 8). From the altar only the two lowest layers of bricks had partly preserved. Since the bricks were 7.5 cm thick, i.e. of post-medieval origin, the altar dates from the time of the Polish rule (1582–1625). North of the altar fragments of a 1–2 cm thick clay floor, similar to that at the southern wall of the chancel could be observed. From the layer of fine brick debris under the altar and the clay floor a Swedish coin from 1568–1592 was found.

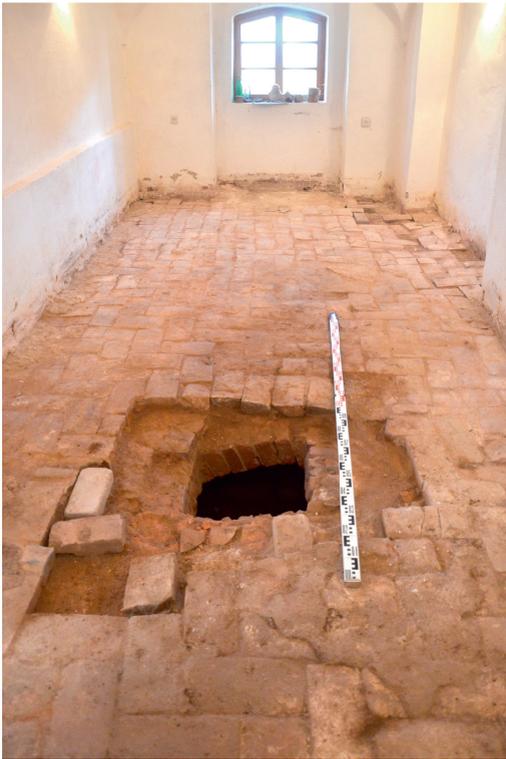
Fig. 9. Floor of the ‘ossuary’ or ‘bone chamber’ of Rannu church.

The western edge of the ‘bone chamber’ floor was partly repaired by using profile bricks of medieval shape and their fragments – the total of ca. 20 items. Later expertise¹⁰ showed, however, that, judging by the contents of clay and the colour of bricks the finds were not medieval, but represent the pseudo-gothic architecture of the 19th century.

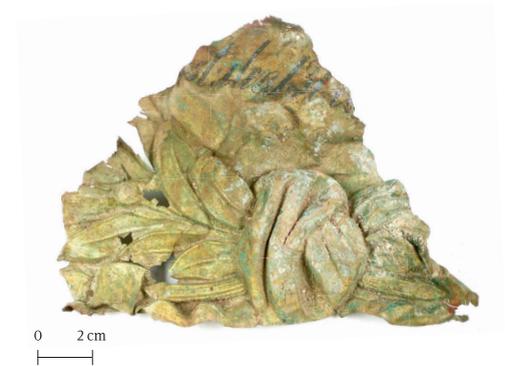
Fig. 10. Fragment of a coffin decoration from the ‘bone chamber’.

An indication to burials in the crypt is also a copper alloy sheet decoration (Fig. 10) found from the brick floor of the bone chamber – coffins of the nobility were richly ornamented with metal applications in the late 17th and 18th century (Hagberg 1937; Viljus 2010). Style features suggest that the fragment represents either rococo or Jugend style, respectively, from the 1750s to the early 1770s or from the early 20th century.⁹ The inscription fragment [...]st. den 13 Oc [...] (evidently from *gest[orben]. den 13. Oct[obri]*, unambiguously refers to the period from the 1750s to early 1770s. Most likely, the walls of the presumed chapel were demolished when the bone chamber was built in 1835. If the crypt functioned as a burial chamber, its partial filling with soil took probably place when burial inside and around churches was prohibited in the Russian empire in 1771–1773 (Hausmann 1903). However, constructing the cellar together with the ‘bone chamber’ cannot fully be excluded, either.

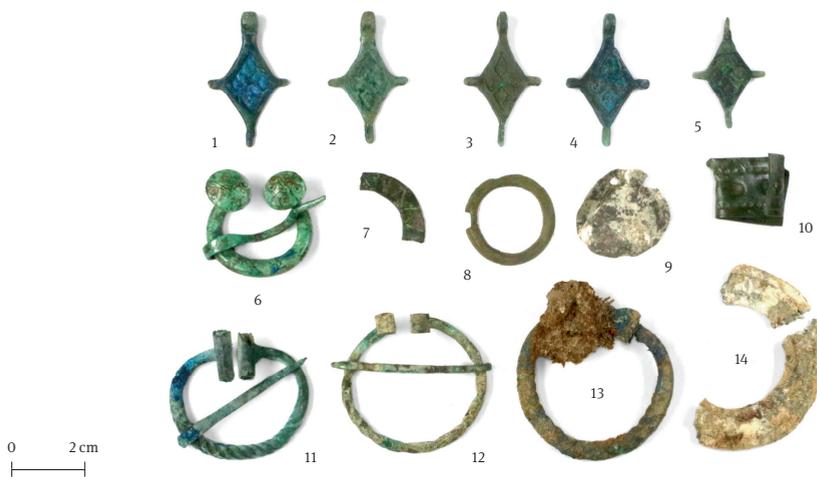
Fig. 11. Pendants and brooches from Rannu church.

From trench 7 two burials were unearthed. One of them (no. 8, a woman aged over 45) had a poorly preserved annular brooch of lead alloy with possible traces of an inscription on it (Fig. 11: 14) under the chin. Bones of the lower part of her body had been removed when digging a grave for another burial (no. 9) with a penannular brooch with rolled ends (Fig. 11: 11) also in the same place – under the chin. In the bottom of trench 10, dug to discover additional items from the assemblage of burnt coins, the lower part of a west-oriented male skeleton cut by a later grave was unearthed.

From the 13th–14th centuries fragments of two annular brooches with a narrow arch (: 209; Fig. 11: 7), and two copper alloy spiral tubes (Fig. 13: 8, 9) might originate. To the same period belongs a small well elaborated penannular brooch with mushroom-shaped ends (Fig. 11: 6). This find from the northern entrance hall to the chancel and sacristy originates from the western Baltic (Semigallian-Zhemaitian) areas.¹¹ Formerly only one brooch of such type was known from southern Estonia. Medieval jewellery is also represented by five 14th–15th centuries' cross pendants with a rhomb-shaped middle part (Fig. 11: 1–5), most of them, probably, from one necklace, and a pin from a penannular brooch (: 171). A lead alloy belt mount (Fig. 13: 23) – a similar item has been found from the chapel of Helme (Valk 2020, 114, fig. 7: 6) – might originate from the 15th century. Of medieval origin are also an oblong (Fig. 11: 10) and a rectangular mount (Fig. 13: 21), a ring with open ends and minuscule inscription (Fig. 14: 2), a lead alloy ring with a pseudo-woven front part (Fig. 14: 3), a round sheet pendant of silver (Fig. 11: 9) and three rectangular mounts – one of copper alloy (: 119), and two identical items of lead alloy (Fig. 13: 14, 15).

To the late 15th – early 17th century might belong a degenerated spiral ring with a twisted middle coil (Fig. 13: 5), two simple penannular brooches (: 675; Fig. 11: 12, 13), and a fragment of a supposed button (Fig. 13: 20).

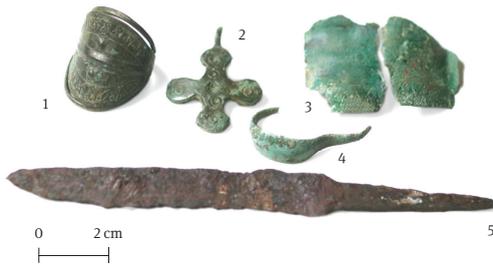
Fig. 12. 13th century grave goods from Rannu church.

pendant decorated with dotted circles (Fig. 12: 2), two fragments of a broad thin bracelet (Fig. 12: 3), and a ring with a thickening middle part and open ends (Fig. 12: 4). Similar bracelets and shielded rings have formerly been found from Ala-Kõrtsi cemetery – a burial site which probably preceded the church and churchyard of Urvaste (Valk *et al.* 2018).

Judging by finds, the earliest phase of the cemetery belongs to the second or third quarter of the 13th century. Finds of that period are represented by a ring with a wide shield and long open ends (Fig. 12: 1), a simple cross

Finds of tools and utensils were rare and their share was small when compared to that in rural village cemeteries. From the church only an iron knife from the 13th or 14th century (Fig. 12: 5), and a blade tip of a knife (: 307), as well as an iron needle (Fig. 13: 25) and a needle fragment (: 297) were found. The bent tip of the needle may not be occasional, but could reflect some ritual activities. A lead plummet from a fishing rod (: 299) may be brought to the church with sand from the shore of Lake Vörtsjärv.

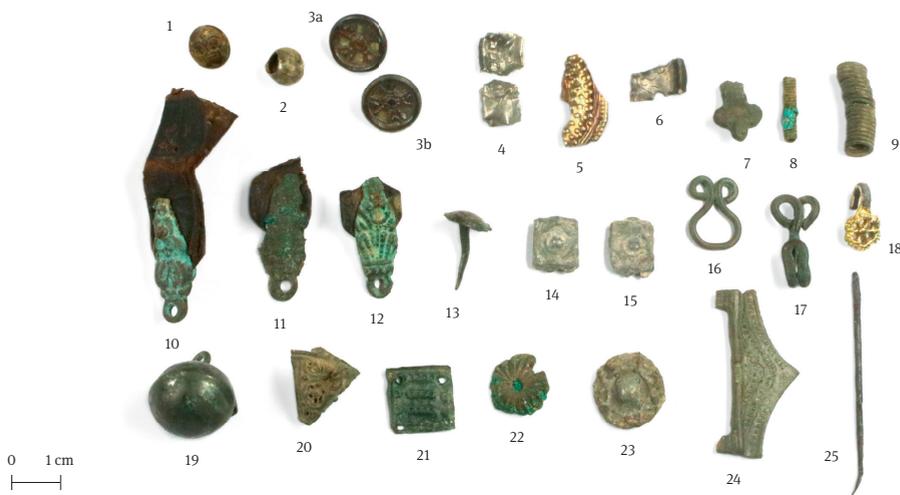
Fig. 13. Finds from Rannu church. 1 – a button, 7, 14, 15, 21–23 – mounts, 2 – a hollow bead, 3a, b – buttons, 4–6 brooch fragments, 8, 9 – bronze spiral tubes, 10–12 – strap ends, 13 – a thumbtack, 16, 17 – a hook and an eye, 18 – a decorative hook, 19 – a bell, 20 – a button (?), 24 – a buckle fragment, 25 – a needle. 2 – glass, 4–6 – silver, 14, 15, 24 – lead alloy, 25 – iron; others – copper alloy. Nos 5 and 18 – gilded.

The Early Modern Times are represented by a simple closed ring (Fig. 14: 1), a signet ring with an abstract image (Fig. 14: 4), a tiny button with a crown image (Fig. 13: 1), a bell without a slot (Fig. 13: 19), a dress hook and its eye (Fig. 13: 16, 17), and a buckle fragment (Fig. 13: 24). A small annular brooch (Fig. 11: 8) dates from the 17th or 18th century, and a fragment of a simple ring with jaggy edges (Fig. 14: 6) from the 18th century. Of unknown date are a thumb-tack of white metal (Fig. 13: 13) and a small round mount (Fig. 13: 22). In addition, three 18th–19th centuries' book clasps of copper alloy (Fig. 13: 10–12) were found.

Some artefacts are alien for the rural popular culture of Estonia, representing the culture of the German nobility. In the village cemeteries of the region there are no parallels to a medieval tiny mount with lily-shaped ending (Fig. 13: 7), to a dressing hook with a gilded

flower-shaped head (Fig. 13: 18), to a fragment of gilded round thin silver brooch (Fig. 13: 5), and to some silver fragments, probably, remains of thin annular brooches (Fig. 13: 4, 6). Two buttons with a cross image (Fig. 13: 3a, b) may have belonged to a priest's robe.

Beads were represented by a fragment of a big round yellow item from the 13th–14th centuries (: 450), a hollow glass bead (Fig. 13: 2), two round dark crystallized glass beads, probably from the 16th century (: 95, 486), and some 17th century beads – a fragmented oblong blue glass bead (: 362), an orange glass bead (: 256), and a tiny black bead (: 249).

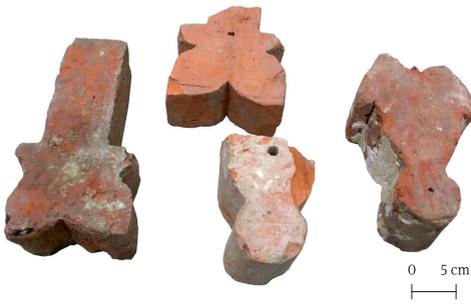
Fig. 15. Fragments of profile bricks from Rannu church.

Finds of profile bricks were not numerous, being represented by fragments from window posts, and from vault ribs¹³ (Fig. 15). Medieval roof tile fragments were also rare. In addition, a piece of strongly worn limestone originating probably from a grave slab (: 348) and a fragment of terracotta figure of an unknown saint (Fig. 16: 8) were found from the interior of the church.

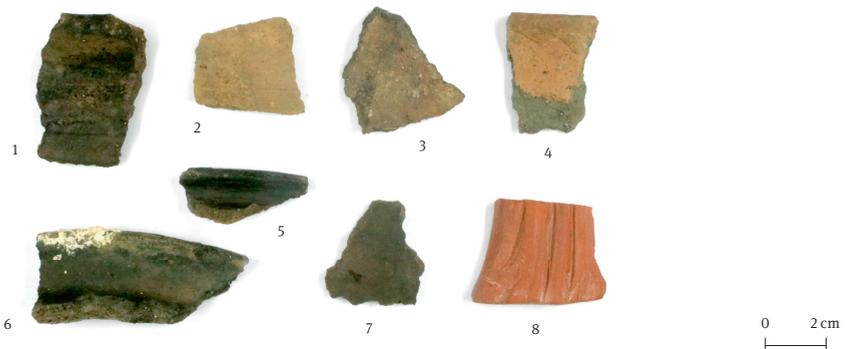
Fig. 16. Pottery finds (1–7) and a fragment of a terracotta statue (8) from Rannu church.

Pottery fragments gained by sieving are represented by about 30 fragments of mostly dark coarseware (Fig. 16: 1–7), some of them decorated with lines (Fig. 16: 2), and one having diagonal hatches along the rim (Fig. 16: 4). Such pottery may date both from the time before and after the crusades.

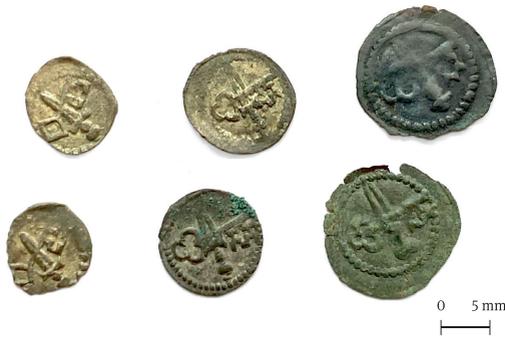
Fig. 19. The so-called ‘Tartu pennies’: coins of Vyffhusen, Velde and ‘Damerow’ are grouped in pairs.

Before archaeological investigation in Rannu church, the so-called ‘Tartu pennies’ (Fig. 19), minted between probably between 1363 and the monetary reform of 1422/26, most likely, only for local circulation in the prince-bishopric, have been rare finds. These coins, both one- and two-sided, were later made of pure copper (Kiudsoo 2019, 52 and references). Beside 74 specimens struck by prince-bishop Johann I Vyffhusen (1364/5–1373) and 11 or 12 by Heinrich I von Velde (1373–1378(?)) (: 91, 96, 125, 498, 535, 541, 543, 558, 565, 597, 673, 674) the finds from Rannu include even at least 240 later ‘Tartu pennies’ (so-called ‘Damerow bracteates’), which date from the time range between 1379 and 1420 and can be attributed either to Dietrich

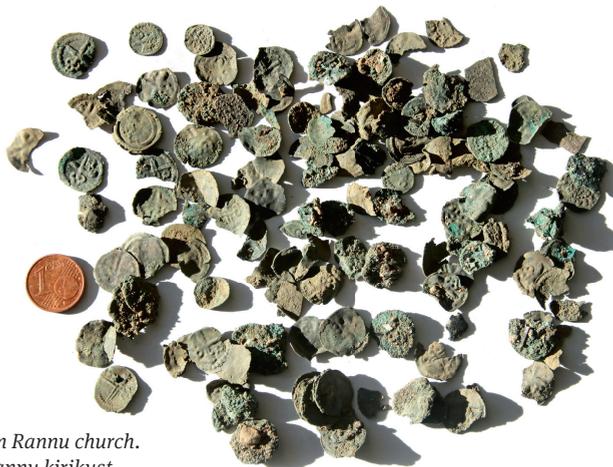
Fig. 20. Burnt coins from Rannu church.

As noted above, numerous coins from the last third of the 14th and/or early 15th century which were found from a limited area in the northern nave bore traces of fire (Fig. 20). Some of them were burnt so strongly that they could not be found by metal detector, but were discovered only by sieving. Due to strong fire damages several coins were stuck to each other or were broken into pieces. Because of these reasons, the total number of burnt coins remains unclear, but it can be estimated roughly to ca. 300 items. The burnt coins which could be identified include mainly the so-called Damerow bracteates (at least 168 items), pennies of Tartu prince-bishop Johann von Vyffhusen (1364/5–1373) (at least 24 items), lübische pennies of Tartu bishopric (12 items) and two pennies of Tartu prince-bishop Heinrich I von Velde (1373–1378). Most likely, the burnt coins were in one container – a cash box for donations or candle money.¹⁶ The reasons for the co-existence of pennies of Vyffhusen with high and those of Damerow with low silver contents in the burnt assemblage are unclear – such complexes are not known in the numismatic material of Estonia. As a rule, when coins of lower silver contents appear, they quickly push the earlier coins with the same nominal value out of circulation. An explanation to the presence of Vyffhusen (and Velde) coins in the assemblage might be that the box was in use for a longer period and when it was emptied, some earlier pennies had remained there (maybe in cracks?), being released from there only by the fire.
