The oldest urban building remains in Kuressaare

Garel Püüa

INTRODUCTION

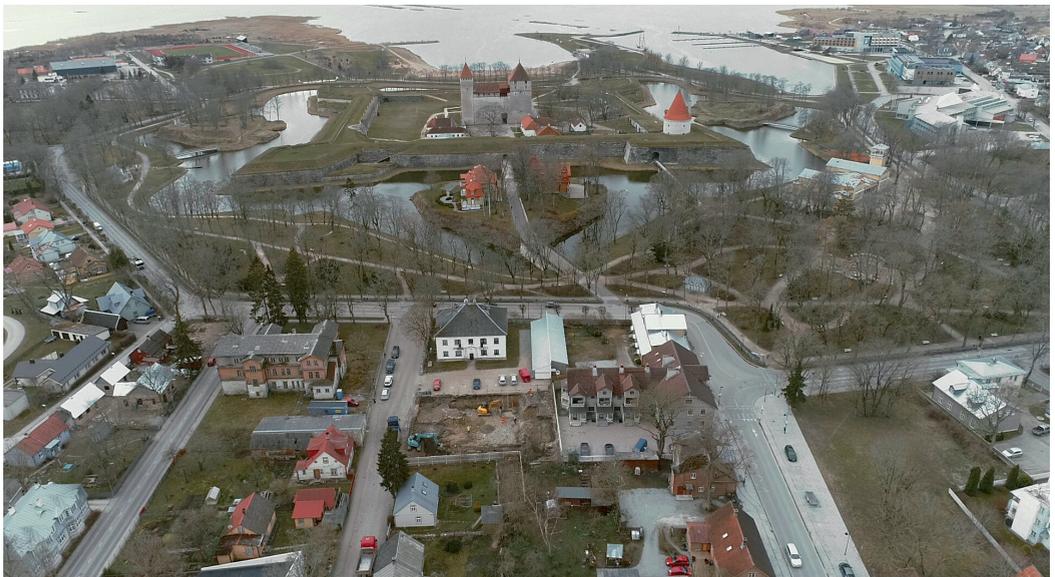
Fig. 1. In April 2021, during the construction of a new residential building on Kitsas Street, remains of the oldest building to date in Kuressaare were found.

The Kitsas St. 16 property is only 300 metres away from the Kuressaare *Konventhaus* (bird's eye view), built in the 14th century and during the excavations, the foundations of the oldest residential building in the town were found (Fig. 1). During the fieldwork, the total of 100 artefact finds were recovered, which are now stored in the archaeological collections of Saaremaa Museum (SM 10889).

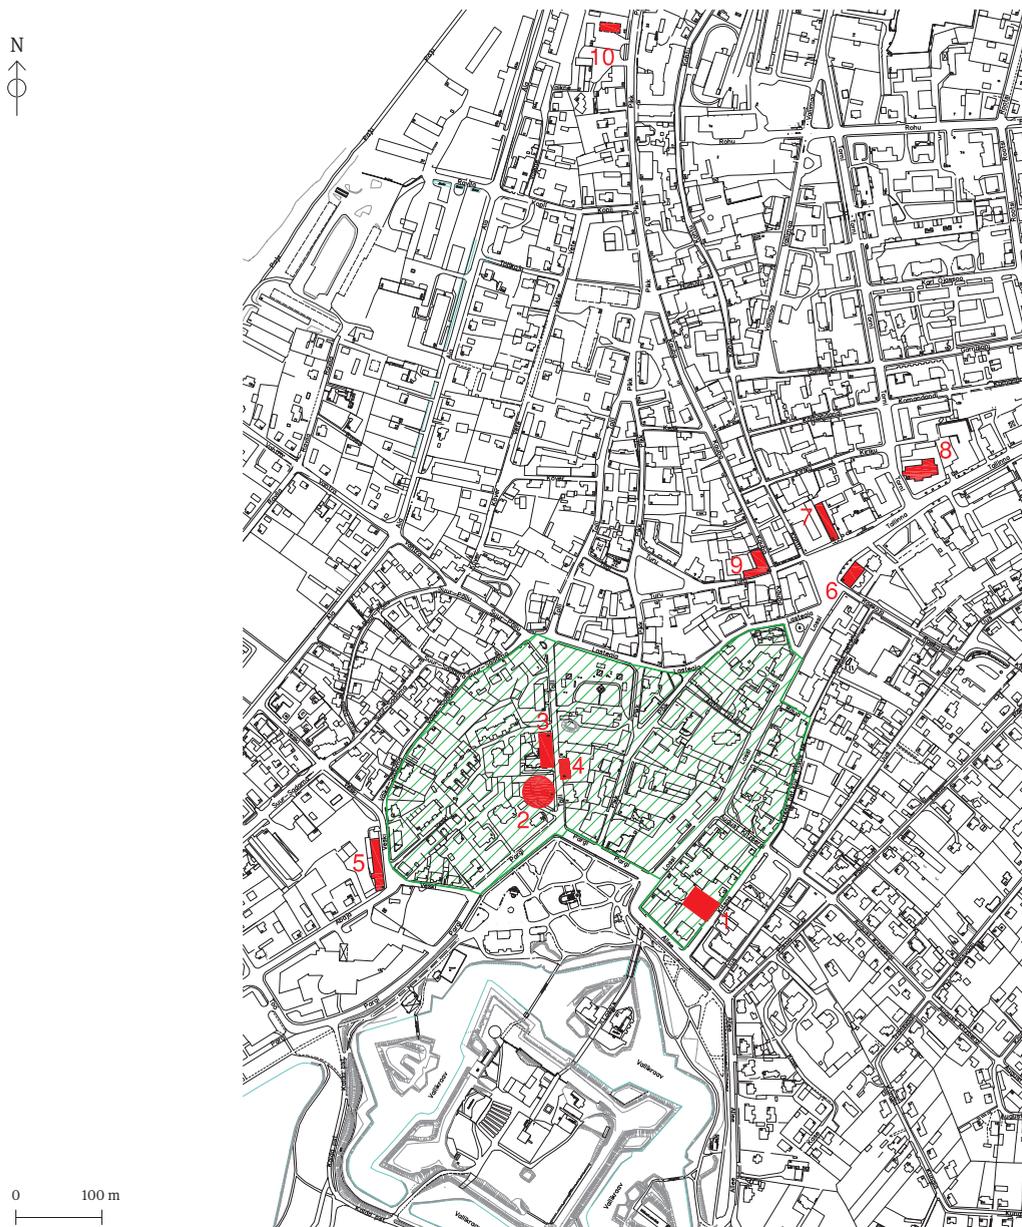
Fig. 2. Probable location of the medieval settlement of Kuressaare and the oldest houses in the town. 1 – Kitsas St. 16, 2 – supposed medieval St Lawrence Church, 3 – building at Tolli St. 3, 4 – building at Tolli St. 4, 5 – port storehouse at Veski St. 9, 6 – town hall, 7 – weighing house, 8 – early modern St Lawrence Church, 9 – parsonage, 10 – building at Pikk St. 44.

The former pastorate building of the St Lawrence Church, located at Kauba St. 5, which is considered to be the oldest residential building in Kuressaare (Sild 2019; Fig. 2: 9), and the Port Storehouse located at Veski St. 9 (Basihhina & Hansar 1999, 43; Välja 2014, 79; Fig 2: 5) have generally also been considered to have been built in the 17th century. However, these buildings cannot be found in the first detailed city plan of Kuressaare from 1747 (RGVIA 349.3.1512).

It is possible that the construction time of the building at Tolli St. 4 (Fig. 2: 4) also dates back to the 17th century. The earlier construction stage of the current Tolli St. 3 building opposite it (Fig. 2: 3) probably dates back as far as to the 16th century. The house may have been destroyed during the great fire in 1612, which also involved the adjoining medieval church (Sepp 1990, 11; Fig. 2: 2).

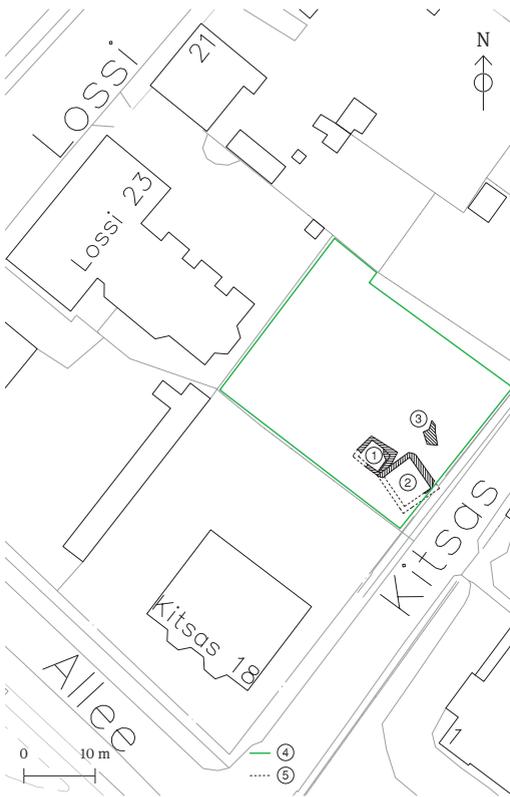
Fig. 3. Excavation plan. 1 – basement, 2 – front building, 3 – courtyard paving, 4 – excavation boundary, 5 – probable extension of walls.

1 – kelder, 2 – eeshoone, 3 – hoovisillutis, 4 – kaevandi piir, 5 – müüride arvatav jätk.

The property at Kitsas St. 16 (Fig. 3) is located on the border of the esplanade surrounding the entrenchments in the 17th–18th century, i.e., of the shooting range, which essentially remained undeveloped (Fig. 2: 1). According to the town plans known to us (since 1681, KrA 0406: 28: 002: 015), the current Kitsas St. 16 property had no buildings on it and was just the backyard of the historically adjacent building at Lossi St. 23, northwest from the discussed area. During the fieldwork, it became clear that the empty Kitsas St. 16 property was used in the 20th century mainly as a place for burying rubbish. The cultural layer had been damaged during the previous excavations in an area of about 340 m² (Püüa 2022). The height of the existing ground on the property was in the range of 3.9–4.4 m a.s.l., and the natural clay layer started at the height of 3.2–3.3 m a.s.l.

Upon removal of the cultural layer, the foundation of the half-basement type of building dug to a depth of about 1 m (height 3.3 m above sea level) came out of the southern corner of the property (Fig. 3: 1; 4). During the construction of the basement the ground may have been 20–30 cm higher. The foundation walls of the basement were laid slightly sloping against the wall of the foundation pit, the thickness of the walls was measured to be 50–75 cm. It was a foundation laid of natural stone and limestone, where clay excavated from the same place was probably used as a binder. The internal dimensions of the basement were 3 × 3.5 m (floor area approx. 9.2 m²).

The front building formed a strange angle to the basement as if the buildings dated back to different eras (Fig. 3: 2; 6). When cleaning the connection point of the two building structures, it turned out that the front building was built on top of the corner of the earlier basement (Fig. 7). The foundation of the front building did not extend beyond the southern corner of the basement.

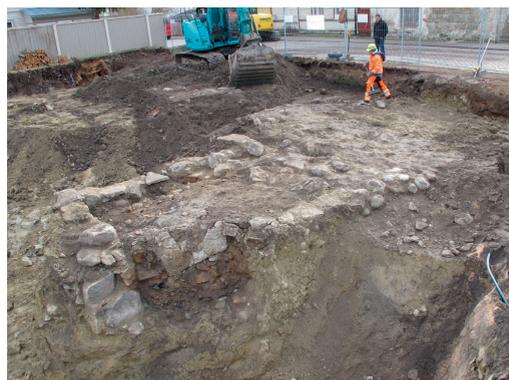
Fig. 4. View of the found basement, the front building on Kitsas Street, and the preserved courtyard paving (to the left of the backhoe).

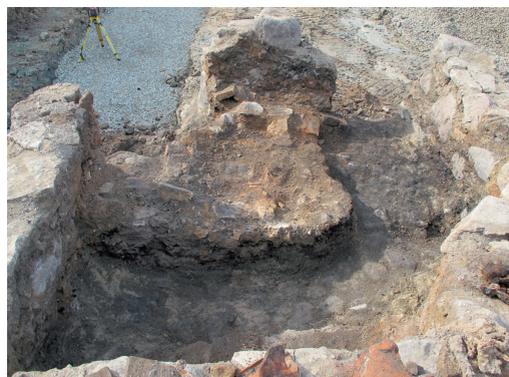
Fig. 5. Fragments of the limestone slab floor of the basement with later fire damage (higher area on the photo) and the original paving.

When the floor and the base layer of the limestone slabs were removed, the original floor paving of the half-basement was revealed (Fig. 5). The paving consisted of cobblestones and single limestones embedded in a sand pad. The stones used in the floor were up to 30 cm in diameter. The fact that the paving of the half-basement and the lower part of the basement walls were not damaged was striking. Traces of burning began only at the height of the secondary limestone slab floor. In short, the walls of the basement were preserved to the height of one metre, measured from the original floor level, the second floor level built after the fire was about 30–40 cm higher than the initial floor. The fieldwork did not establish the floor of the front building, but the clay layer of the subfloor was one metre higher than the original paving of the basement.

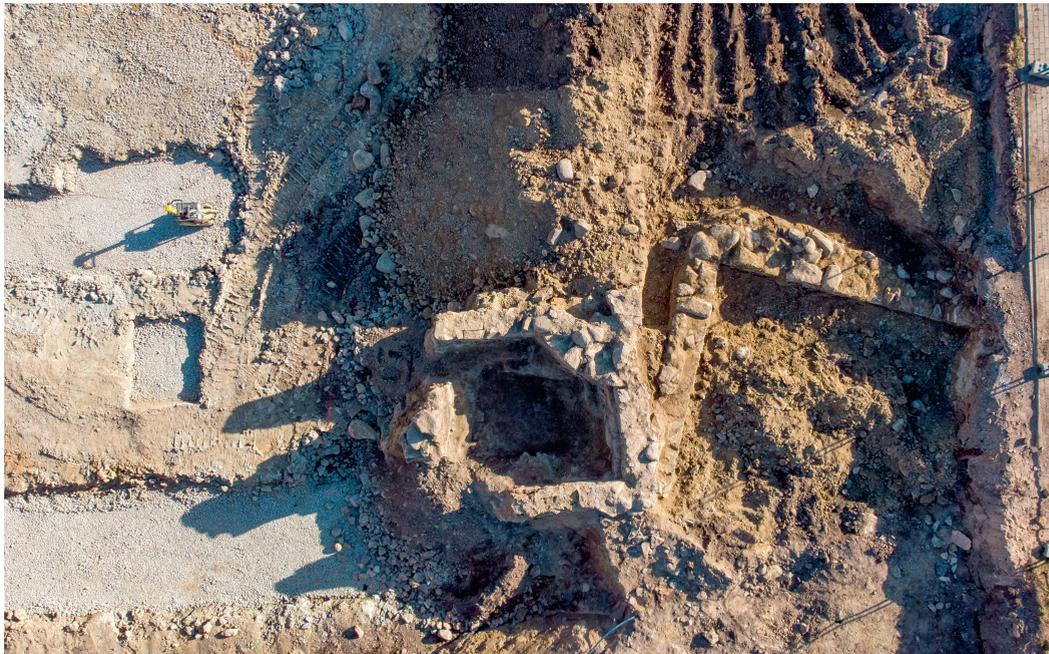
Fig. 6. Foundations of the front building on the side of the basement (left) and Kitsas Street.

The foundation of the front building, laid of earth and limestone, had been preserved to a maximum height of 95 cm, and its southeast and southwest walls had practically been destroyed (Fig. 6). The foundation wall of the building was laid with a slight slope directly against the wall of the foundation pit, the binder being clay mortar. The thickness of the walls was measured to be 70–90 cm. The internal dimensions of the building were about 4.5 × 5.2 m (an area of about 23 m²).

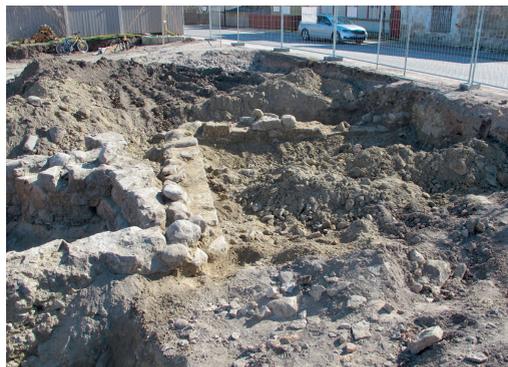
Fig. 7. The foundation of the front building was built on top of the corner of the basement.

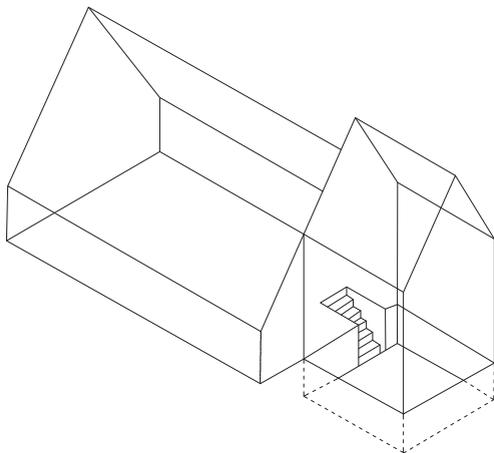
Fig. 8. Reconstruction of a barn-residential building.

What type of buildings are half-basements associated with? As a rule, half-basements are smaller stone buildings with one to two floors, partly below ground level, consisting of two parts: a (half-timbered) front building and a stone basement in the back. The latter is usually partially above-ground and thus can be called half-basement. In the written sources of the German-speaking areas, this type of building occurs under various names, the most common being *Steinwerk*, *Kemenate*, *Steinkammer*, etc. Researchers do not agree on whether these terms relate to the same type of building or to its different forms. Therefore, considering the method of use, a generalized name has also been proposed – the so-called rear building made of stone (Pärn 2010, 39). The latter arises from the position of the stone building, which generally remained either in the middle of the property or at the rear of it and was mostly built against the rear end wall of a wooden front building with a lattice structure. The fact that the house itself was an extension is indicated by the entrance on the street-side end wall of the half-basement, which connected the basement to the front building (Fig. 8).
