# Wall fragments of the medieval town church in Viljandi

Heiki Valk and Mait Raudsepp

# Archaeological research in Joaorg and former Peter's district of the town Narva

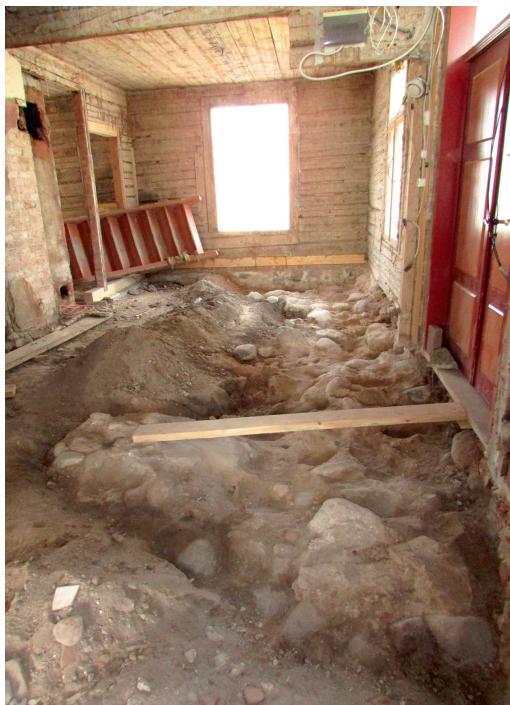
**Fig. 2.** The foundation unearthed under the floor of Johan Laidoneri Square 3a, view from the east.

During the archaeological monitoring the surface of the discovered foundation (Figs 2–3) was cleansed of demolition debris which also contained some brick, roof tile and stove tile fragments, as well as fragments of melted window glass, one of them of blue colour – probably, from a stained glass window. Some animal bones from the debris represented sheep/goat, pig and cattle.<sup>2</sup> The foundation, almost parallel to that of the existing house, was made of granite stones of 15/20–30 cm in diameter, but contained also some tiny fragments of medieval bricks (thickness ca. 9 cm). The stones were packed with hard white lime mortar. The surface of the wall was unearthed in the length of ca. 6 metres, but it continued eastwards, being demolished deeper there: the presence of the wall could be observed in test pits. Since the northern side of the foundation remained under the building at Johan Laidoneri Square 3a, the thickness of the wall remains unclear, but it was at least 1.3–1.5 metres wide.

When the foundation surface was cleaned of loose debris, three foundations perpendicular to it were discovered. In the western end of the opened area foundation fragments stretched to the south of the main wall where they could be observed until 0.8 m south of it (Fig. 3: A). This wall basis, the width of which remained unclear because its western edge was hidden by the western foundation of the house, was at least 1 m wide. The second perpendicular

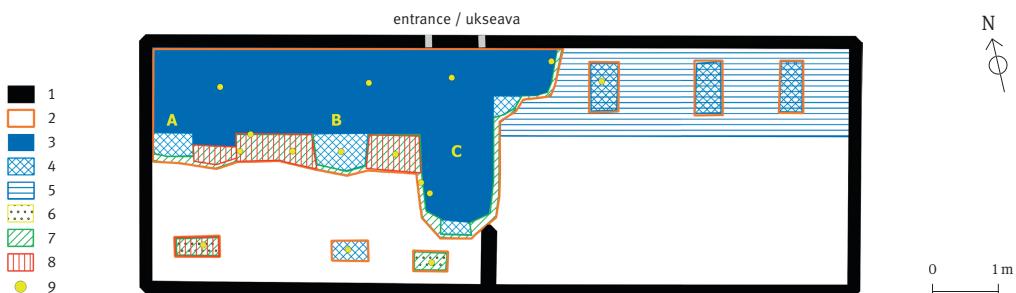
**Fig. 3.** 1 – walls of Johan Laidoneri Sq. 3a building, 2 – opened areas, 3 – the medieval wall, 4 – a broken wall surface with mortar rubble, 5 – supposed medieval wall, 6 – brick rubble, 7 – lime mortar rubble, 8 – cultural layer with finds, 9 – finds and find assemblages.

foundation (Fig. 3: B) was 1.0 m wide and could be observed for ca. 0.5 m towards the south. The easternmost structure (Fig. 3: C) was 1.3–1.5 m thick and at least 1.4 m long – further to the south it was demolished. All the perpendicular structures seemed to be not of secondary origin, but built simultaneously with the main wall.

Immediately south of the discovered east–west directional foundation, patches of *in situ* occupation layer came to light under the demolition debris (Fig. 3: 6). The dark, ca. 10 cm thick cultural layer contained fragments of pottery and animal bones. The pottery is represented by dark, almost black ware of 16th century origin, but also a fragment of a Russian green glazed field bottle was found. This find and pottery characteristic of the Livonian War (1558–1583) period make it possible to date the find assemblage. The cultural layer indicates intensive occupation activities beside the ruins of a big medieval building in that time. Since a new layer of debris appeared under the occupation layer, the building with massive walls had partly been demolished already before the deposition of the layer, which reflects human

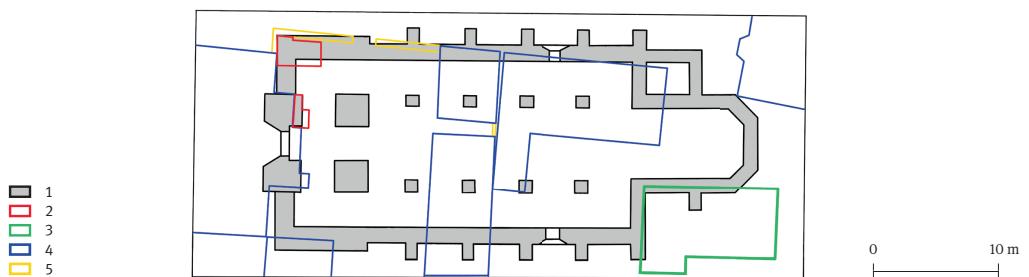
**Fig. 4.** The location of Viljandi medieval town church in present-day townscape (after Stöör 1996, with updates by Mait Raudsepp). 1 – the medieval town church, 2 – trenches of 1996, 3 – Johan Laidoneri Sq. 3a, 4 – other buildings, 5 – a stone fence.

Two wall fragments of medieval Viljandi town church made of bricks and granite came to light in 1996 (Valk 1997, 130) when a wheelchair access to Johan Laidoneri Square 5 building was constructed. In the context of that investigation, architect Ülo Stöör located the trench, based on the church image on the town plan from 1656, to the north-western inner corner of the building (Fig. 4). In addition to their location, the wall remains were identified as belonging to the church also by the remarkable thickness of the foundation (2.6 m). The location of the remains of a brick staircase made it possible to interpret it as access from the nave corner to the church tower. In the same context Stöör marked, based on the town plan from 1656, the location of the church on the present-day town plan, also in relation to Johan Laidoneri Square 3a building (Fig. 4).

Archaeological monitoring of 2022 showed that the reconstruction made in 1996 was correct. Evidently, the massive foundation under the northern wall of Johan Laidoneri Square 3a belongs to the southern wall of the chancel of the medieval town church. The north-south directional medieval foundation under the western wall of Johan Laidoneri Square 3a (Fig. 3: A) might belong to the eastern wall of the church nave, and the bigger perpendicular wall (Fig. 3: C) fits well with the buttress depicted on the town plan from 1656. Only a minor error of ca. 50 cm both in the north-south and east-west direction could be detected in the reconstruction made on the basis of comparing excavation results with the 17th century and present-day town plans.

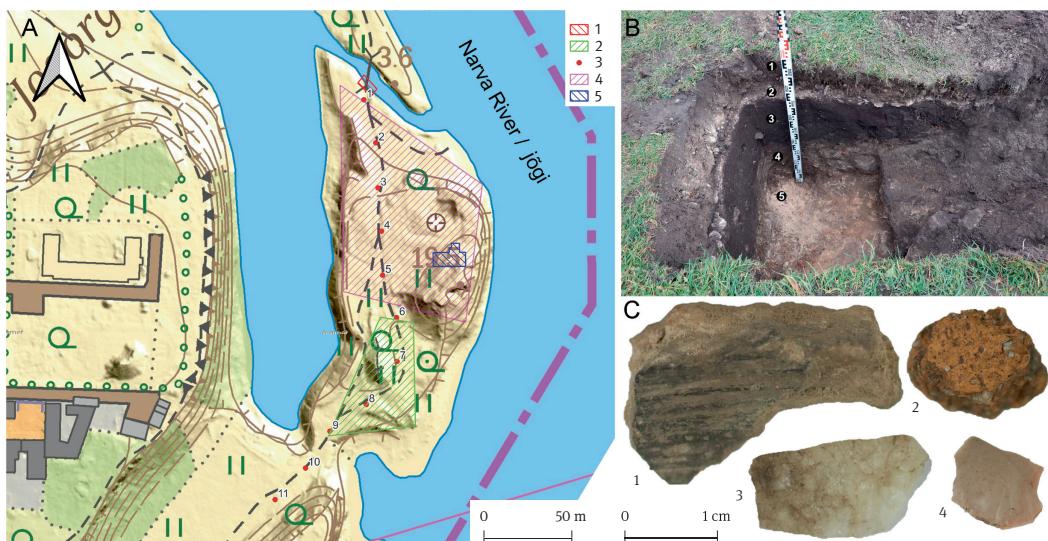
**Fig. 1.** A – Areas of archaeological research conducted during the construction work of the second stage of Narva Promenade in Joaorg, within the protected Stone Age settlement site and the fortified settlement site, and in their immediate vicinity. 1 – excavation of bridge abutment, 2 – fortified settlement (no. 9135), 3 – test pit, 4 – Stone Age settlement (no. 9136), 5 – L. Jaanits's excavations in the 1960s; B – test pit no. 5. Layers: 1 – humus, 2 – clay fill layer with limestone, 3 – cultural layer, 4 – limestone dust mixed with humus, 5 – sand; C – finds. 1 – shard of Narva-type pottery from test pit no. 3 (AI 8615: 1), 2 – shard of Iron Age hand-made pottery from test pit no. 5 (AI 8615: 4), 3 – quartz flake from test pit no. 5 (AI 8615: 9), 4 – Carboniferous flint flake from test pit no. 5 (AI 8615: 3).

to the period between 5200–3900 BC (Kriiska *et al.* 2020, 49). Two flint and one quartz flakes (Fig. 1C, 3–4) may possibly also originate from the Stone Age. One flake (retouched) is made of Carboniferous flint, and the other of Cretaceous flint.

Although the 0.35 m thick dark humus-rich cultural layer (Fig. 1B) is partially disturbed, the finds are significant enough to warrant archaeological investigations in case of further earthworks.

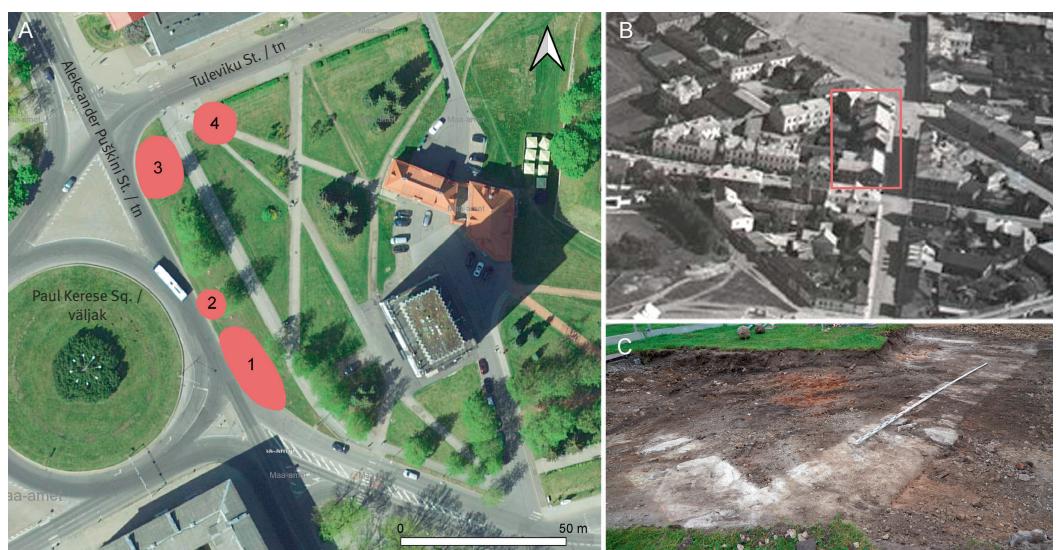
**Fig. 2.** A – Locations of the excavated remains of buildings found along Aleksander Puškini and Tuleviku Streets; B – excerpt from an aerial photo of the town Narva taken in 1932 depicting the buildings along Posti and Tuleviku Streets; buildings, the remains of which were partially excavated during the fieldwork in 2022 are enclosed by a red rectangle; C – partially excavated remains of building no. 4 along Tuleviku Street.

The building ruins are located along the former Posti and Tuleviku Streets (Fig. 2B)<sup>1</sup>, which were developed only in the last couple of decades of the 19th century as part of the former Peter's district of Narva. This became possible only after 1864 when Narva was excluded from the list of fortress towns of the Russian Empire, and the bastions were handed over to the town (Soom 1935, 76). The buildings were destroyed during intensive bombings of Narva by the Soviet Union Air Force in March 1944 (Tõnisson 2014).

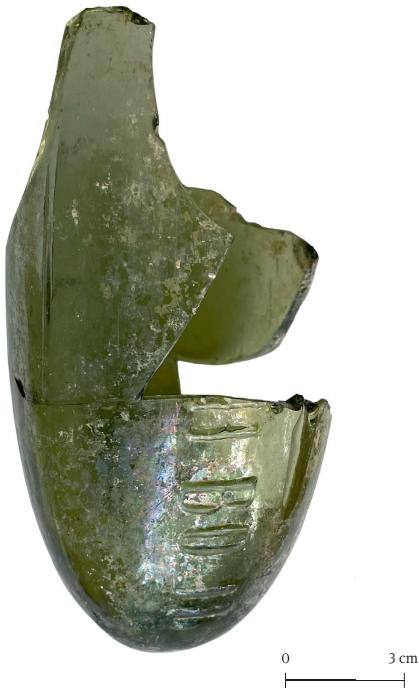
**Fig. 3.** Fragment of a glass mineral water bottle with a text.

In some areas, there were also layers of fill soils transported to the site from elsewhere, containing artefacts (including glass, building ceramics and faience vessels fragments) and animal bones. Among other things, a fragment of a light-green glass bottle with an oval-shaped bottom was found (Fig. 3). It is a part of a mineral water bottle with the text '...н. водъ'. Most likely, it was made in St Petersburg, where bottles of such shape and with this text were manufactured from 1834 until 1918 (see Archaeological collection of Memorial Museum 'Raznochinnny Petersburg'; Popkov 2021, 343–344). From the early 20th century onwards, the street was paved with cobblestone.

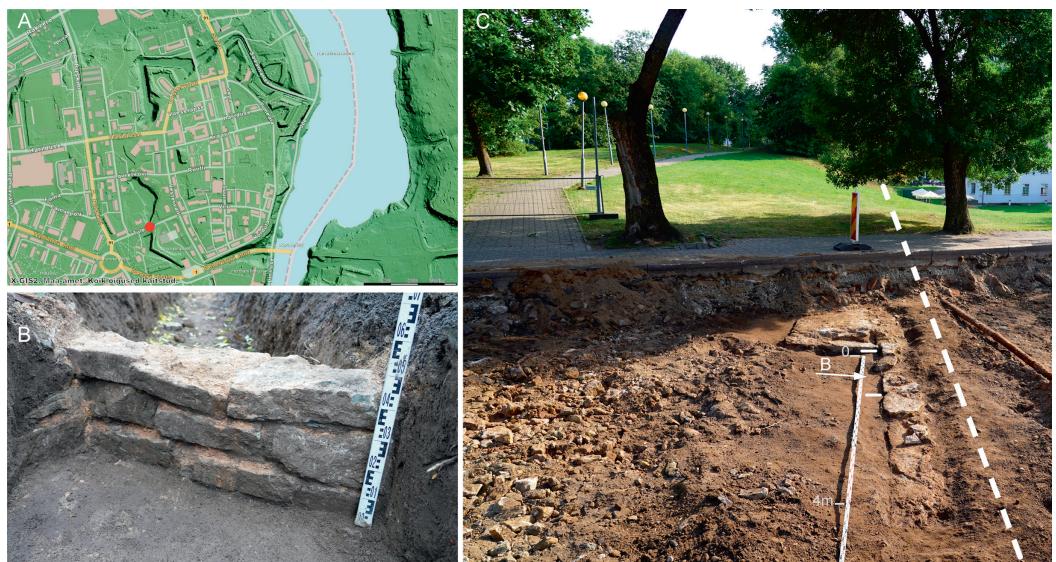
**Fig. 4.** A – Location of a section of the escarpment wall of Triumph Bastion uncovered on Tuleviku Street; B – view of the wall section from the former bastion; C – part of the escarpment wall, the white dashed line connects the excavated section with the remaining bastion wall, and ‘B’ indicates the location of the wall section shown in photo B.

A section of limestone wall, measuring 6.2 m in length, was excavated on the street, which is aligned with the preserved escarpment wall of the right face of Triumph Bastion and is a part of it (Fig. 4). The wall, up to 0.7 m thick, is constructed of limestone blocks bonded with lime mortar. On the inner side of the bastion, an additional buttress constructed of limestone blocks joined this wall. The exact construction period of this specific section of the wall cannot be de-
