Archaeological investigations in the western room of the ‘Clergy house’ of the Teutonic Order Castle in Viljandi

Heiki Valk

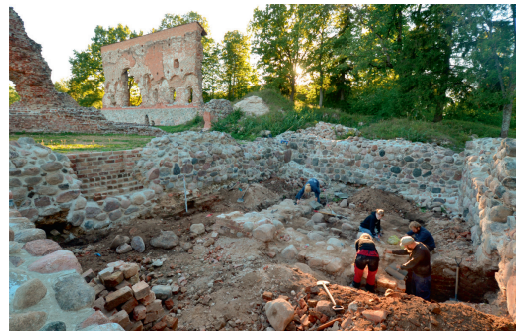
Fig. 1. Location of the research area in the castle ruins of Viljandi.

In 2022 conservation work, accompanied by archaeological investigations, began in a long building in the first outer bailey, north of the High Castle and south-east of the preserved castle gateway (Fig. 1). This building is depicted on the castle plan from 1656 as having three rooms (Fig. 2). The Polish inventory from 1599 (Viljandi 1599, 158–159) notes in this area six crumbled unroofed vaulted rooms and cellars of stone which once functioned as the dwelling of the Teutonic Order clergy. The walls of ‘the Clergy house’, although locally preserved up to the height of 1–1.5 metres, had mostly perished until the ground level – to an extent that the contours of the building as a whole could hardly be perceived.

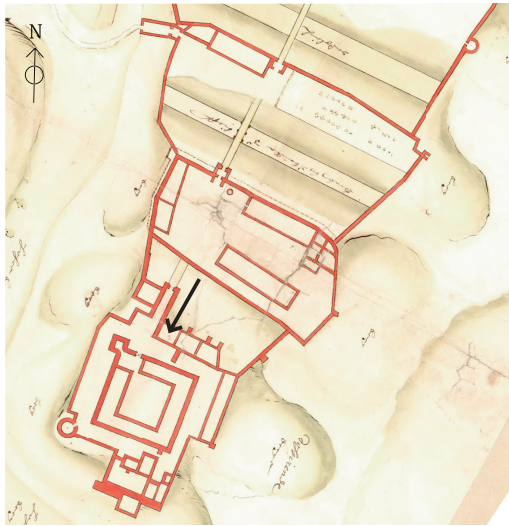
Fig. 2. Plan of Viljandi High Castle and its outer baileys from 1656.

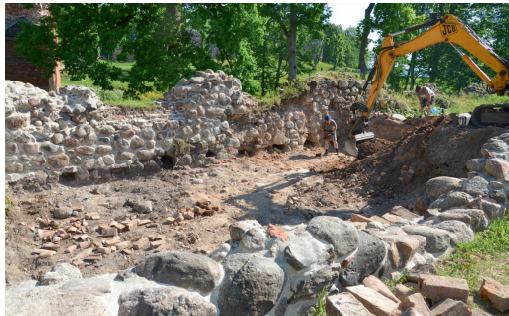
Fig. 3. Removal of debris from the western room of the ‘Clergy house’.

Debris of rather even composition, consisting of decomposed mortar, granite and brick rubble, as well as some better preserved bricks and roof tile fragments, were removed by a big excavator (Fig. 3). From the rubble also a fragment of hard mortar floor, covered by black layer of soot referring to a great fire was found.

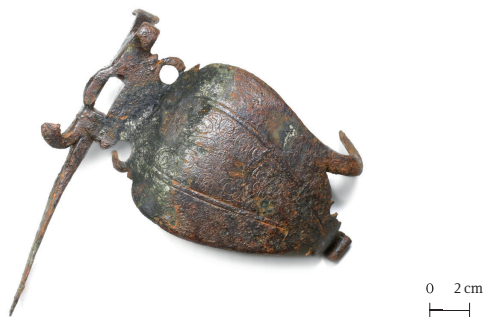
Jn 4. Mõõga või vasakukäepistoda käekaitse.
(VM 11646: 7.)

Fig. 4. A basket-hilt of a sword or left-hand dagger.

Finds from the debris were not numerous, being represented by a few Late Medieval or Early Modern Times pottery fragments. The most outstanding item was the basket-hilt of weapon, decorated with engraved images (Fig. 4). According to the estimation by Ain Mäesalu (TÜ) it might originate from a sable, according to Jaak Mäll (SALM) from a left-hand dagger – a

civil weapon which belonged to the same set with a rapier. Both estimations date the find to the second half of the 16th or first half of the 17th century. In addition, from the debris a decorative bone plate with engraved plant ornamentation, probably also from the same period (Fig. 5: 1), and some animal bones were found.

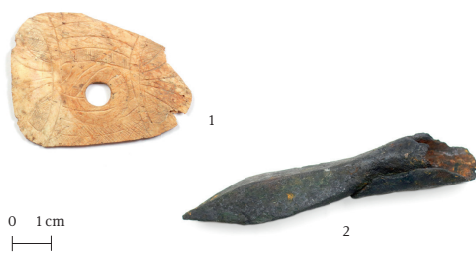
(VM 11646: 15, 26.)

Fig. 5. Finds from the debris. 1 – a decorative bone plate, 2 – a crossbow bolt.

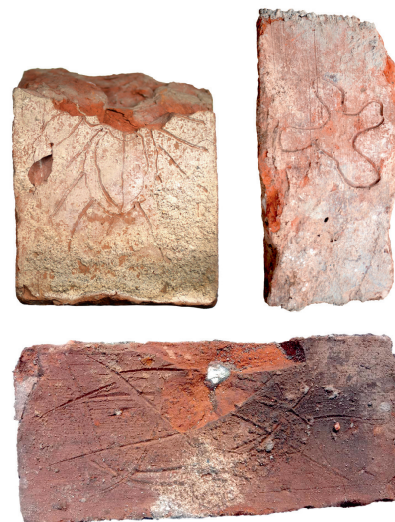
Fig. 6. Graffiti images on medieval bricks from Viljandi.

The debris also contained six bricks with animal footprints – cat and dog paw prints and sheep/goat hoof prints were all represented with two items (Valk 2022) – and three examples of graffiti drawn on unburnt bricks. The most outstanding, but only partly preserved graffiti find depicts a bug (Fig. 6: 1), but there were also a cross-like image (Fig. 6: 2) and a fragment resembling an eye (Fig. 6: 3). Paw prints are common finds on medieval bricks. For example, in Turaida castle in Latvia over 150 such items have been unearthed (Ose 2015, 119–135; figs 35, 66). From Turaida also different graffiti images were found (*ibid.*, fig. 10).

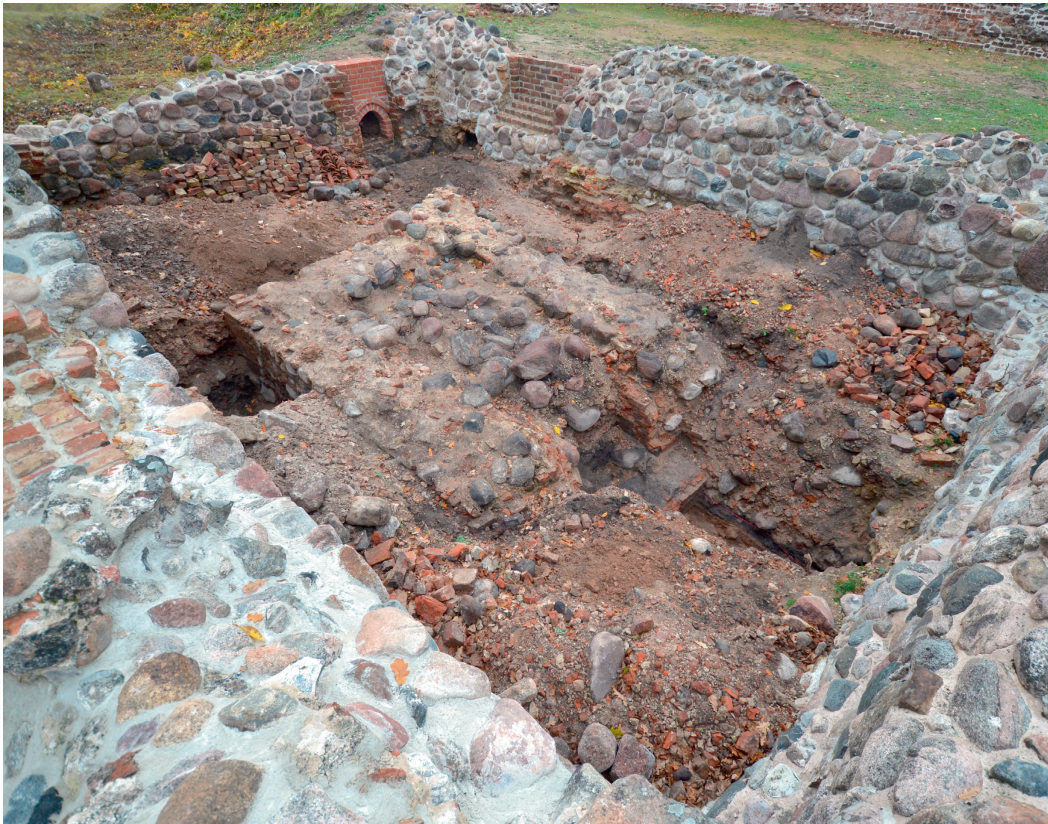
Fig. 7. The western room of the ‘Clergy house’ in Viljandi with discovered walls inside it and the re-constructed hypocaust mouth in the background. View from the north-west.

When the wall surfaces were cleaned of debris in September, remains of a quadrangular building of somewhat irregular shape, not depicted on the plan from 1656, appeared (Figs 7–8). The structure was 5.05–5.75 m

In the distance of 1.7–3.2 m from the south-eastern corner, the southern wall of the room became lower on the inside, having a slanting surface (Figs 7, 8, 11). Judging by brick remains and pieces of travertine on both broken sides of the lowering part of the wall, a window site can be suggested there. Probably, the opening had been lined with bricks – those, as well as

The western trench with the original size of ca. 1 × 1 m was made at the western wall of the ‘Clergy house’. This wall beside the trench had been conserved until the depth of 2.45 m from its preserved top in 2007.² After discovering the terrace in front of the doorway of the inner building, the trench was extended towards the east until the research areas combined (Figs 7, 8, 12).

The second, northern trench was dug at the northern wall of the 'Clergy house', in a place where the top of a brick arch indicating an opening in the wall appeared after the removal of debris (Figs 7, 8, 13). The trench made between the outer wall of the house and the wall of the discovered inner building measured finally 1.3×1.5 metres. From its upper part, filled with light brown debris, similar to those removed by the excavator, a 14th–15th century crossbow bolt⁵ (Fig. 5: 2) and some bones of domestic animals were found. At the depth of 0.6–1 m the character of the fill changed. The ground, still consisting mainly of debris, turned dark brown and contained bone fragments, both of domestic and wild animals, represented by elk (7 toe bones, partly with traces of skinning), even-toed ungulates (4), cattle (10), horse (1), sheep/cattle (8), pig (5) and fish.⁶ Near the inner wall in the upper part of the dark layer 13 osmund iron bars of Swedish origin⁷ and a blacksmithing slag cake were found. The soil contained also tiny particles of forge scale formed during the process of blacksmithing.⁸

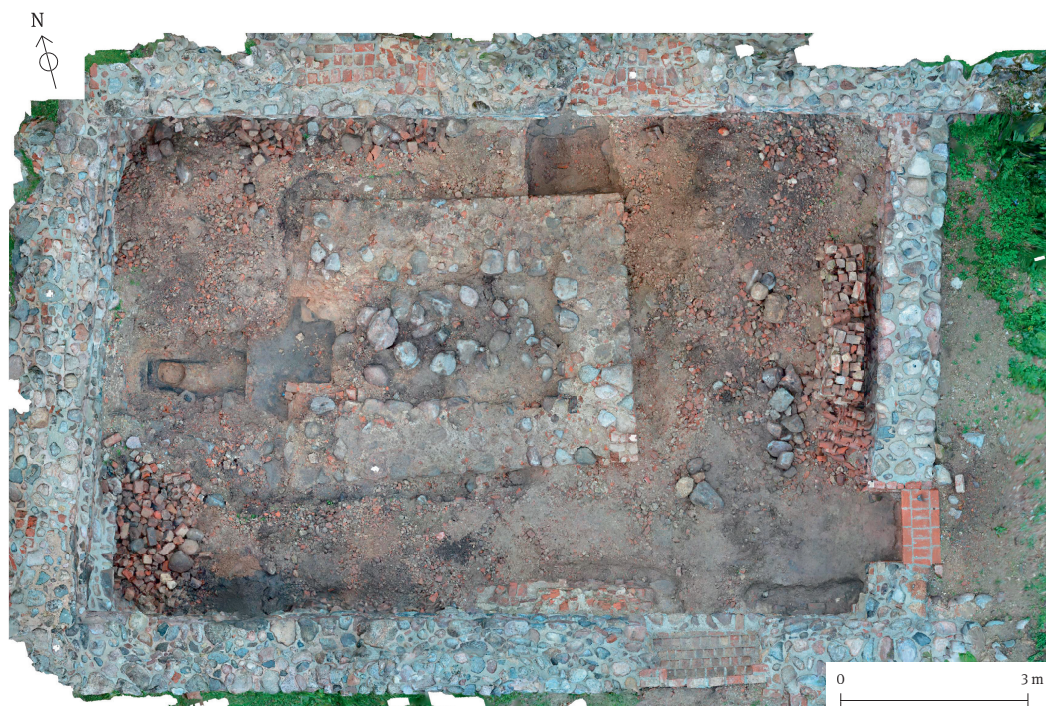
Fig. 8. The western room of the 'Clergy house' in Viljandi with discovered walls of an unknown building.

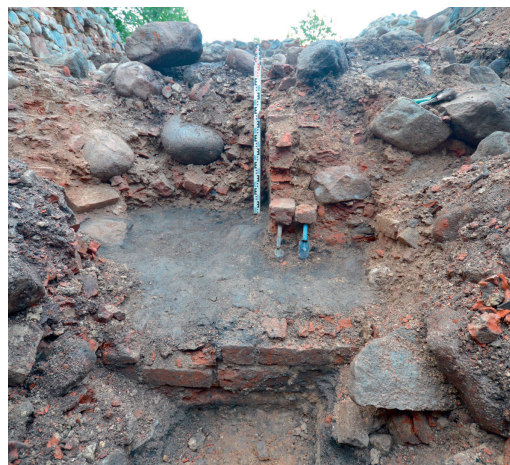
Fig. 9. The doorway of the discovered building and terrace in front of it.

In front of the doorway a terrace made of bricks projected 75 cm out of the wall line (Fig. 9). It remained unclear how long the structure in north–south direction was, since it was opened only in the width of 1.1 metres. When opened from the west, it appeared that the terrace was 5 bricks (ca. 50 cm) high and its bottom lay on intact light brown clay. A radiocarbon date from some pieces of birch bark from under the wall at the depth of 81.76 m a.s.l.¹) gave the result 860±30 BP, calibrated age with 95.4% probability 1052–1077 (5.8%) or 1156–1263 AD (89.6%). Both the doorway and the terrace were covered with intensively black sooty cultural layer which contained several up to 3–4 cm thick patches of ash, indicating making fire inside the building, but there were no finds.

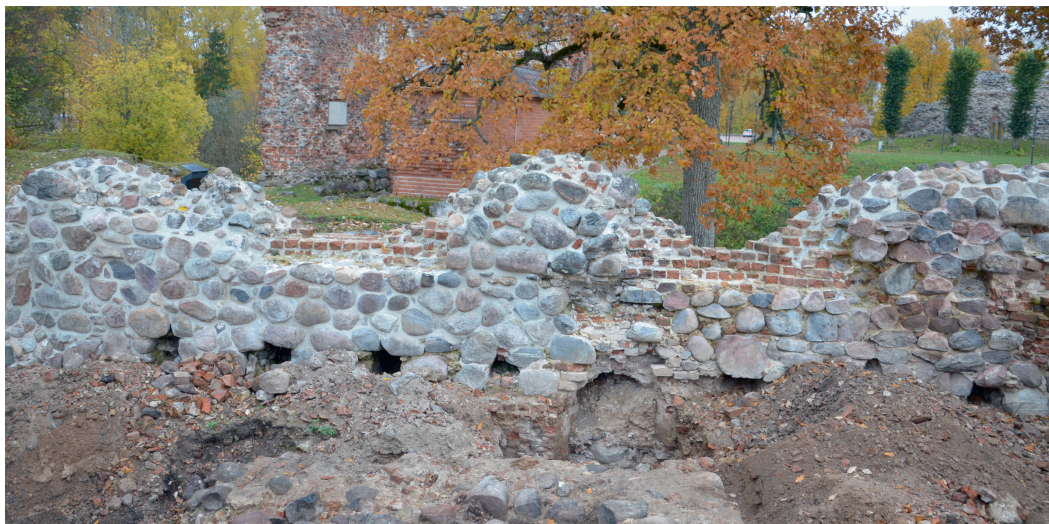
Fig. 10. *Openings for beams in the northern wall of the 'Clergy house'.*

Some formerly unknown structures appeared also in or at the walls of the western room of the 'Clergy house'. In the northern wall of the room seven rectangular openings with the width and height of ca. 35–40 cm and the depth of 78–90 cm – evidently meant for the floor beams of the ground floor – came to light (Fig. 10).

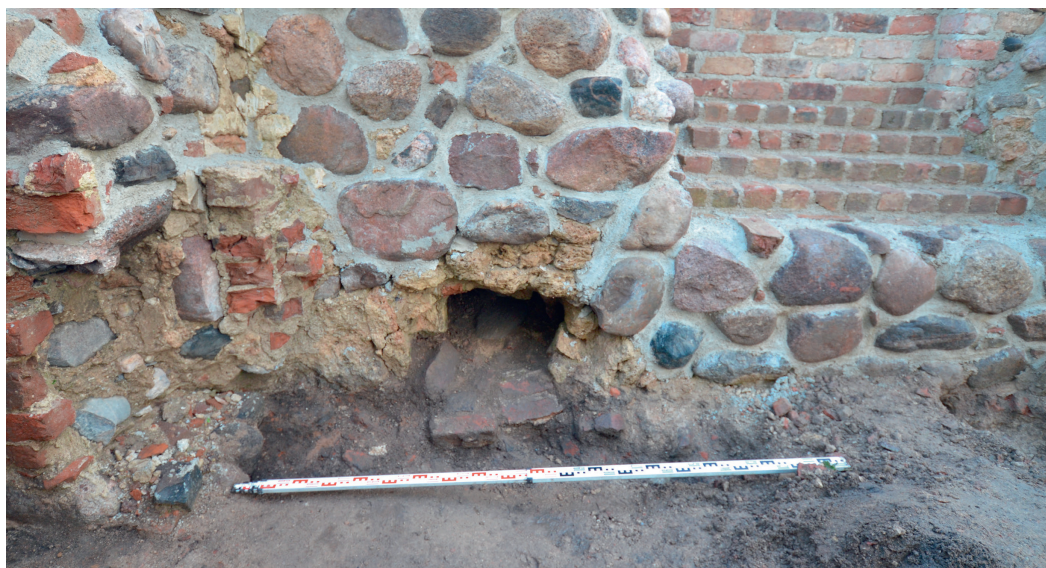
Fig. 11. An opening of unknown purpose and vault-basis like construction in the south-eastern corner of the room (after conservation).

75 cm west of the south-eastern corner a 45 cm wide and 50 cm high opening framed with blocks of travertine came to light (Fig. 11). The opening which had a rising bottom made of carelessly laid bricks, and a rising ceiling, became wider both towards the south-east and south-west. Both its mouth and end were filled with debris. When the opening was discovered and debris had been removed from its mouth, half-decayed maple leaves, referring to recent exposure, came to light.

In the south-eastern corner of the room also remains of a ca. 1-metre-high brick structure which at first reminded vault basis remains (Fig. 11) was unearthed. The layer of plaster, painted white with limewash, between it and the wall indicated secondary origin of the structure. However, since the south-western vault corner should have been located in the place of the unearthed supposed window site – the cellar west of it was occupied by the unearthed massive foundation with fire traces on its inner side –, the discovered structure cannot originate from a vault, but rather from a brick arch in the eastern wall. In the north-eastern corner of the room a similar brick structure existed, but it seemed not to be a secondary addition to the walls.

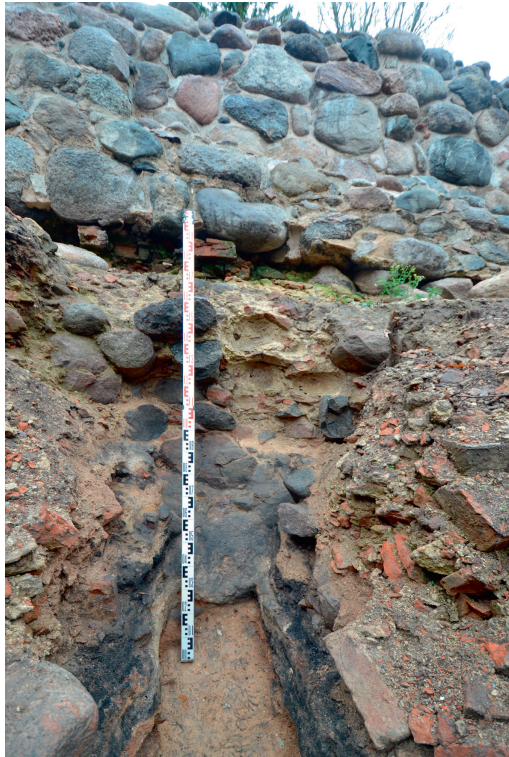
Fig. 12. *The western wall of the ‘Clergy house’ and the western trench, view from the east.*

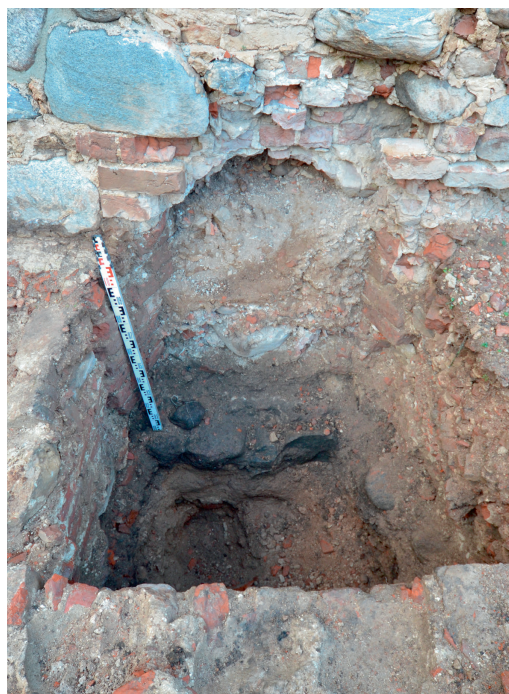
Fig. 13. The northern trench, view from the south.
