Medieval well found in a wall of Kuressaare prince-bishop's castle

Garel Püüa

SA Saaremaa Museum (Saaremaa Museum Foundation), Lossihoov 1, 93810 Kuressaare, Estonia;
garel.pyya@gmail.com

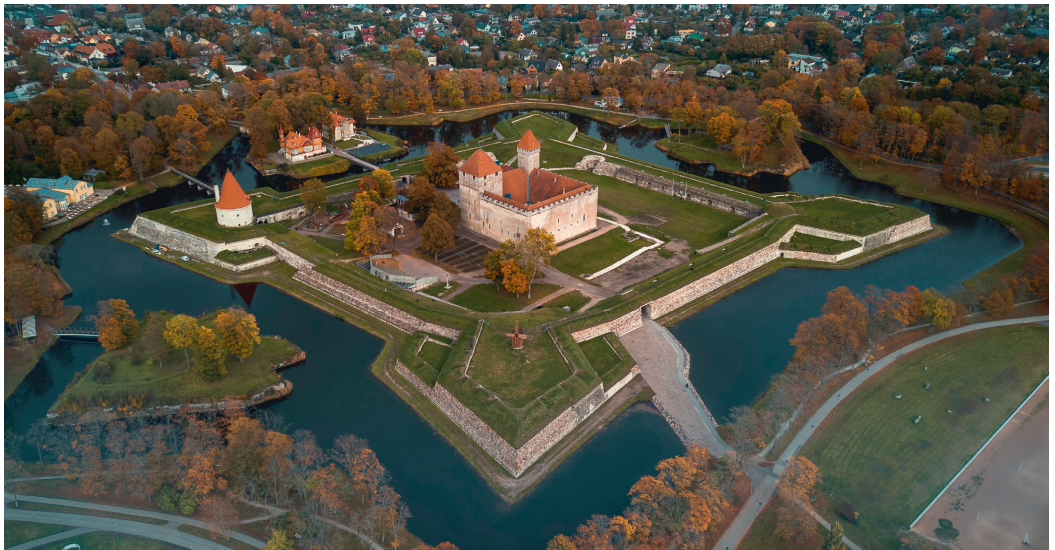
Fig. 1. View from the west to the Kuressaare Castle-Fortress and its settlement situated on the southern coast of Saaremaa. This water castle built on a low-lying coastal site in the 14th century was enclosed by earthwork fortifications by the start of the 17th century. The Sturvolt tower can be seen at the northern corner of the *Konventhaus* (on the left), the Pikk Hermann tower is at the eastern corner.

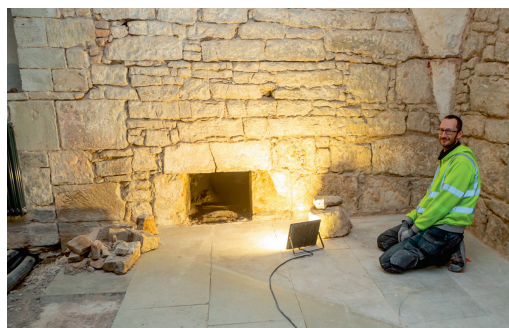
Fig. 4. Workman Heigo Leemet at the opening to the chamber found in the Sturvolt wall after the removal of the plaster covering the wall. The well's door opening remained partially concealed by the cellar's current floor.

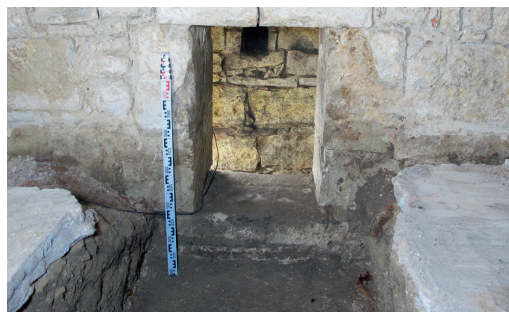
Fig. 5. The cellar's original floor was around 75 cm lower than the current floor (1985). A wooden hatch covered the well's door opening (100×70 cm). The locations of its hinges are still identifiable. A small illumination opening can be seen in the well's outer wall in the background.

välisseinas leidis 15 × 40 cm suurune valgusava, mis ulatus keskajal maapinnast napilt kõrgemale (jn 3: 8; 5). Kaevu ette kaevatud šurfis selgus, et torni algne põrand jääb praegusest, 1985. a paigaldatud kivipõrandast 0,7 m madalamale (jn 3: 1–3; 5).

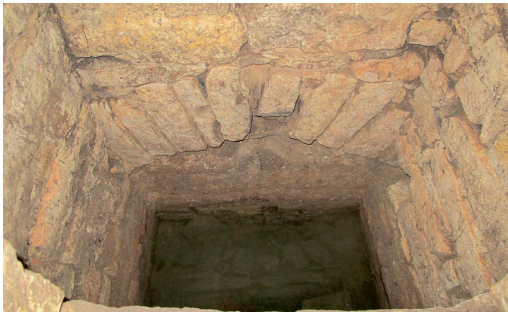
Fig. 6. *The current water level in the well that has been hewn into the natural limestone is 1.2 m above sea level, yet before the moats were dug for the castle-fortress, water level extended to a considerably higher elevation. A relieving arch is visible in the wall of the well.*

In the autumn of 2022, a mysterious walled-up door opening was found in the cellar storey of Sturvolt tower in the course of restoration work. A little door (approximately 100×70 cm) opened up into a shaft measuring 150×105 cm built into the tower's 265 cm thick exterior wall. The shaft was filled with soil and was covered by a barrel vault (Figs 2–6). The shaft and the vault were made of dolomite blocks and were built together with the tower, evidently in the second quarter of the 14th century. An iron rod had been bricked into the middle of the vault. The presumable hook part of the rod that was meant for winching had already broken off earlier (Fig. 7). An illumination opening measuring 15×40 cm, which barely extended above the ground surface in the Middle Ages, was found in the 90 cm thick exterior wall of the shaft (Fig. 3; 8; 5). After the nearly 3.5 m thick filler layer was removed, it turned out that the shaft was most probably the oldest well of Kuressaare Castle. The well had been hewn into the natural limestone stratum to a depth of at least 1.2 m, yet the actual bottom of the well was not reached during the cleaning process. A relieving arch, which was evidently needed for redistributing the load of the wall, had been built into the well's wall at the boundary of the limestone stratum (Fig. 6).

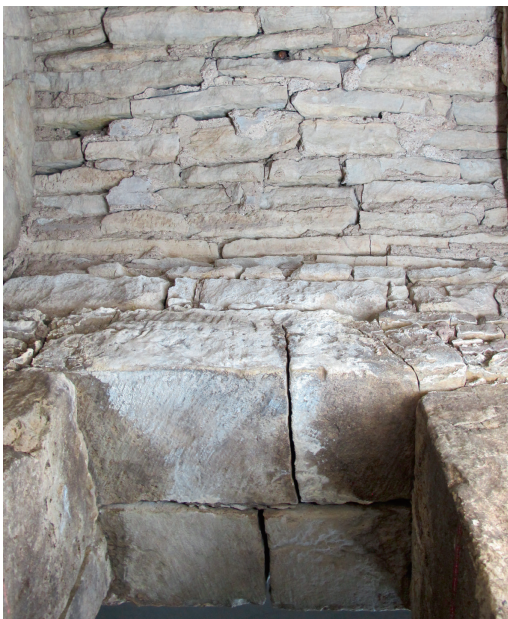
Fig. 7. *An iron rod was bricked into the well's ceiling. A bucket hung from a rope tied to that rod. Traces of the rope worn into the doorjamb indicate that the well was used intensively in the Middle Ages.*

2022. aasta sügisel leiti restaureerimistöödel Sturvolti keldrikorruse seinast salapärase kinni müüritud ukseava. Väike uks (u 100 × 70 cm) avanes torni 265 cm paksuse välisseina sisse ehitatud 150 × 105 cm suurusesse ja pinnasega täidetud šahti (jn 2–6), mida kattis silindervõlv. Dolomiitplokkidest laotud šaht ja võlv olid rajatud koos torniga, ilmselt 14. sajandi teisel veerandil. Võlvi keskele oli müüritud rauast varras, mille arvatav vintsimiseks mõeldud konksoosa oli juba varem murdunud (jn 7). Šahti 90 cm paksuses
