# Preliminary results of the archaeological investigations of the Käpa forest brothers bunker in the border zone of Harju and Järva Counties

Mauri Kiudsoo<sup>1</sup>, Pearu Kuusk<sup>2</sup>, Martin Arpo<sup>3</sup> and Martin Malve<sup>4</sup>

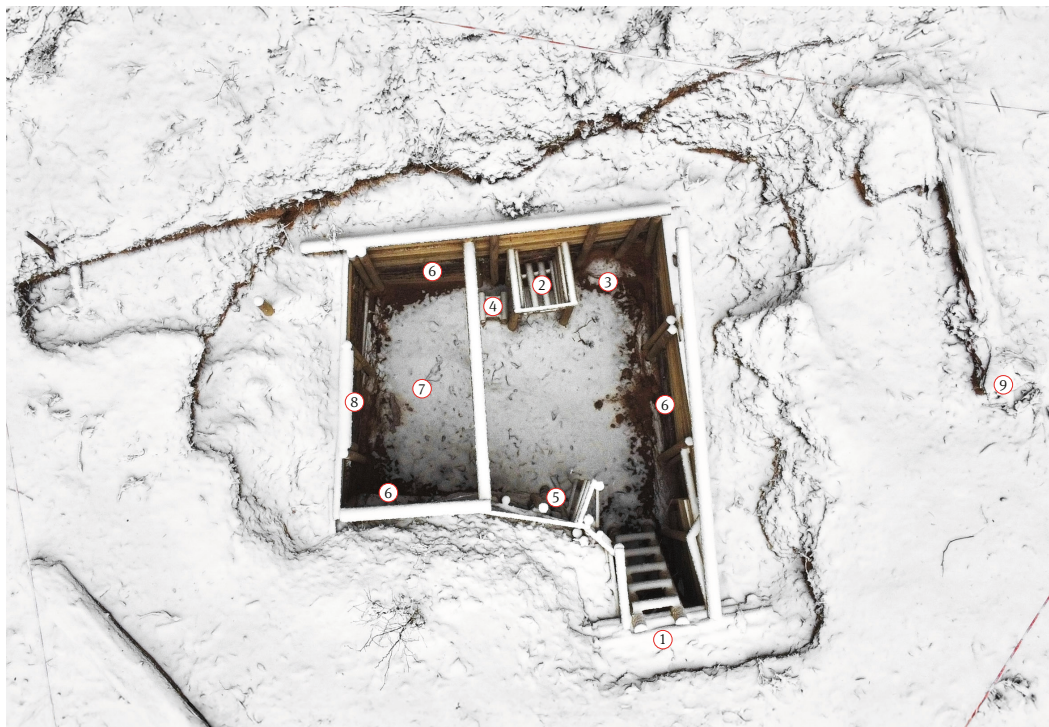
**Fig. 1.** The external dimensions of the Käpa bunker, including the vertical entrance shaft, are shown, also the assumed roof pitch, the central support post, and other construction elements are marked with numbers. 1 – entrance, 2 – stove, 3 – firewood, 4 – well, 5 – piggin, 6 – shelves, 7 – sleeping platform, 8 – window, 9 – lookout tree.

The Käpa bunker was a one-man underground refuge, measuring just over four square metres. The skilfully hidden construction could be accessed through a vertical shaft (Fig. 1: 1) protruding from the main room, the top of which was covered by a hatch. In winter, it was crucial not to leave any tell-tale traces outside the bunker; hence the entrance shaft was dug deeper than the bunker's floor, forming a pit that served as a disposal area for ashes from the stove. Opposite the entrance was a stove with a sheet iron body (bottom dimensions: 45 × 42 cm; height: 60 cm) (Fig. 1: 2), lined with bricks on the inside. The chimney barely extended above ground level, so an additional pipe (approximately 1 metre) was fitted on top of it during heating. The space between the stove and the northern wall of the bunker was used for drying and storing firewood (Fig. 1: 3).

The first item discovered during the preliminary research of the Käpa bunker was an iron milk container, likely used for storing clean water. Behind the southern side of the stove, there was a ca. 90 cm deep narrow well (Fig. 1: 4). On the left side of the entrance, clear traces of a wooden water pail, a piggin (e.g., Viires 1995, 65), reinforced with iron rods were discovered, likely used for washing and personal hygiene. Availability of water was vitally

The underground structure was unique compared to others because of the double-glazed vertical window (Fig. 1: 8) located at the top of the southern wall (width approx. 50 cm; height approx. 20 cm). Under the window, we identified the remains of a sleeping platform with a body on top, lying on his left side. A pouch for hygiene items, made from a pre-war wallet, was found near the arms (Fig. 4). At the time of discovery, only a razor and a comb were in it; the remaining toiletries, a toothbrush, a mirror, scissors, etc., were on the sleeping platform next to the pouch. Findings associated with hygiene appear in almost all bunkers that we have studied comprehensively: toothbrushes

From weaponry, only two pistol cleaning rods can be mentioned, one of which was found from the rubble of the shelf remains on the north side of the building, and the other from the fallen lookout tree (Fig. 1: 9) located near the bunker. Although there were large numbers of active resistance fighters in the woods who caused a lasting headache for the Soviet regime, most of the forest brothers were passively hiding themselves. Their main objective was simply to survive.

Käpa punker oli veidi üle nelja ruutmeetri suurune maa-alune ühemehepunker. Ehitisse pääses põhiruumist eenduva vertikaalse šahti kaudu (jn 1: 1). Sissepääsu põhja tarviti ahju kütmisel tekkiva söe ladustuskohana ning šahti vastas oli plekkkorpusega

ahi (jn 1: 2), mis oli seestpoolt vooderdatud tellistega. Ahju ja punkri põhjaseina vahelist ruumi tarviti küttepuude kuivatamiseks ja hoiustamiseks (jn 1: 3). Lisaks vaevalt maapinnani ulatuvale korstnale oli kasutusel ka lisakorsten.

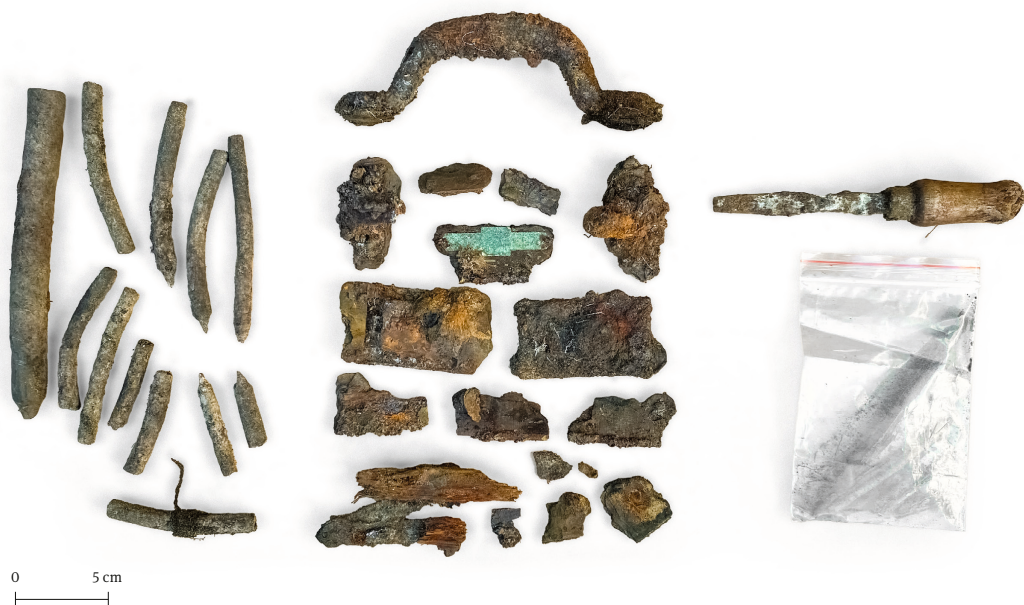
**Fig. 3.** Candles, remains of a suitcase, a chisel, etc.

In winter time, when opportunities for moving about were almost non-existent, the forest brothers engaged in crafts to pass the time. Tools and raw materials have been found in all archaeologically studied bunkers. Based on the variety of findings from Käpa, it can be inferred that the bunker's occupant practised various crafts and wood-working, as indicated by pieces of leather, sheet metal and cloth (raw materials), along with tools: chisels, a saw, a sharpener, etc. Additionally, more than half a dozen cups of tree pitch were identified, placed on the shelves alongside other objects and tools. The shelves (Fig. 1: 6) were located on the north side of the bunker and on both sides of the sleeping platform (Fig. 1: 7). A small suitcase, pencils and some candles were also among the items found on the shelves (Fig. 3).

tatud punkri seinariilulete koos muude esemete ja tööriistadega. Riilulid (jn 1: 6) asusid punkri põhjaküljel ning magamislavatsi (jn 1: 7) jalutsis ja peatsis. Näiteks oli peatsi kohal olevale riilule algselt asetatud väiksemat sorti kohver, nööriaga kokku seotud küünlad, pliatsid jms (jn 3).

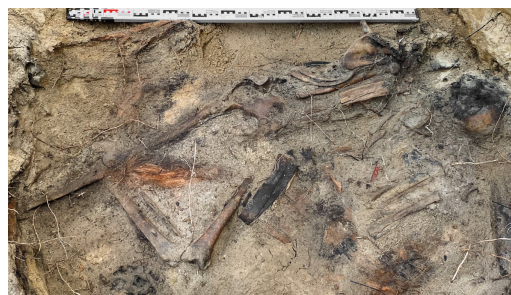
**Fig. 5.** Skeleton in situ.

During the excavations, a fully articulated *in situ* skeleton was discovered (Fig. 5). The skeleton<sup>1</sup> was almost complete; it missed smaller bones: the carpal bones of both hands, the right patella, II and IV metacarpals of the left hand, three first metatarsals of the left foot, sesamoid bones of the first metatarsals and the medial, middle, and lateral cuneiforms of the left tarsus. Also, all hand and foot phalanxes were absent. Probably the smaller skeletal remains had decayed due to the acidic sandy soil environment. The surface of all the bones was affected by heavy erosion. The skeleton had suffered from several fractures and damage during excavations. Regardless of poor bone preservation, several pathologies were detected on the tooth and skeletal remains. A copper alloy corrosion splodge was detected on the head of the right II rib of the chest, probably caused by a metal object against the bone. Fragments of textile were traced on the left cranial bones.

Punkri lavatsilt avastatud luustik oli peaaegu terviklik (jn 5), puudusid vaid pisemad skeletiosad: kõik randmeluud, parem põlvekeder, kolm vasaku jalalaba esimest põialuud, jalalabade esimeste varvaste seesamluud ja vasaku kannaoosa talbluud. Samuti ei olnud kogumis enamik käe- ja jalalabaluid. Tõenäoliselt olid väikesed luud lagunenud liivase pinna tõttu, mis on happeline. Seetõttu olid ka enamike luud välispind tugevasti erodeerunud.

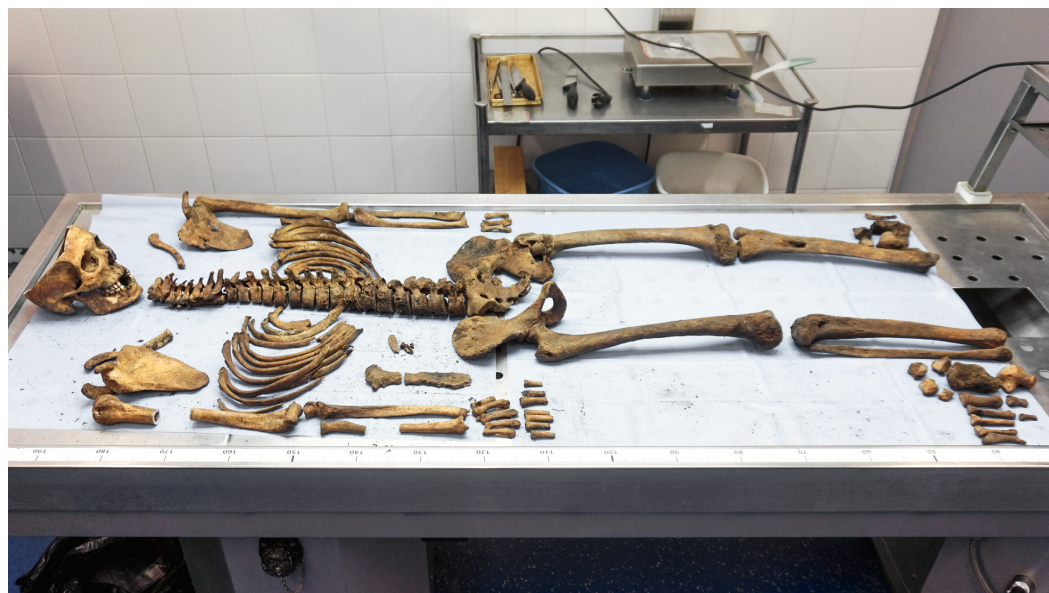
**Fig. 6.** The nearly complete skeleton of a male found in the bunker.

The exhumed skeleton (Fig. 6) was a male over 40 years of age at the time of death. Based on the maximum length of the left femur, the height of the man was calculated to have been  $171.84 \pm 3.27$  cm. 20 permanent teeth out of 32 had been preserved. The occlusal surfaces of all molars were slightly worn down to the dentin. The right canine of the maxilla and the left third molar of the mandible were lost *ante mortem*. The remaining missing teeth were lost *post mortem*. The teeth had slight dental calculus on all sides of the crowns. However, calculus was slightly more prevalent on the lingual side of the mandibular incisors and canines. Mild alveolar reduction was also detected in the maxilla and mandible. Periapical lesions in the alveoli of the maxillary II and III molars and the mandibular III molar were indicative of probably advanced caries due to apical inflammation.

Skelett (jn 6) kuulus mehele vanuses 40+ aastat, kelle kehapikkus eluajal oli 171,84±3,27 cm. Tema 32 hambast oli säilinud 20. Kõikide purihammaste mälumispinnad olid kulunud kergelt dentiinini. Ülalõualuu parema poole silmahammast ja alalõualuu
