ARCHAEOLOGICAL STUDIES IN THE CHURCH AND CHURCHYARD OF LÜGANUSE

VILLU KADAKAS

TÕNNO JONUKS

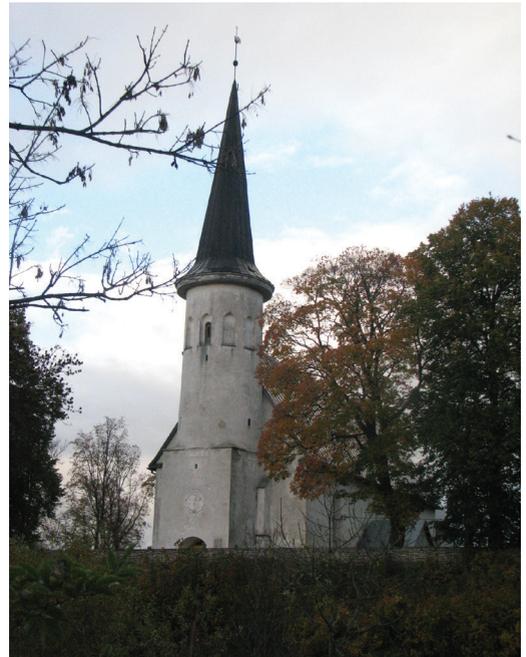
*Fig. 1. Lügánuse church from the south-west.
Jn 1. Lügánuse kirik edela poolt.
Photo / Foto: Villu Kadakas*

The church of Lügänuše, dedicated to St John the Baptist, is a single-nave building of local limestone, with a slightly narrower chancel and a western tower (Fig. 2–3). The church has been first mentioned in 1373. The original stone building consisted of only the present nave (Tuulse 1953, 38; Raam 1997). According to Villem Raam it was probably built approximately in the middle of the 14th century (Fig. 3). It was a simple unvaulted building (ca. 27.7 × 11.6 m) with exceptionally thin walls (ca. 0.9–1 m); the masonry of the portals and windows have not been preserved. Influence of the architecture of the Dominican Order to the layout has been supposed (Raam 1997).

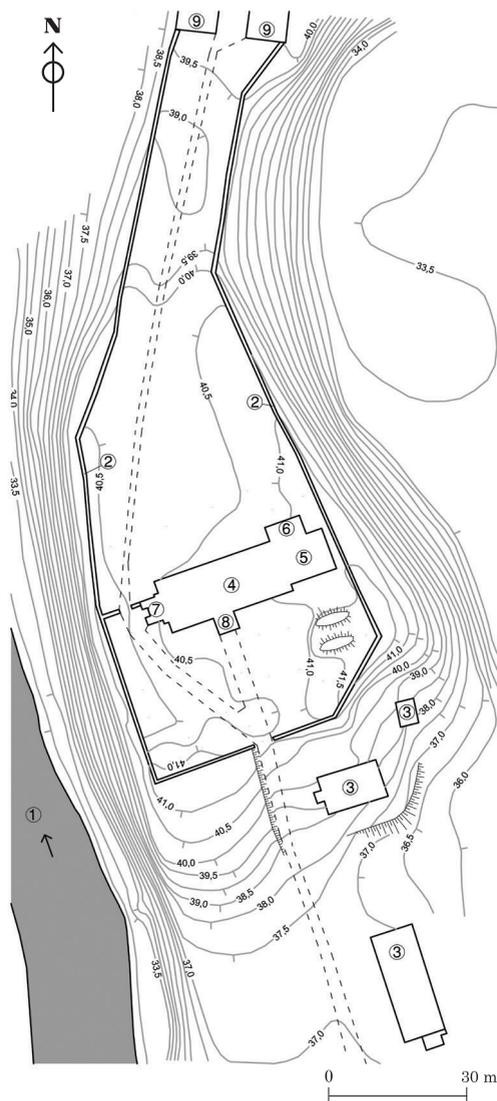
Fig. 2. Plan of Lügänuše churchyard. Based on the plan by U. Hermann (1975). 1 – Puritse River, 2 – stone wall, 3 – modern buildings, 4 – nave, 5 – chancel, 6 – sacristy, 7 – western tower, 8 – southern porch, 9 – early modern chapels.

It has been supposed that an Iron Age fortress was situated in the place of the later churchyard (Tamla 1996, 229). The churchyard is located on a 6–8 m high *ca.* 200 m long and 40–70 m wide plateau, which is situated on top of a natural ridge with high and steep slopes, positioned in the north-south direction (Fig. 2). Directly

in the west a steep valley of the Puritse River borders the ridge (Fig. 2: 1). On the southern, the most gentle slope, directly south of the churchyard, some sherds of local hand-made earthenware were found (AI 4986) and the existence of an Iron Age settlement site was identified in 1978 by Toomas Tamla. In the same year also a sherd of hand-made and some sherds of wheel-thrown earthenware were found from the sacristy during floor replacement (AI 4987). A bronze cross-headed decorative pin, probably from late 12th or early 13th century, has been discovered while digging a pit for a grave in the middle of the 20th century (<http://muis.ee/museaal-view/23137423>). It has been supposed that if there indeed was a hill fort in the place of the churchyard, it was probably used during the second half of the I millennium AD (Tamla 1996, 229; Tõnisson 2008, 232).

Probably in the second quarter of the 15th century a slightly narrower rectangular chancel (*ca.* 10.4 m long, *ca.* 9.3 m wide) with a sacristy on the northern side and the western tower were added (Fig. 2: 5–7). The shape of the tower, quadrangular in its lower and round in the upper part, has only two analogies in Estonia: the former town church of Narva, destroyed in the WWII and the Risti church in Harjumaa (Raam 1997). In Lügänuuse church the portal of the sacristy and the two large sitting benches recessed into the chancel walls and the masonry decorations of the main altar are all characteristic to master masons who worked in Tallinn and the Risti church in the period. The vaults were destroyed probably during the Livonian War (1558–1583) or the war between Sweden and Russia in 1657 (Raam 1997).

The shape of the steep ridge on which the churchyard (Fig. 2) is located does not enable to speculate only about a prehistoric hill fort on the site, but also about a medieval fortified churchyard, surrounded by a palisade or even a stone wall. The natural

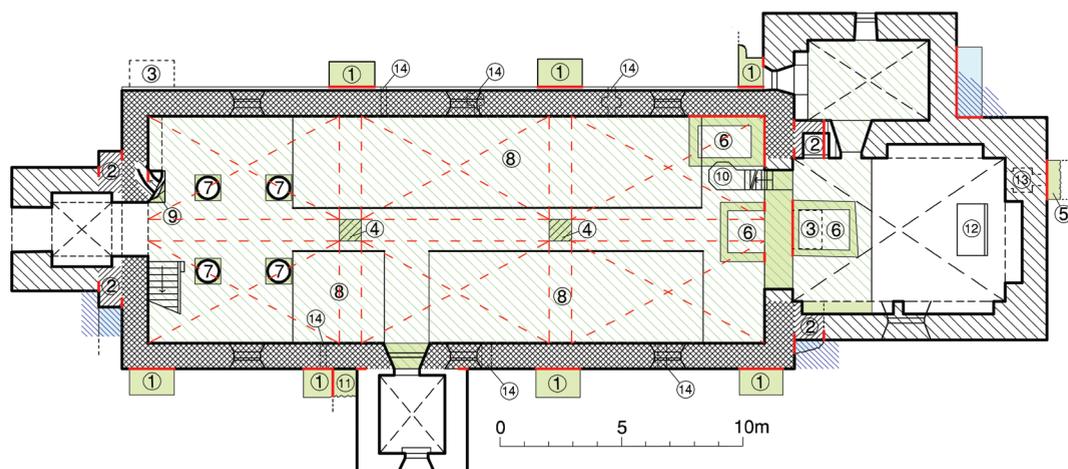
- Discovered vertical joints / Avastatud püstuugid
- - - Reconstruction of nave vaults/ Pikihoone võlvide rekonstruktsioon
- Area studied in 2012–2013 / 2012.–2013. a uuritud ala
- Approximate area of test pits in 1991 / 1991. a šurfile ligikaudne asukoht
- Foundations discovered in 2012–2013 / 2012.–2013. a avastatud vundamendid
- Foundation discovered in 1991 / 1991. a avastatud vundamendid
- I stage: walls of the original unvaulted stone church / I etapp: algse võlvimata kivist kiriku müürid
- II stage: vaults of the nave with pillars and buttresses / II etapp: pikihoone võlvid koos piilarite ja tugipiilaritega
- III stage: chancel, sacristy and western tower / III etapp: kooriruum, käärkamber ja läänetorn

Fig. 3. Plan of Lügänuuse church. 1 – foundations of buttresses, 2 – preserved buttresses, 3 – supposed buttresses, 4 – pillar foundations, 5 – foundation of stairs to the hagioscope, 6 – burial chambers, 7 – pillars of the organ balcony, 8 – pew areas, 9 – stairs to the tower, 10 – pulpit, 11 – older foundation west of the porch, 12 – altar, 13 – hagioscope, 14 – ventilation openings.

the building (Fig. 3). A 2 m deep test pit was situated directly south of the western tower to specify the stratigraphic sequence of the nave and the tower. The soil consisted mostly of sand. R. Vaiksoo identified two vertical joints in masonry, revealed in the test pit: one between the wall of the nave and the buttress, the other between the buttress and the tower. It confirmed the conclusion of V. Raam that the tower is a secondary addition to the nave but also specified that the system of buttresses is a secondary addition to the nave as well. He also noted a very wide step (*ca.* 105 cm) of the foundation of the western wall of the church. Possibly it was only a foundation for the buttress but it cannot be excluded that the wall of the nave had a wide step.

The church floor was replaced in most parts of the building, except the eastern part of the chancel, the western tower and the southern porch (Fig. 3). In most parts of the nave, the chancel and the sacristy the top part of soil under the floor was removed in *ca.* 10–15 cm depth, in some places even less. Thus only debris of the 1941 fire and debris from Early Modern reconstruction periods was removed. Some deeper test pits were dug to specify the original floor level of the rooms, but structures hidden deep and burials were not reached, except pillar foundations. The original floor level of the chancel and the sacristy has probably been situated approximately on the same level as the present one, *ca.* one 25 cm step higher than the one of the nave, but in the nave it has probably been *ca.* half metre deeper of the present floor.

In the chancel and the eastern part of the nave limestone walls of several burial chambers (Fig. 3: 6) were uncovered, probably built during the 17th or 18th centuries by the owners of the local manors. All of these had lost the grave slabs once laid on top and had been filled with various debris, partly only during the reconstruction works after WWII. Thus only the top surface of the chamber walls was cleaned and the plan of the chambers recorded, except for the largest burial chamber (170 × 210 cm) in the western part of the chancel, positioned exactly on the symmetry axis of

Exceptionally, the foundation of the buttress directly west of the southern porch has been built in two stages. The eastern part of it (Fig. 3: 11) probably belongs to some earlier structure as it has been built together with the nave. Its masonry continues also under the wall of the porch which must have been built later than the older part of the buttress or even after it had been demolished. The older part of the buttress protrudes 115 cm from the nave, but it has extended further south. The original extent could not be specified in the shallow test pit. Possibly this older part of the buttress once belonged to an older porch, erected together with the original nave. The western part of the buttress has been added later, secondarily both towards the nave and the earlier foundation in the east. As another exception, the north-western corner of the north-eastern pillar next to the sacristy had a narrow (*ca.* 30 cm wide and *ca.* 55 cm long) extension towards the north, which does not fit the layout of other buttresses. It has extended from the nave even further north but the extension had not been preserved in the upper part of the soil and the intense construction work did not allow to dig a deeper pit. Possibly this extension might belong to an eastern wall of an older sacristy, which might have existed next to the nave in the period prior to building the chancel and the present sacristy. Such an earlier sacristy could not have been built together with the original nave, but rather during the same period as the buttresses. As supposed already by V. Raam and proven by the identification of the eastern buttresses (see below), the vault system with the buttresses was built before erecting the chancel and the present sacristy. Thus it must have been reasonable to at least plan a sacristy next to the nave, although it might have never been completed because of the rather short time span between building the vault system and the chancel. The western wall of the supposed earlier sacristy was searched for with an iron rod in the area of the neighbouring buttress, appropriate for the western wall, but without success. A hypothetical walled up doorway of the supposed earlier sacristy was unsuccessfully searched for inside the nave, observing the underground unplastered section of the wall, revealed temporarily during the floor replacement in the north-eastern part of the nave.

In 2013 during replacement of the limestone slabs under the central walkway of the nave foundations and lower parts of two quadrangular pillars (Fig. 3: 2; 6) were discovered, as quite expectable after the discovery of the buttresses in the previous year. The pillars have been built with a square plan measuring *ca.* 90 × 90 cm and have preserved in the height of two stone layers. Although this dimension corresponds exactly to the nave pillar of Risti church, the ones of Lügänuuse have been built of roughly worked limestone, unlike the nicely worked pillar of Risti. It appears that the nave has been covered with six very oblong vaults.

Fieldwork of both 1991 and 2012/2013 increased significantly the knowledge of the building history of Lügänuuse church as well as about the early burial activities on the site. The two burials with grave goods from the 13th century, discovered in 1991 next to the southern wall of the chancel (Fig. 3) prove that the area was used for burying already in this period. A network of Early Modern burial chambers consisting of limestone walls was mapped in the chancel and the eastern part of the nave (Fig. 3: 6). Of the oldest finds, a round silver pendant (Fig. 8: 5) is notable, probably coming from a disturbed burial of the 13th century. Gilded copper buttons (Fig. 8: 1–2) from a burial chamber of the 17th or 18th century deserve attention among the newer finds.

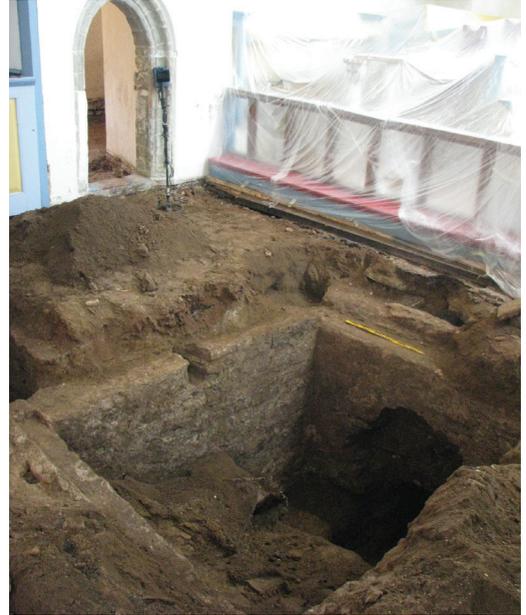
Fig. 4. Burial chamber emptied in the chancel. Sacristy portal in top left.

the church, which was emptied and made accessible through a hatch in the new timber floor (Fig. 4). It appeared that the coffins and burials had been removed before filling the chamber. There is not enough information in the present research stage to relate any chamber to a specific manor or noble family.

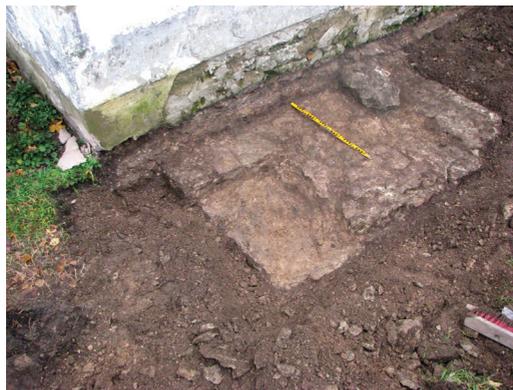
Fig. 5. Foundation of a buttress near the southwestern corner of the nave.

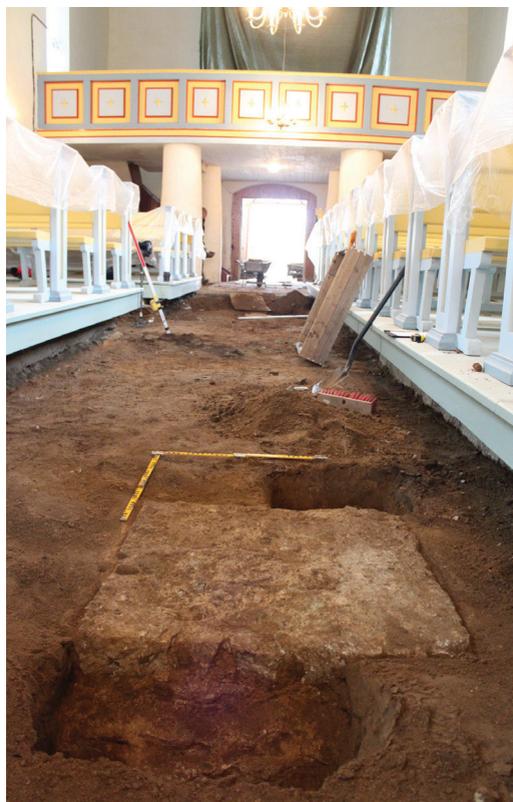
Fig. 6. Foundation of the eastern pillar in the nave.

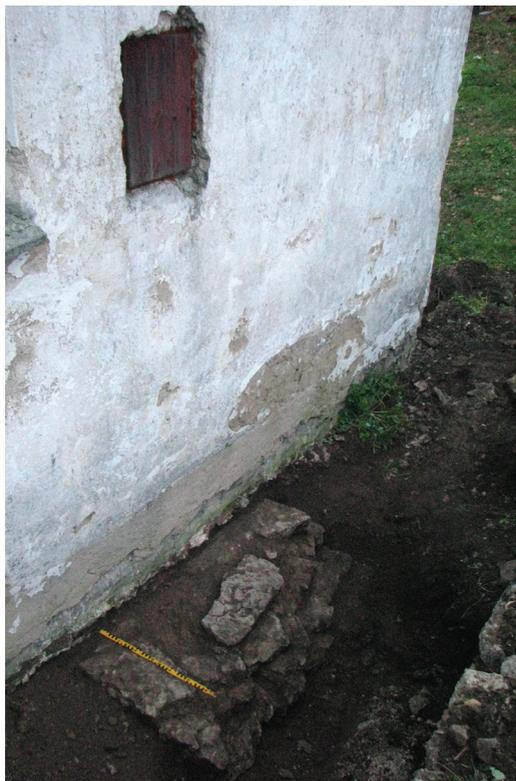
Fig. 7. Foundation of the stairs to the hagioscope.

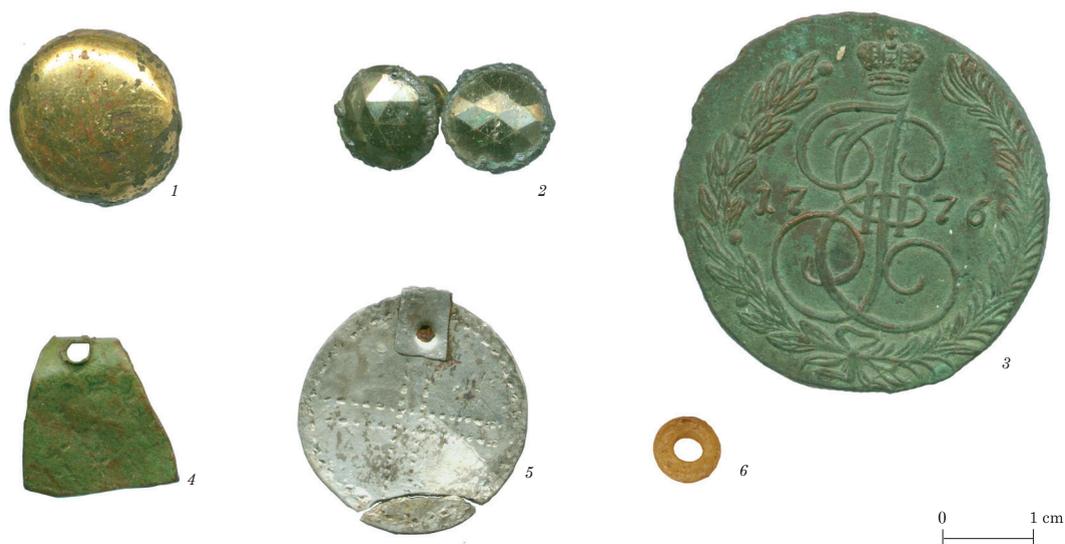
Fig. 8. Finds from Lügänuše church and churchyard. 1 – gilded copper button, 2 – double button with glass ‘gems’, 3 – Russian 5-kopeck coin, 4 – trapezoid pendant, 5 – round pendant, 6 – bead.

A single find – a glass bead from the test pit next to the southern wall of the tower – survives from the excavations of 1991 (Fig. 8: 6). Among the few Early Modern finds obtained in 2012 and 2013 nine

gilded copper buttons (Fig. 8: 1) from the central burial chamber of the chancel deserve attention. One double button, also of gilded copper, has two glass imitations of cut gems inserted (Fig. 8: 2). These must have belonged to a burial of a high-ranking person.

Less than ten Swedish or Russian copper coins (Fig. 8: 3) from the 17th – 19th centuries were discovered from under the floor slabs and from the soil removed from around the church. Lack of medieval coins can be explained by the rise of the floor level in the nave, rising the ground level around the church and building large burial chambers in the studied part of the chancel. A number of medieval coins, once lost or sacrificed in the nave might be preserved *ca.* 0.5 m deep under the present floor in the nave, on the medieval floor level.

A trapezoid copper pendant, with diagonal grid ornamentation (Fig. 8: 4), found from the churchyard, probably represents the Middle Ages. A round silver pendant (Fig. 8: 5), found from late debris filling the central burial chamber of the chancel, probably originates from a burial of the 12th century or the first part of the 13th century, disturbed when building the chancel or a burial chamber. No finds were obtained from the supposed Iron Age hill fort period.
