# Archaeological studies in the church of Järva-Jaani

Villu Kadakas

## INTRODUCTION

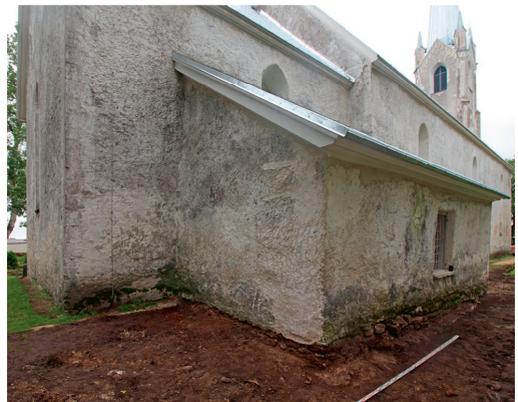
Fig. 1. Järva-Jaani church from the north-east during the soil removal in 2019.

The existing sacristy is a rectangular building (Figs 1–3) with rather thin stone walls (ranging between 60 and 85 cm), built next to the northern wall of the chancel. Its eastern wall is built secondarily against the northern wall of the chancel, the western wall against the north-eastern corner of the nave. Before the field studies and conservation work it was clear that the sacristy is an Early Modern addition, but without details which could enable more precise dating. It has existed by at least 1843 already, when it was depicted on a map of the land estate of the vicarage (RA, EAA.3724.4.398). During the conservation work in 2019 it was discovered that the first interior layer of plaster is covered in particular areas with blue paintings, plant ornamentation in Baroque style (Rohtla & Riigov 2019, 29–30). Based on the style of these decorative elements, it can be concluded that the building was presumably erected either in the second half of the 17th or in the 18th century. The timber floor of the sacristy was built probably during the second half of the 20th century.

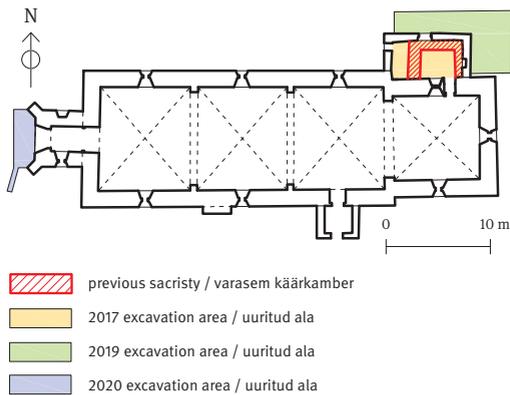
**Fig. 2.** Plan of Järva-Jaani church and excavation areas.  
**Jn 2.** Järva-Jaani kiriku ja kaevamisalade plaan.  
 Drawing / Joonis: Villu Kadakas

In case the stone chancel was built some time before the stone nave, standing against the previous, probably timber nave, one could imagine, that while planning the sacristy, the north-eastern corner of the timber nave might have theoretically blocked the space for the stone sacristy (Fig. 2). However, in order to block the space for the sacristy, the timber nave must have embraced the western part of the stone chancel. Such arrangement would be difficult to explain in a rational way and has not been a common pattern. Rebuilding patterns of medieval churches, including the replacement processes of the initial timber churches, have not been studied much in Estonia, mostly because of scarce information (see Kadakas 2020, 46–47).

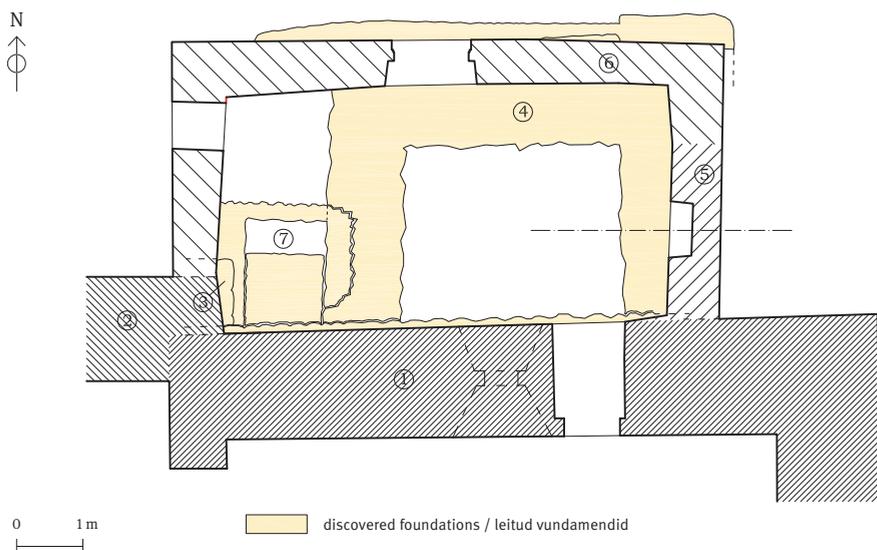
**Fig. 3.** Plan of the sacristy: 1 – chancel wall, 2 – nave wall, 3 – foundation of the nave, 4 – foundation of the medieval sacristy, 5 – wall of the existing sacristy, supposed phase I, 6 – wall of existing sacristy, supposed phase II, 7 – lime box.  
**Jn 3.** Käärkambri plaan: 1 – kooriruumi sein, 2 – pikihoone sein, 3 – pikihoone vundament, 4 – keskaegse käärkambri vundament, 5 – praeguse käärkambri, oletatava I etapi sein, 6 – praeguse käärkambri, oletatava II etapi sein, 7 – lubjakast.

During the excavation, a stone structure was first unearthed next to the eastern wall and the eastern part of the northern wall of the sacristy (Fig. 3: 4; 4). At first glance it seemed to be a protruding foundation of the existing sacristy walls. The protrusion (80–95 cm) is obviously too wide for foundations of the existing rather thin (65–85 cm) walls. The walls in the western part of the sacristy lack such a protrusive foundation. Soon another thick (ca. 115 cm) foundation, running in the north-south direction under the western part of the floor came to light. In this research phase it became clear that all the three foundations were probably not originally built for the existing sacristy but for a previous, considerably smaller sacristy which has been demolished before building the present one, apart from the foundation. The eastern wall and the eastern part of the northern wall of the existing sacristy have obviously been built on top of the foundations of the old one. This interpretation also explains the existence of the hardened floor level with 16th century finds: this floor level belonged to the earlier sacristy, although the floor itself (probably limestone slabs) has been completely removed. Roughly estimating, the floor level of the old sacristy could have been ca. 25 cm lower than that of the new one.

In 2019 the foundation of the northern wall of the existing sacristy could be studied from the outside during soil removal work (Fig. 3). The main goal of this study was to find remains of the medieval sacristy, to identify the exterior size of the demolished building. The results were rather contradictory. Most of the exposed foundation surfaces could be connected with the new sacristy. The easternmost part of the foundation of the northern wall, ca. 160 cm long, protrudes significantly more (ca. 40 cm) than the rest of the foundation (ca. 25 cm) and therefore may belong to a different building phase (Fig. 3). The length of this protrusive foundation corresponds with the width of the foundation of the eastern wall of the old sacristy, found two years before in the interior. It is difficult to explain such a limited protrusive element as a surviving part of the old sacristy. Possibly, there was a buttress on the north-eastern corner of the old sacristy. In conclusion, it was not possible to obtain clear knowledge about the outer contours of the old sacristy during the soil removal of 2019. The foundations of the northern and eastern walls must have been at least 1.2 m thick, but not more than 1.5 m.

The survey of the interior plan contours and discovery of a blocked window in the eastern wall of the new sacristy (Figs 3; 5) gave indications that the building process of the new sacristy was probably not as simple as it seemed at first glance. It is possible that the old sacristy was not replaced with a new one during one demolition and construction campaign but it was rather a step-by-step process.

but have points in between, where the wall surface changes direction. Especially noteworthy is the point in the eastern wall, which divides the wall into two segments. Curiously, this turning point is aligned with the inner edge with the northern wall of the old sacristy (Fig. 3). In 2019, during conservation work a blocked window was discovered in the eastern wall (Figs 3; 5; Rohtla & Riigov 2019, 6, 29–30). It has remains of timber jambs and paintings with Baroque style plant ornamentation on the first layer of plaster around it (Rohtla & Riigov 2019, 6, 29–30). One could expect that such a window should be positioned symmetrically as regards to the interior of the new sacristy, but surprisingly it follows the symmetry axis of the old one (Fig. 3).

Such a location of the window and the point of alignment change of the wall make sense if this part of the eastern wall would be interpreted as an independent building stage (Fig. 3: 5). Possibly the process of replacing the sacristy started with the eastern wall: the old thick eastern wall (but not the corner) was demolished and replaced with a much thinner one together with a window. Replacement of the old eastern wall with a new one was probably done with a purpose to obtain more interior space – ca. 1.9 m<sup>2</sup> of floor surface could be added to the previous 9 m<sup>2</sup>. After some time, this gain probably turned out to be insufficient, so demolition of the rest of the old sacristy followed. This hypothesis of two building stages in the Early Modern sacristy is supported by the fact that in 2018, a crack was cleaned and anchored in the outer surface of the eastern wall, close to the north-eastern corner (Rohtla & Riigov 2019, 6). Remains of similar mural paintings with blue plant ornamentation in Baroque style were also found around the window of the northern wall. This indicates that the reconstruction process of the sacristy was completed in the 18th century already.

In the western part of the existing sacristy, next to the western foundation of the old sacristy, a stone box, built of limestone with lime mortar was discovered (Fig. 3: 7). It is built in a manner the burial vault boxes inside rural churches usually are, but is too small to fit a single coffin (1.6 × 1.2 m). It could have been built only after the demolition of the old sacristy, because part of the foundation of the old sacristy has been demolished in order to fit it. Probably it was made to keep lime during the construction of the new sacristy, as evidenced by a thick layer of lime, which still covers the walls inside. Later, a filling masonry was fitted into part of the box, probably as a foundation for an oven or mantelpiece which probably stood in the corner. Eventually the rest of the box was filled with demolition debris, probably from the walls of the old sacristy.

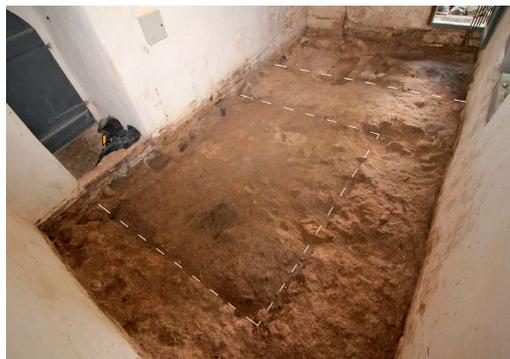
**Fig. 4.** Interior of the sacristy after excavations in 2017: contours of the foundations of the medieval sacristy are marked in a dashed line. View from the north-eastern corner.

After removal of the remains of the rotten timber floor organic rich soil came to light at the depth of ca. 30 cm under the room (Fig. 4). It was studied with a metal detector and three small test pits. It appeared that this soil layer includes also various demolition debris and fragments of human bones. The layer has become very hard probably because of walking on it for a long period. Such a hardened surface cannot evolve under a timber floor, but in case of a dirt floor or may indicate to a slab floor, which has been later removed. However, the inner surfaces of the walls of the sacristy do not correspond to such a deep floor level but indicate that the floor has been on the same level with the present chancel floor all the time. The soil under this hardened level contains sherds of window glass, but also three coins from the 16th century could be gathered from it, indicating a much earlier period than the existing sacristy. Although originally it was planned to remove this soil layer in order to build a steady base for the new floor, finally it was agreed to keep it for study in the future.

After the identification of the remains of the old sacristy, it was noticed that one built element of it has always been visible, but left unregarded. Although the present door between the chancel and the sacristy, with its diagonal boards (Fig. 4) comes from the Gothic Revival period (Rohtla *et al.* 2014, 18), the segment arched niche of the doorway and probably also the simple portal with plaster cover and a pointed arch seem to originate from the Middle Ages. It may have hinted that there must have been a sacristy in the Middle Ages already, but until now, this portal has somehow evaded professional description.

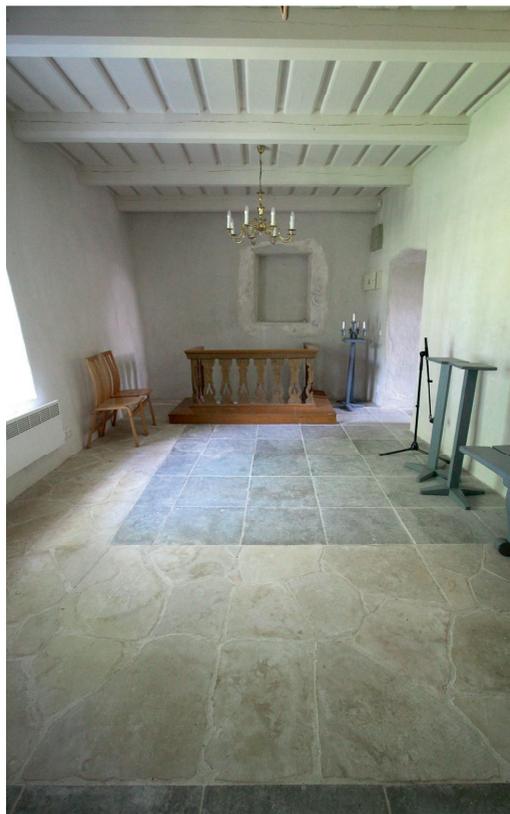
**Fig. 5.** *The interior of the sacristy after conservation works in 2019: the contours of the foundations of the medieval sacristy have been marked in the floor with irregular limestone slabs. Blocked window in the eastern wall. View from the west.*

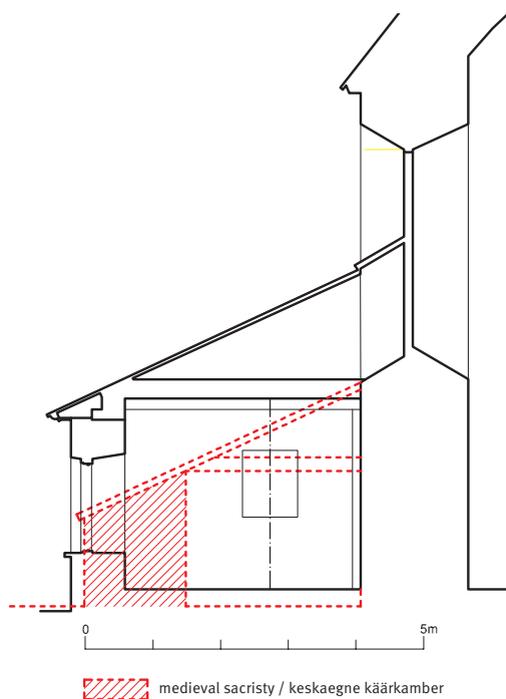
Fig. 6. Cross-section through the sacristy: reconstruction of the extent of the medieval sacristy.

However, when estimating possible coexistence or planning together of the old sacristy and the chancel window, it should be taken into consideration that the interior of the old sacristy was ca. 90 cm narrower, and its floor was probably ca. 25 cm lower than the later one. One can imagine on top of the medieval sacristy a lean-to roof with the same sloping angle as the roof of the present sacristy has (ca. 25°). Because of a rather thick northern wall, like the medieval sacristy probably had (120–150 cm), and the long slope of the rafters above it, the eaves could have been located 40–50 cm lower than the ceiling inside.

a narrower interior, a thicker wall and a lower floor level, the lean-to roof of the medieval sacristy could have been located much lower than the similar roof of the Early Modern one. Such a roof would have left the chancel window exposed in its full extent, yet there could have been a 2 m high room under the ceiling of the sacristy (Fig. 6).
