Archaeological investigations in Tarvastu Castle of the Teutonic Order

Aivar Kriiska, Ragi-Martin Moon and Sander Jegorov

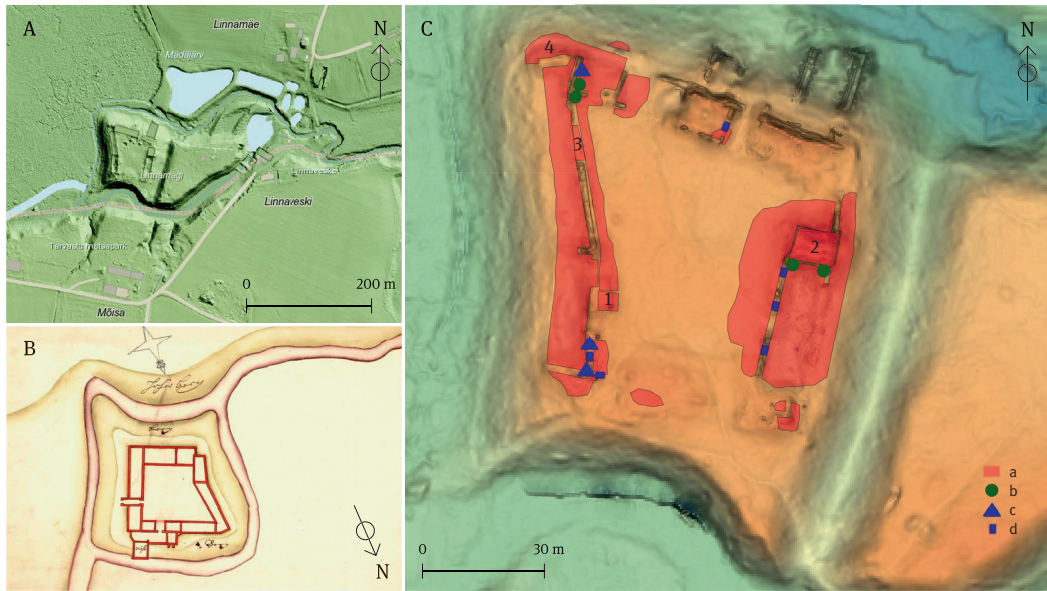
Fig. 1. A – location of the Tarvastu Castle of the Teutonic Order. B – plan of the castle, presumably from the 1680s (SE/KrA/0406H/28/049/001). C – investigated area in 2022 and significant exposed structures at Tarvastu Castle (1 – vaulted cellar, filled with rubble, 2 – the eastern gate, 3 – a presumed gate in the western wall, 4 – a presumed gate in the northwest corner of the castle). Legend: a – areas where rubble was removed during conservation, b – remains of a brick vault, c – a niche, d – a door or window opening.

construction rubble for conservation work (Fig. 1). All cleared structures and their parts were documented, and finds were collected. This article provides a brief overview of the results of these studies, focusing on architectural elements and construction details.

Tarvastu Castle covers a relatively large area of 6555 m². Part of the castle follows the strict rectangular shape characteristic of castles, while the western side conforms to the natural contour of the hill. In addition, a dansker associated with a watermill was located in the northern part (Tuulse 1942, 146; Fig. 1).

The destruction of the castle was extensive, as it had burnt with such intense heat that the bricks in the walls partially became clinkered and even melted. In the case of Quaternary clays from which these bricks were probably made, this would mean that the temperature must have risen to over a thousand degrees (Kriiska 2008, 191–192 and references therein). Furthermore, the use of stones from the castle for the construction of the manor and church further contributed to the destruction of the castle (Valk *et al.* 2022, 114). However, during the fieldwork in 2022, a partially rubble-filled vaulted cellar room was discovered in the southwest corner of the castle, which has likely survived in its entirety (Fig. 1C: 1).

It is possible that there used to be another gateway in the western wall of the castle. A 3.4 m wide opening with brick lining⁴ filled with rubble is discernible (Figs 1C: 3; 3). From the northwest corner of the castle, another 2.6 m wide opening was cleared, possibly the site of a small secondary gate (Fig. 1C: 4).

In three rooms, brick vault supports were found (Figs 1C; 4), which were constructed later than the walls and confirm the previous assumption that the wooden beamed ceilings were replaced with vaulted ones (Tuulse 1942, 246).

In two of the rooms, wall niches were discovered. In one case, it was constructed within the crystalline stone wall and lined with bricks, while the other two were built into the brick wall on either side of the door opening (Figs 1C; 4). In total, five door and window openings were cleared out in three rooms. They ranged in width from 0.85 m to 1.9 m and were mostly framed with brick jambs (Fig. 5A).

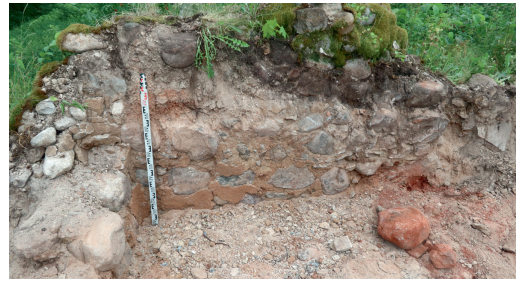
Fig. 2. Eastern part of the southern wall of the gateway in the eastern wall of the castle. Plaster has partially preserved on the wall.

The castle was constructed using crystalline stones bound with lime mortar, with bricks used sporadically (Figs 2, 3). At least in some places, the visible portions of the walls built on the plinth (Fig. 3) were made of larger stones, while smaller stones were used for the inner parts (Fig. 3). The outer wall was up to 2.2 metres thick. Mortar was applied between the larger stones to which smaller stones and brick fragments were added. Lining stones were hewn on the exposed sides. While most architectural elements and details were made of bricks, some were also carved out of lime- and sandstone. The bricks were in at least four sizes: 10 × 15 × 30 cm, 8 × 15 × 30 cm, 8 × 14 × 28 cm, and 9 × 12 × 26 cm.

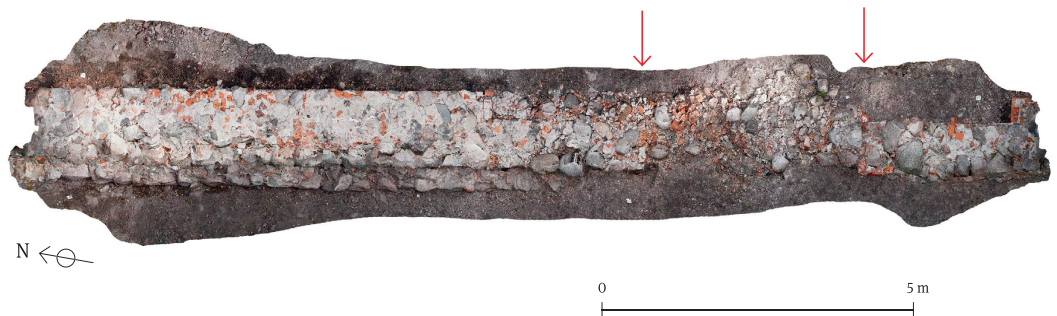
Fig. 3. A possible gateway filled with rubble in the western wall of the castle, marked with arrows.

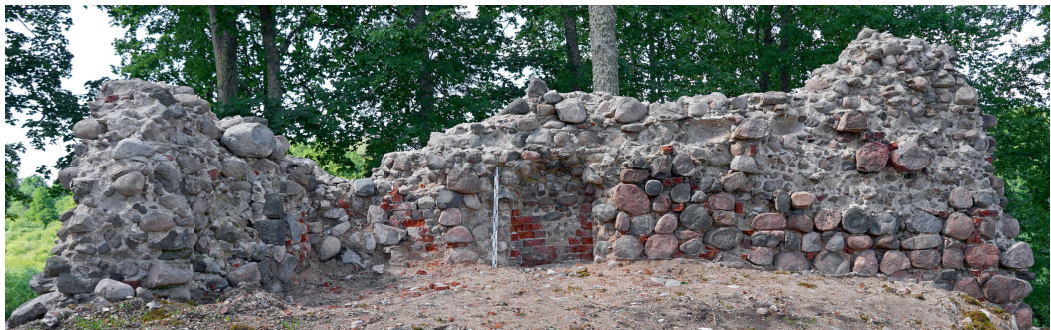
Fig. 4. A room in the northwest part of the castle, in which remains of brick vault arches and a brick-lined niche were discovered.

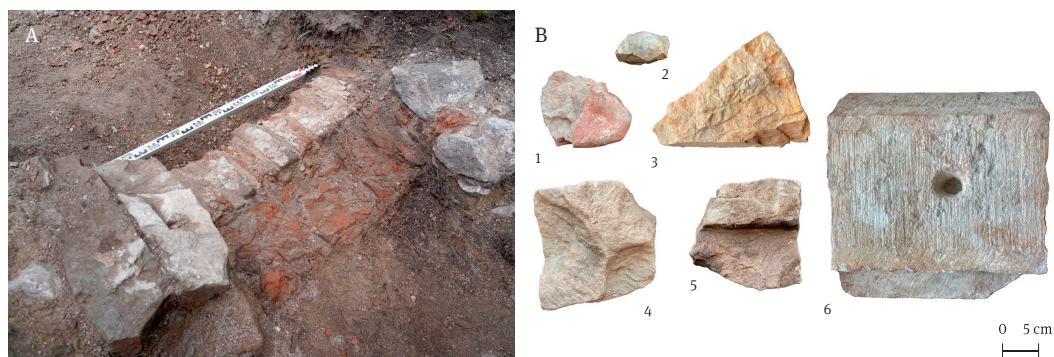
Fig. 5. Limestone and sandstone finds from Tarvastu Castle. A – a door opening uncovered in the southwest part of the castle, with carved sandstones on one side. B – examples of limestone and sandstone, 1–3 – pieces of limestone found in the rubble layer of the eastern gateway, possibly originating from the moraine of the castle hill, 4 – a fragment of carved sandstone found near the eastern gate, 5 – a fragment of carved sandstone found near the rubble layer of the eastern gate, 6 – a fragment of carved limestone found in the door opening uncovered in the southwest part of the castle.

The largest partially investigated structures are the gateways. Clearing the gateway located in the eastern wall of the castle was undertaken. It is the only identifiable gate which is also the only gate shown on the oldest known plan of the castle which probably dates from the 17th century (Fig. 1B). The length of the passageway is 12 metres and its width is 4.4–4.6 metres, and 3.8 metres in the outer part. The southern wall of the gateway, part of which was exceptionally well-preserved, was plastered (Fig. 2). It is possible that the plaster was tinted red. The gateway has suffered significant damage from an explosion. In the central part, the walls have been pushed outward, and most of the lining stones on the northern wall have collapsed. The rubble layer filling the gateway contained, among other things, clinkered and powdered brick fragments. The appearance of natural limestone pieces³ in this layer suggests that the explosion may have mixed the soil up to the moraine (Fig. 5B: 1–2).

Most of carved limestone and sandstone details and their fragments are associated with door and window openings, with the exception of the gateway and its surroundings located in the eastern wall (Fig. 5). Sandstone has been used both for crafting carved details and, in some places, laid as pieces in the walls. Sandstone is either gray or reddish, rich in fine-grained more or less cemented aleurolite. The rocks are local and originate from the Middle

³ This is likely micritic limestone from the Upper Ordovician deposits (Fig. 5: 1, 3) and the Lower Silurian Raikküla Formation limestone (Fig. 5: 2).

Devonian Aruküla Formation of the Tarvastu Member, the closest outcrop of which is beneath the castle hill. Some of the carved stones (Fig. 5: 6) are from layered bioclastic gray limestone. These come from the Middle Ordovician Vão Formation outcropping in North Estonian Klint areas and were likely transported as finished products to Tarvastu.

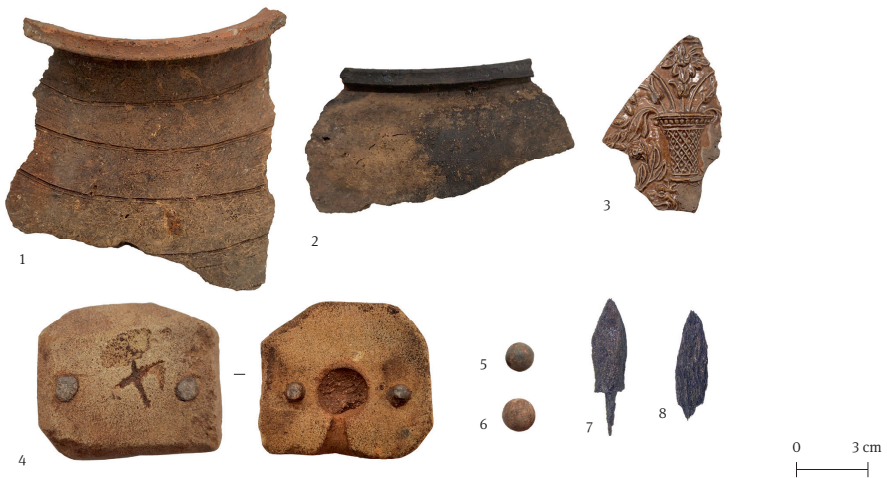
Fig. 6. Finds collected from Tarvastu Castle. 1–3 – pottery fragments, 4 – a casting mould made of sandstone for lead bullets, 5–6 – lead bullets, 7–8 – crossbow bolt tips.

In total, 148 finds were obtained from the castle, with the majority coming from the inner courtyard. The predominant part (127) consists of fragments of simple wheel-made coarseware pots, supplemented by green-glazed grayware (TÜ 3056: 1), a sherd of Raeren stoneware (Fig. 6: 3), and a foot of a tripod pot (TÜ 3056: 113).

Of the 24 rim fragments of coarseware pots, at least 15 belong to Northwestern Russian-style ceramics group 5 (Tvauri 2000; 2004, 389–400) (Fig. 6: 2), characterized by a short outwardly turned rim. Considering typochronological datings and written records related to Tarvastu Castle, group 5 pottery fragments, as well as one sherd of green-glazed grayware, can be dated to a relatively short period in the 1560s when Tarvastu Castle was under the control of the Muscovite Tsardom's military. Based on the distribution of the finds, it appears that some of the debris was discarded in the corners of the castle's inner courtyard at that time.

Some pottery fragments (Fig. 6: 1) may originate from pots that were made before the events of the Livonian War (1558–1583). Finds that for certain date from the Medieval period are crossbow bolts (Fig. 6: 7–8). They originate from the 14th to 15th centuries according to analogies (Mäesalu 1991). Among other finds, it is worth mentioning a sandstone casting mould for making lead bullets with a maker's mark on one side (Fig. 6: 4), two lead bullets (Fig. 6: 5–6), a fragment of a small cannonball (TÜ 3056: 141), and an axe (TÜ 3056: 136) with preserved wood in its eye.
